HL-LHC Nonconformity Report LQXFA/B01 Leak Check

Work Package	WP3	Equipment <u>HCQQXF_SC002-FL000001</u>			
Collaboration	S. Feher, R. Rabehl, T. Vouris,	Process	Leak Check		
Contract Team	J. Blowers	Inspector	J. Blowers

The combination leak check/pressure test of the CM01 after being cryostated, did not meet the leak rate specification of lower than 1E-9 Torr-liter/sec (1.32E-9 atm-cc/sec). This is requirement #9 in "Requirements Specification for the Assembly of LQXFA/B/E/F", EDMS <u>1828585</u>.

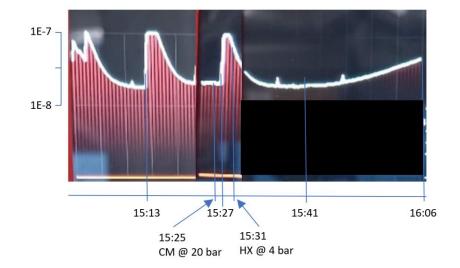
- A pumping cart (turbo, roots blower, roughing pump) was connected to one end of the cryoassembly, and an Adixen ASM390 leak detector was connected to back the turbo pump when valved in. The MSLD reached a stable background of ~2.5E-8 atm-cc/sec.

Figure 1 – Pumping cart being backed by Adixen MSLD
