ProtoDUNE 2 PDS Connector Issues

Manuel Arroyave, [David Warner](#), Francesco Terranova
FD1 Technical Board Meeting
8 November 2023

FD1 Photon Detector (PDS) TCO Closure Status: SUMMARY

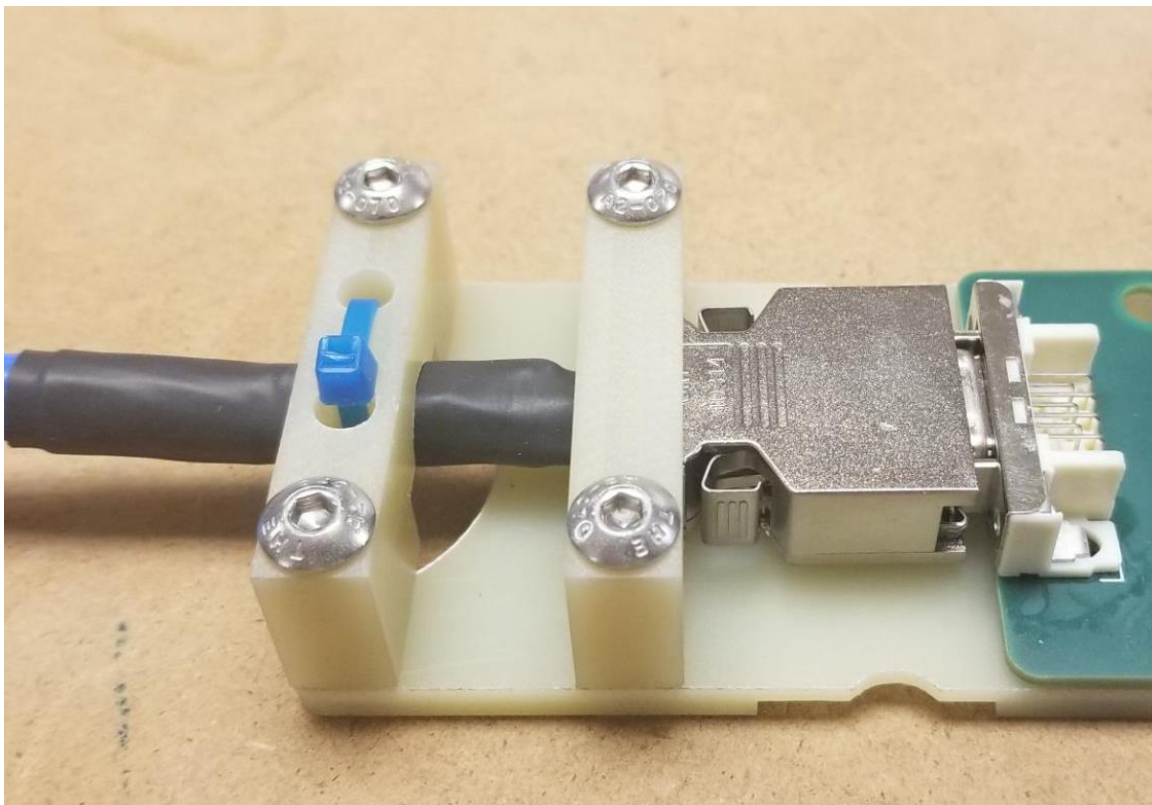
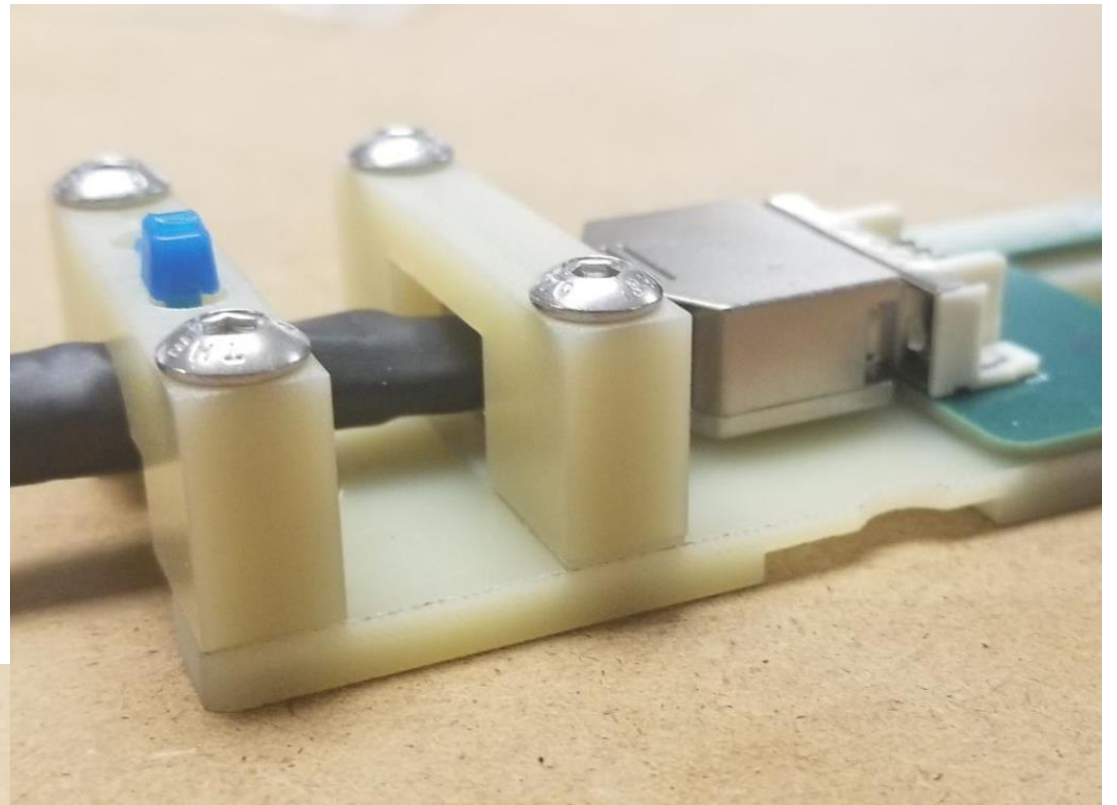
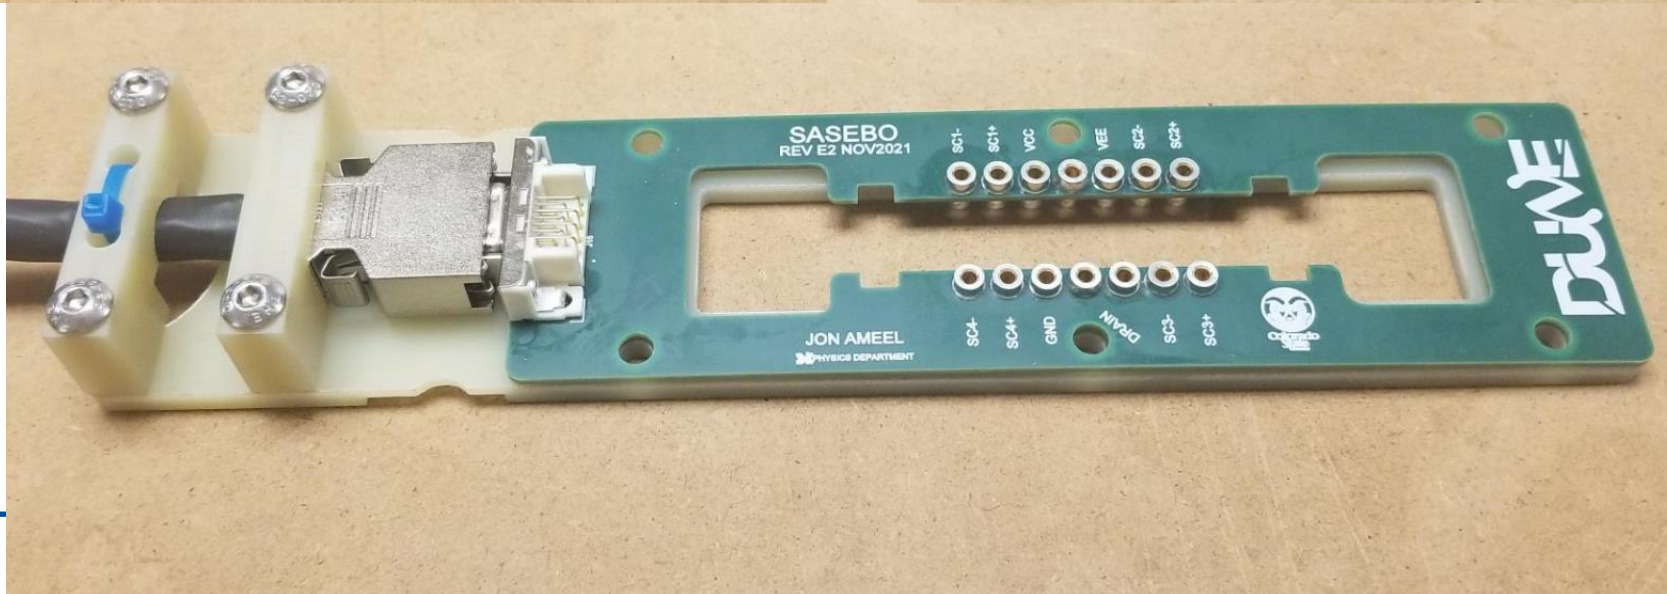
ProtoDUNE 2 Design: Significant (~2mm) PD cable interference with temperature sensor and cable tie clip (Upper APA only)

New PD cable strain relief (prototype August 2022)
