# Temperature sensors on APAs

A. Cervera

IFIC-Valencia

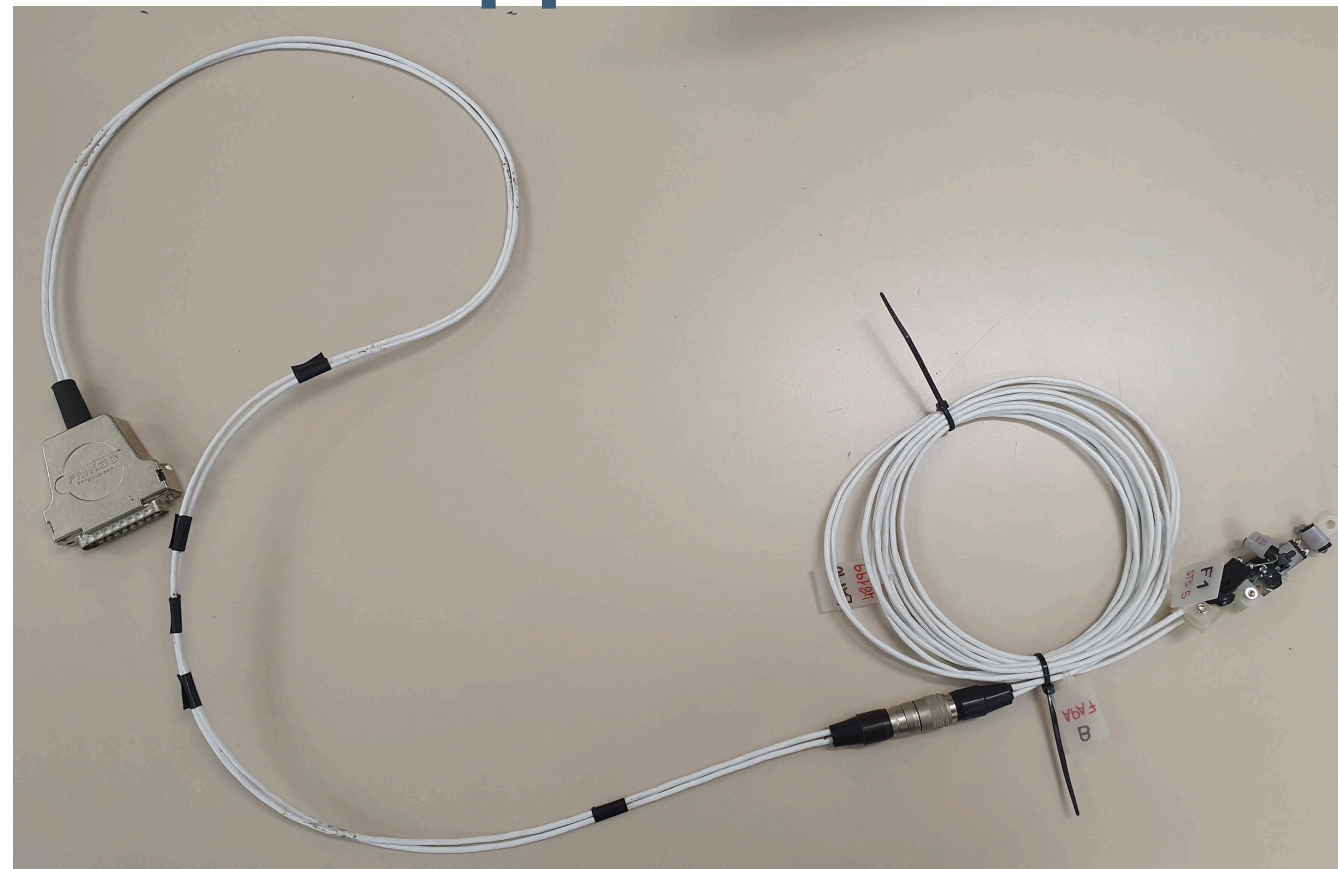
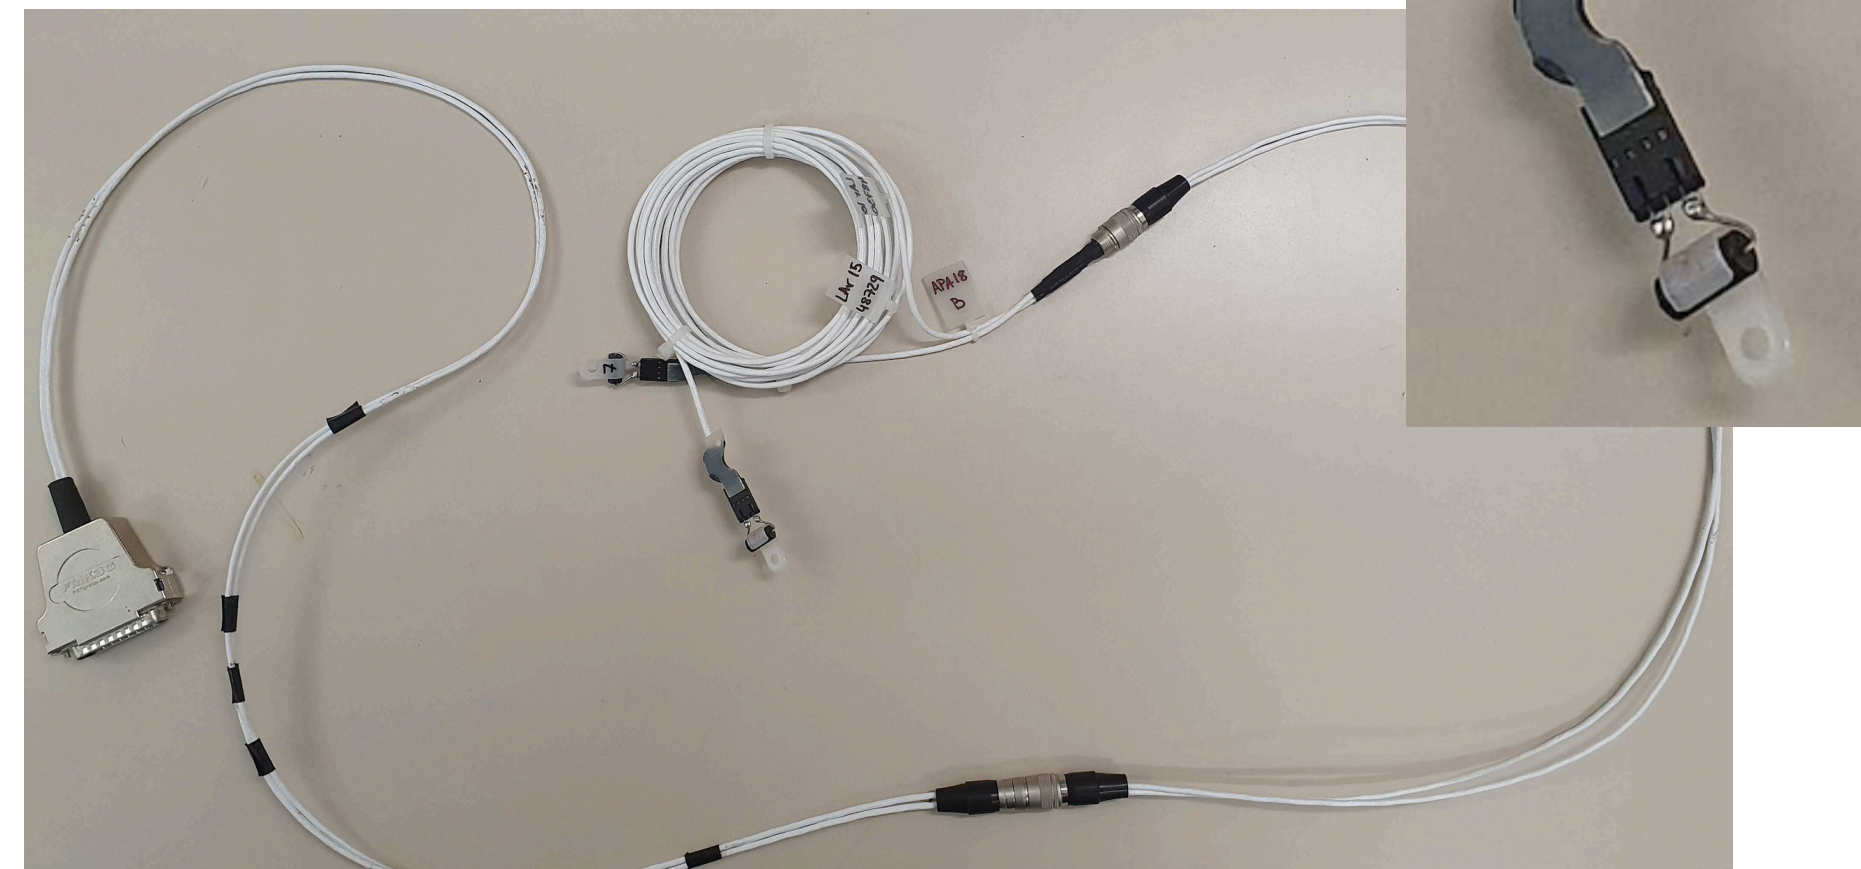
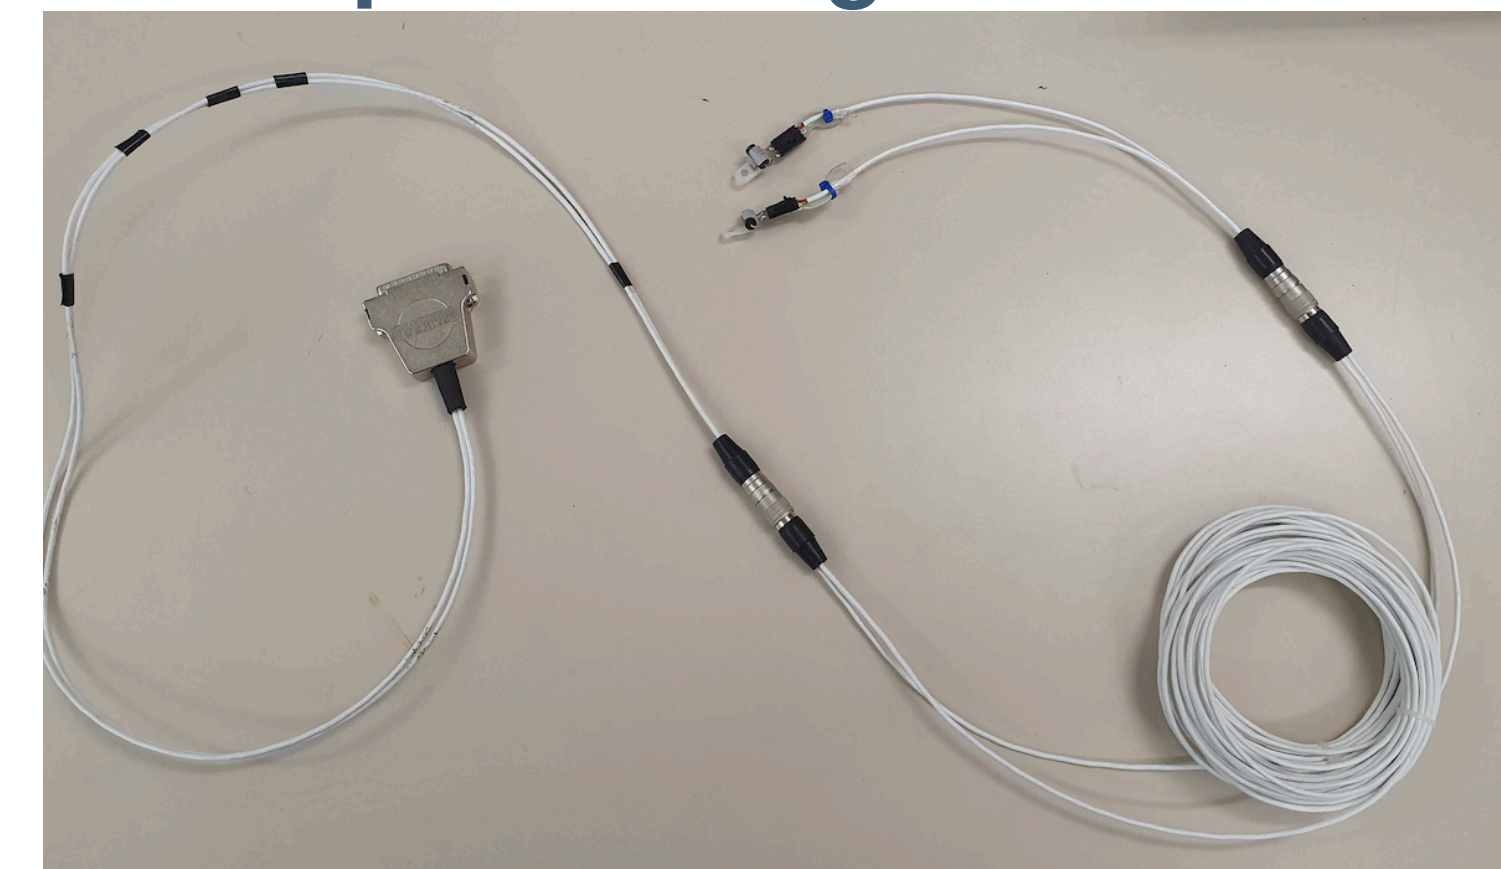
- Daresbury has reported electrical failures for many RTD cables
- We have retested all cables at IFIC and confirmed there is not a single failure
- Electrical tests were not foreseen at APA production factories and therefore there was not written procedure
  - All tests were done at IFIC before shipment, both in cold and in warm.
  - Probability of failure after shipment was estimated to be negligible
- We have now reconsidered this decision and will provide to APA production factories with the necessary hardware to quickly perform electrical tests in all cables

- **Repair:** none
- **Changes in production:** none
- **Changes in QA/QC:** electrical tests at APA production factories before and after installation

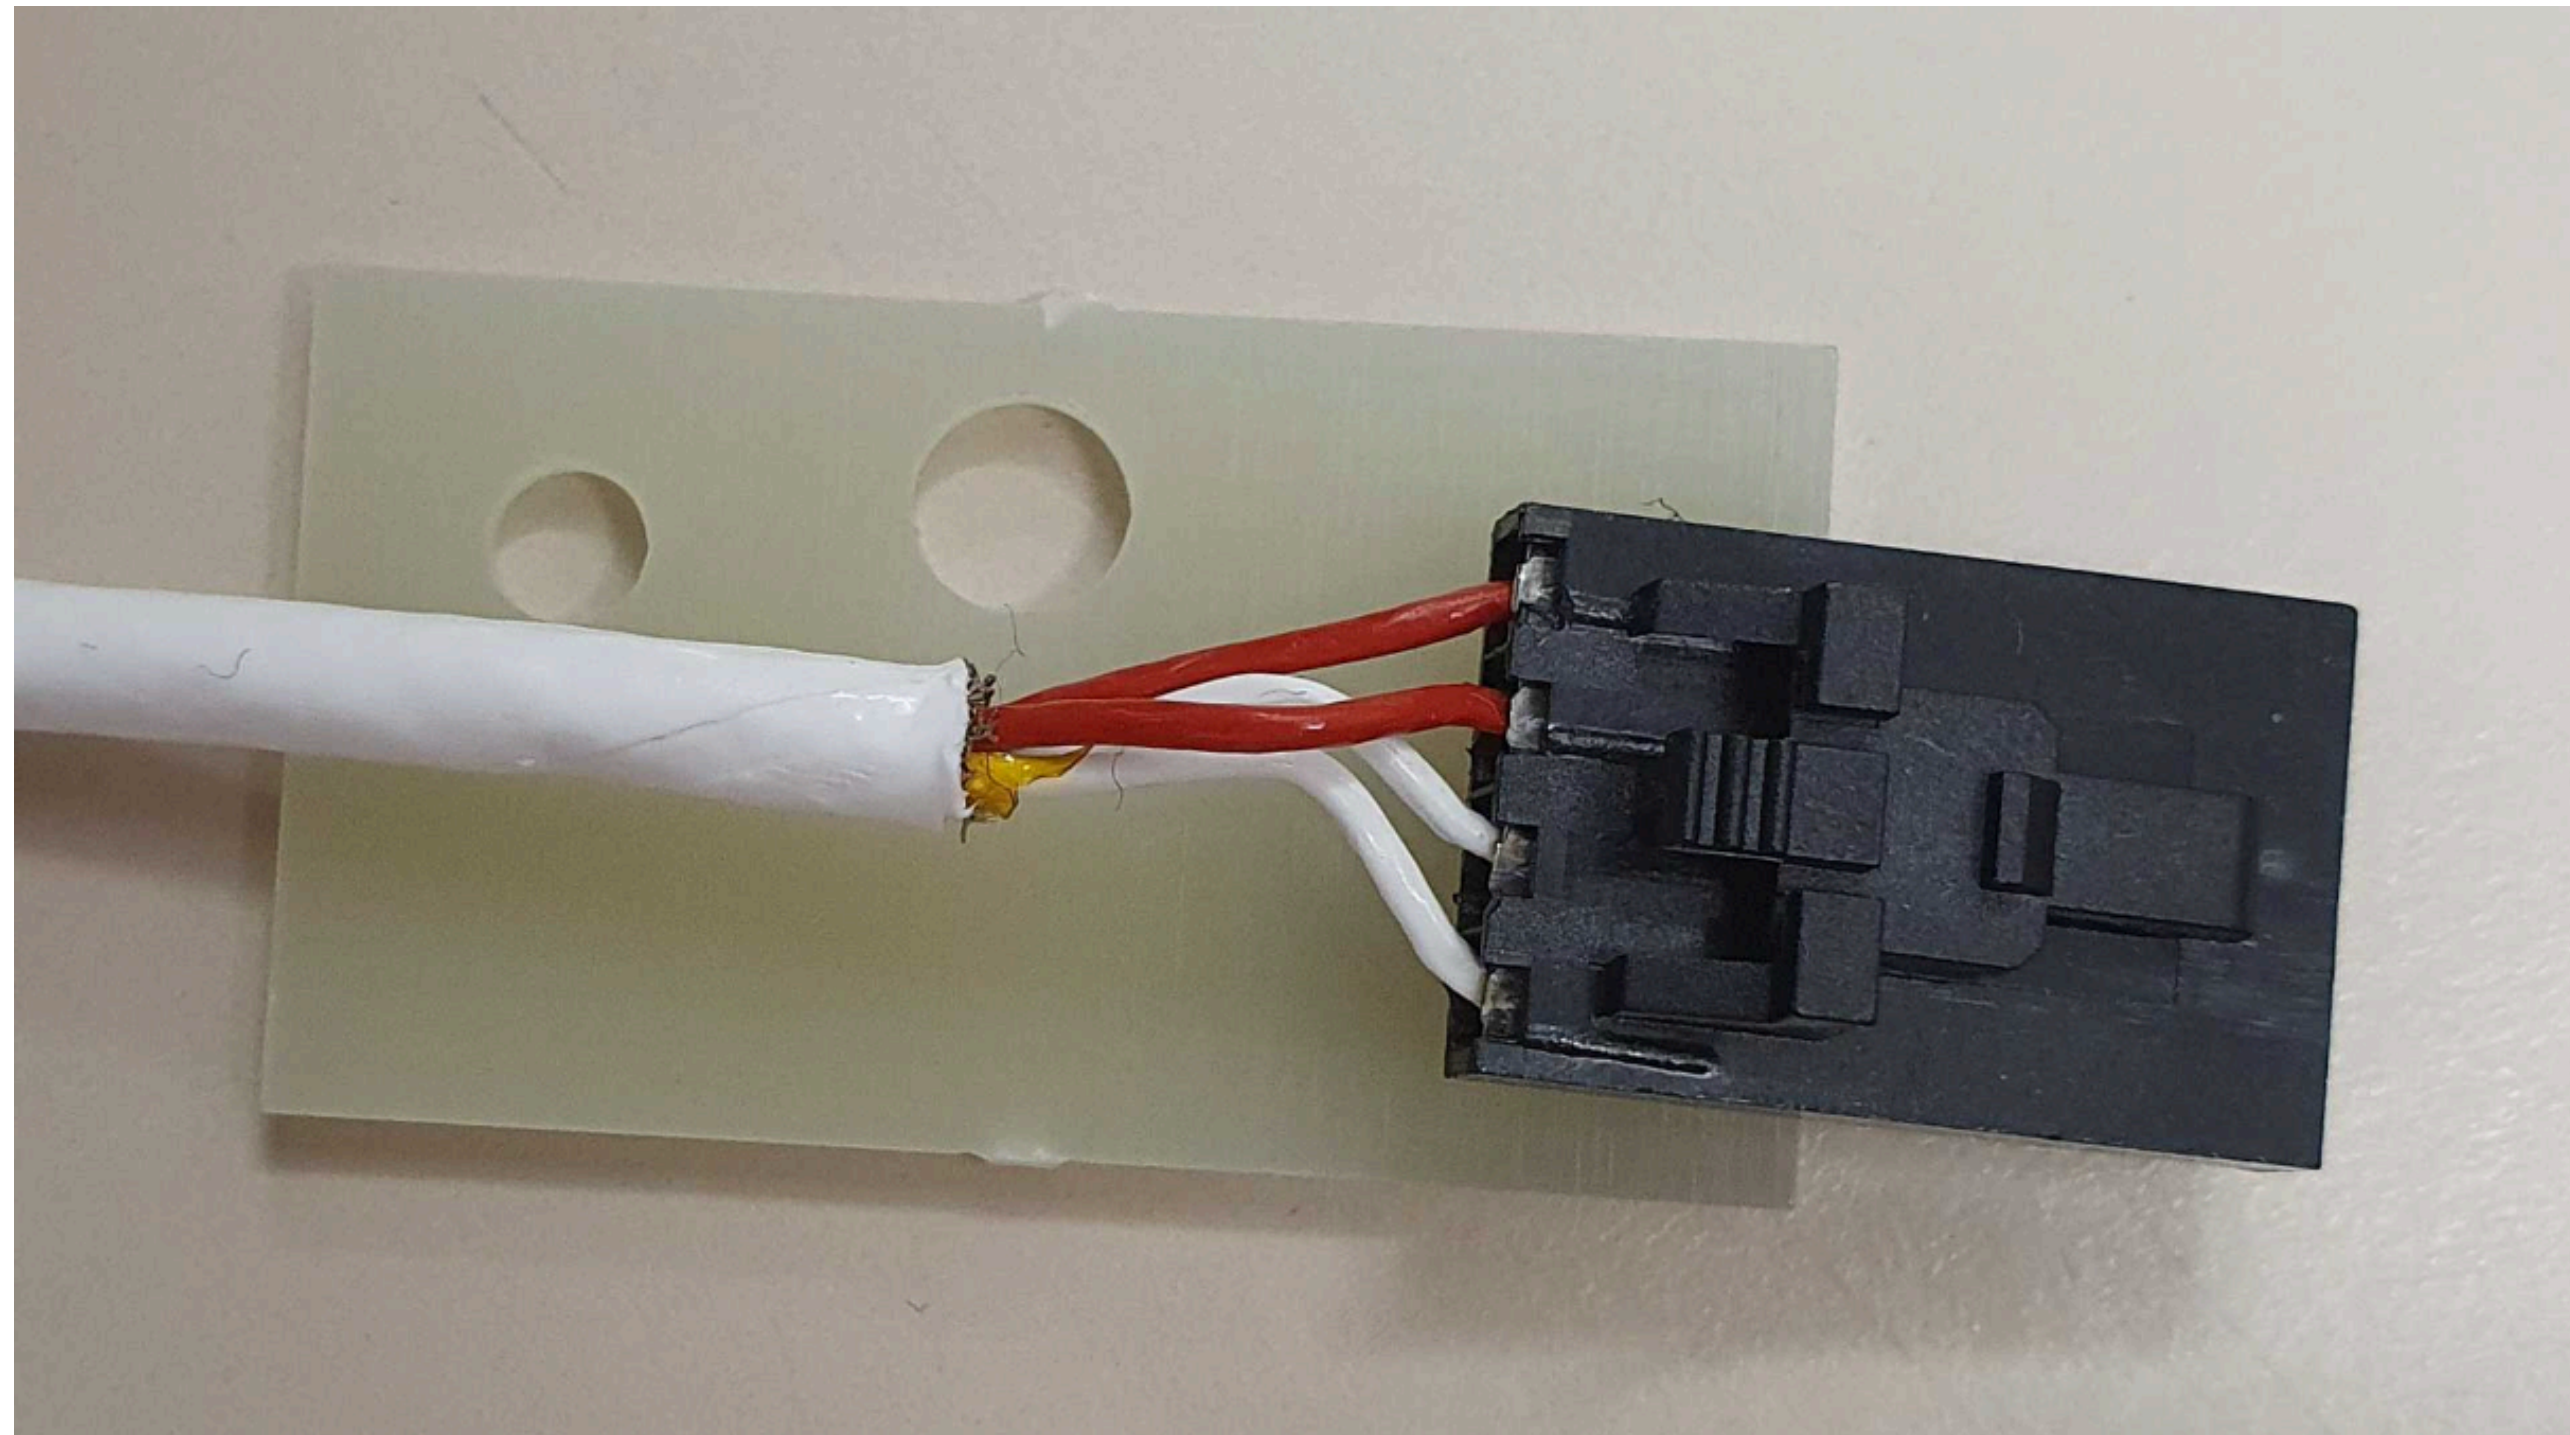
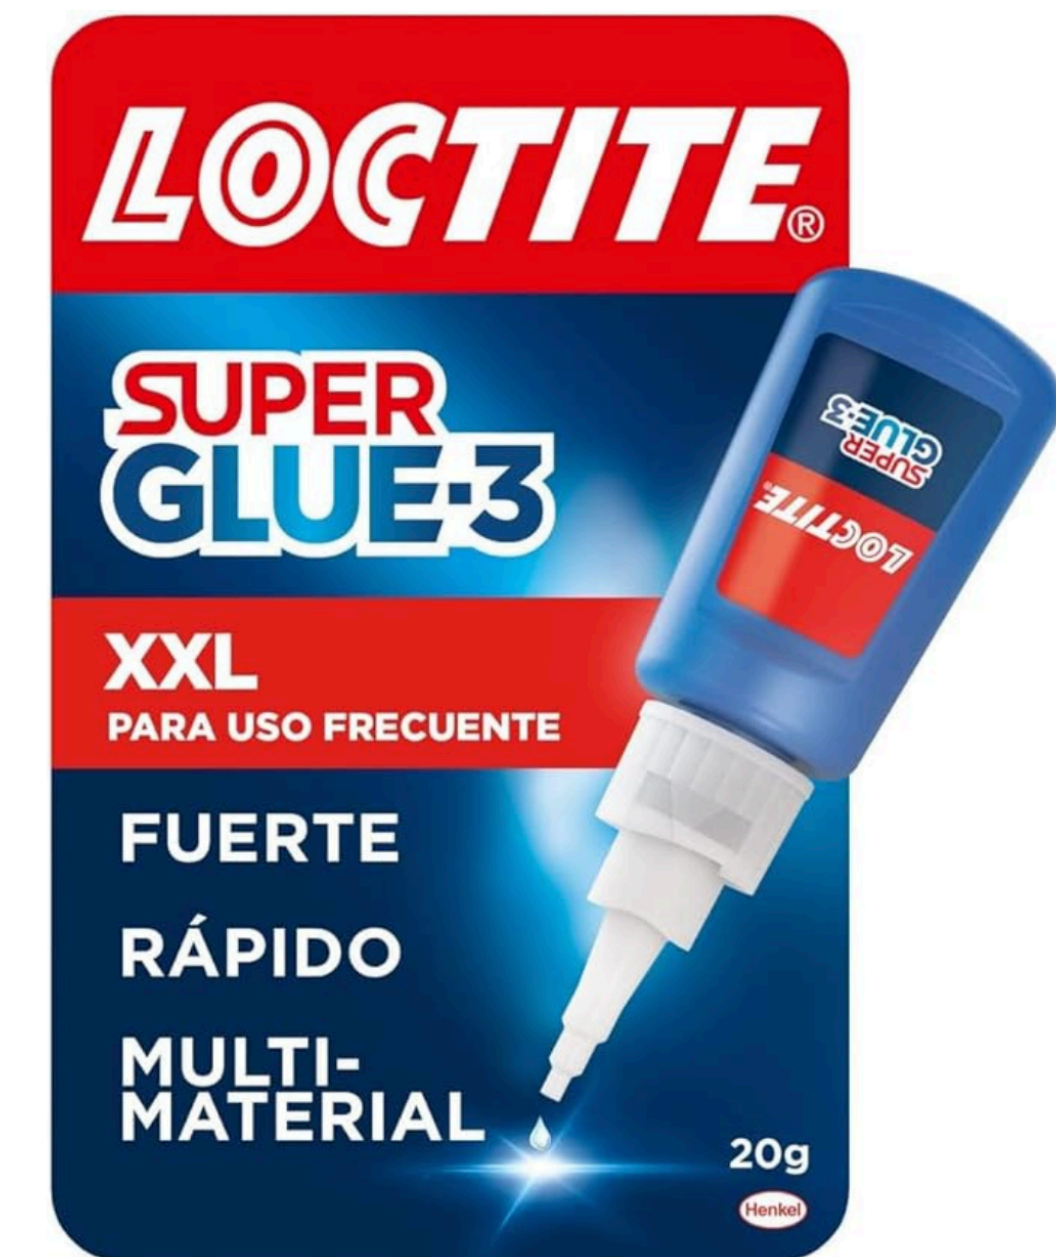
# Problem 4: Misaligned holes in PCBs

- The IDC-4 female connector is glued with loctite super glue-3 on the cable PCB. This is done manually, and alignment is done by eye

- In some cases the alignment is not correct and once the sensor is plugged in the holes of the two PCBs doesn't match each other

- **Repair:** Use a cylindrical lime to increase the size of hole in lower PCB
- **Changes in production:** A special tool where the cable PCB and the IDC-4 female connector are placed before gluing is been fabricated
- **Changes in QA/QC:** Mount the entire kit

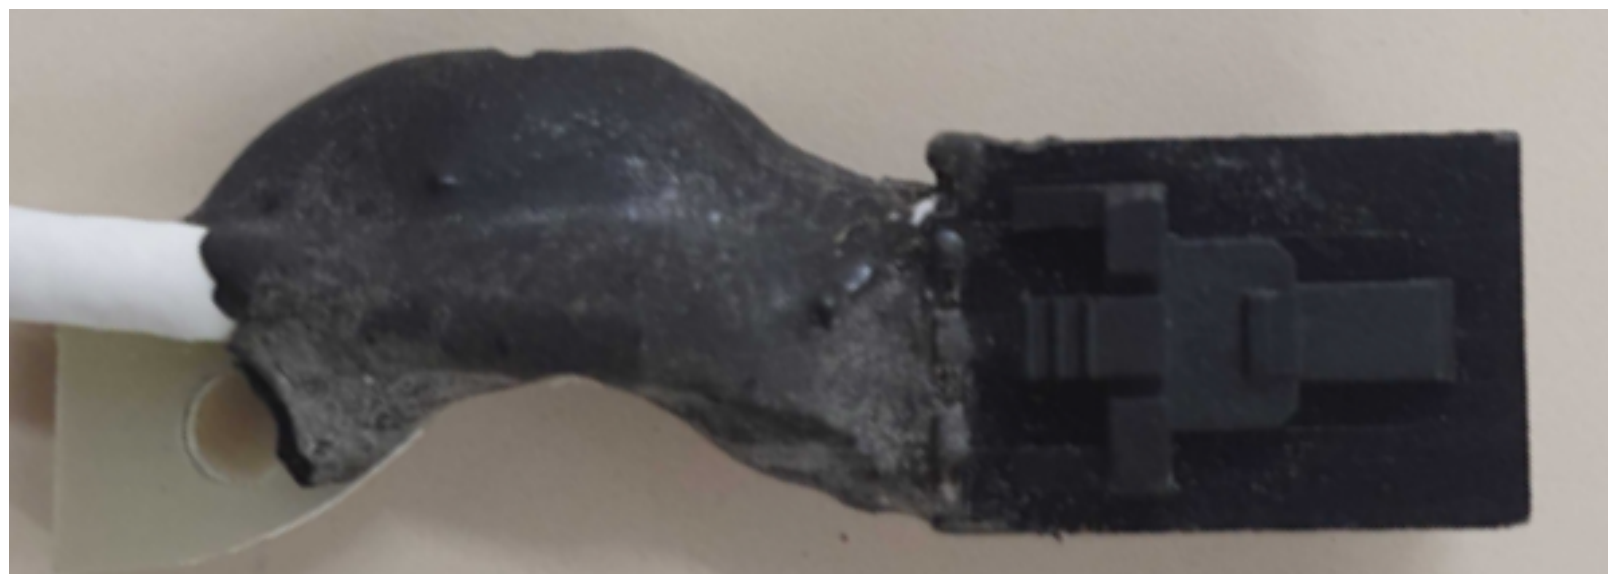
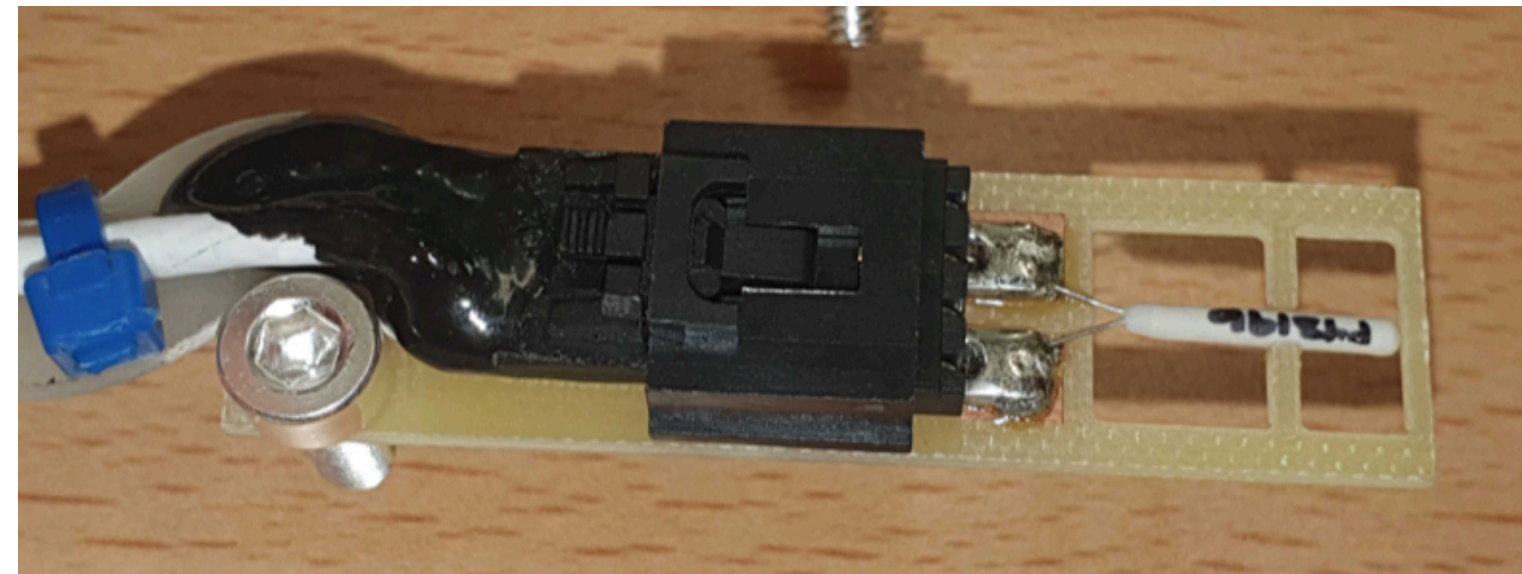
**Good**

- For lower APAs there is no hole in the PCB. Instead a narrower PCB with the appropriate curve is used. Sometimes the cable prevents adding the M4 bolt
- **Repair:** There is no quick solution for this. The cable must be cut as close as possible to the edge and a new PCB and connector should be installed
- **Changes in production:** Correctly position the cable before epoxying. Add a bit of loctite super glue to fix the cable
- **Changes in QA/QC:** Mount entire kit with M4 bolt

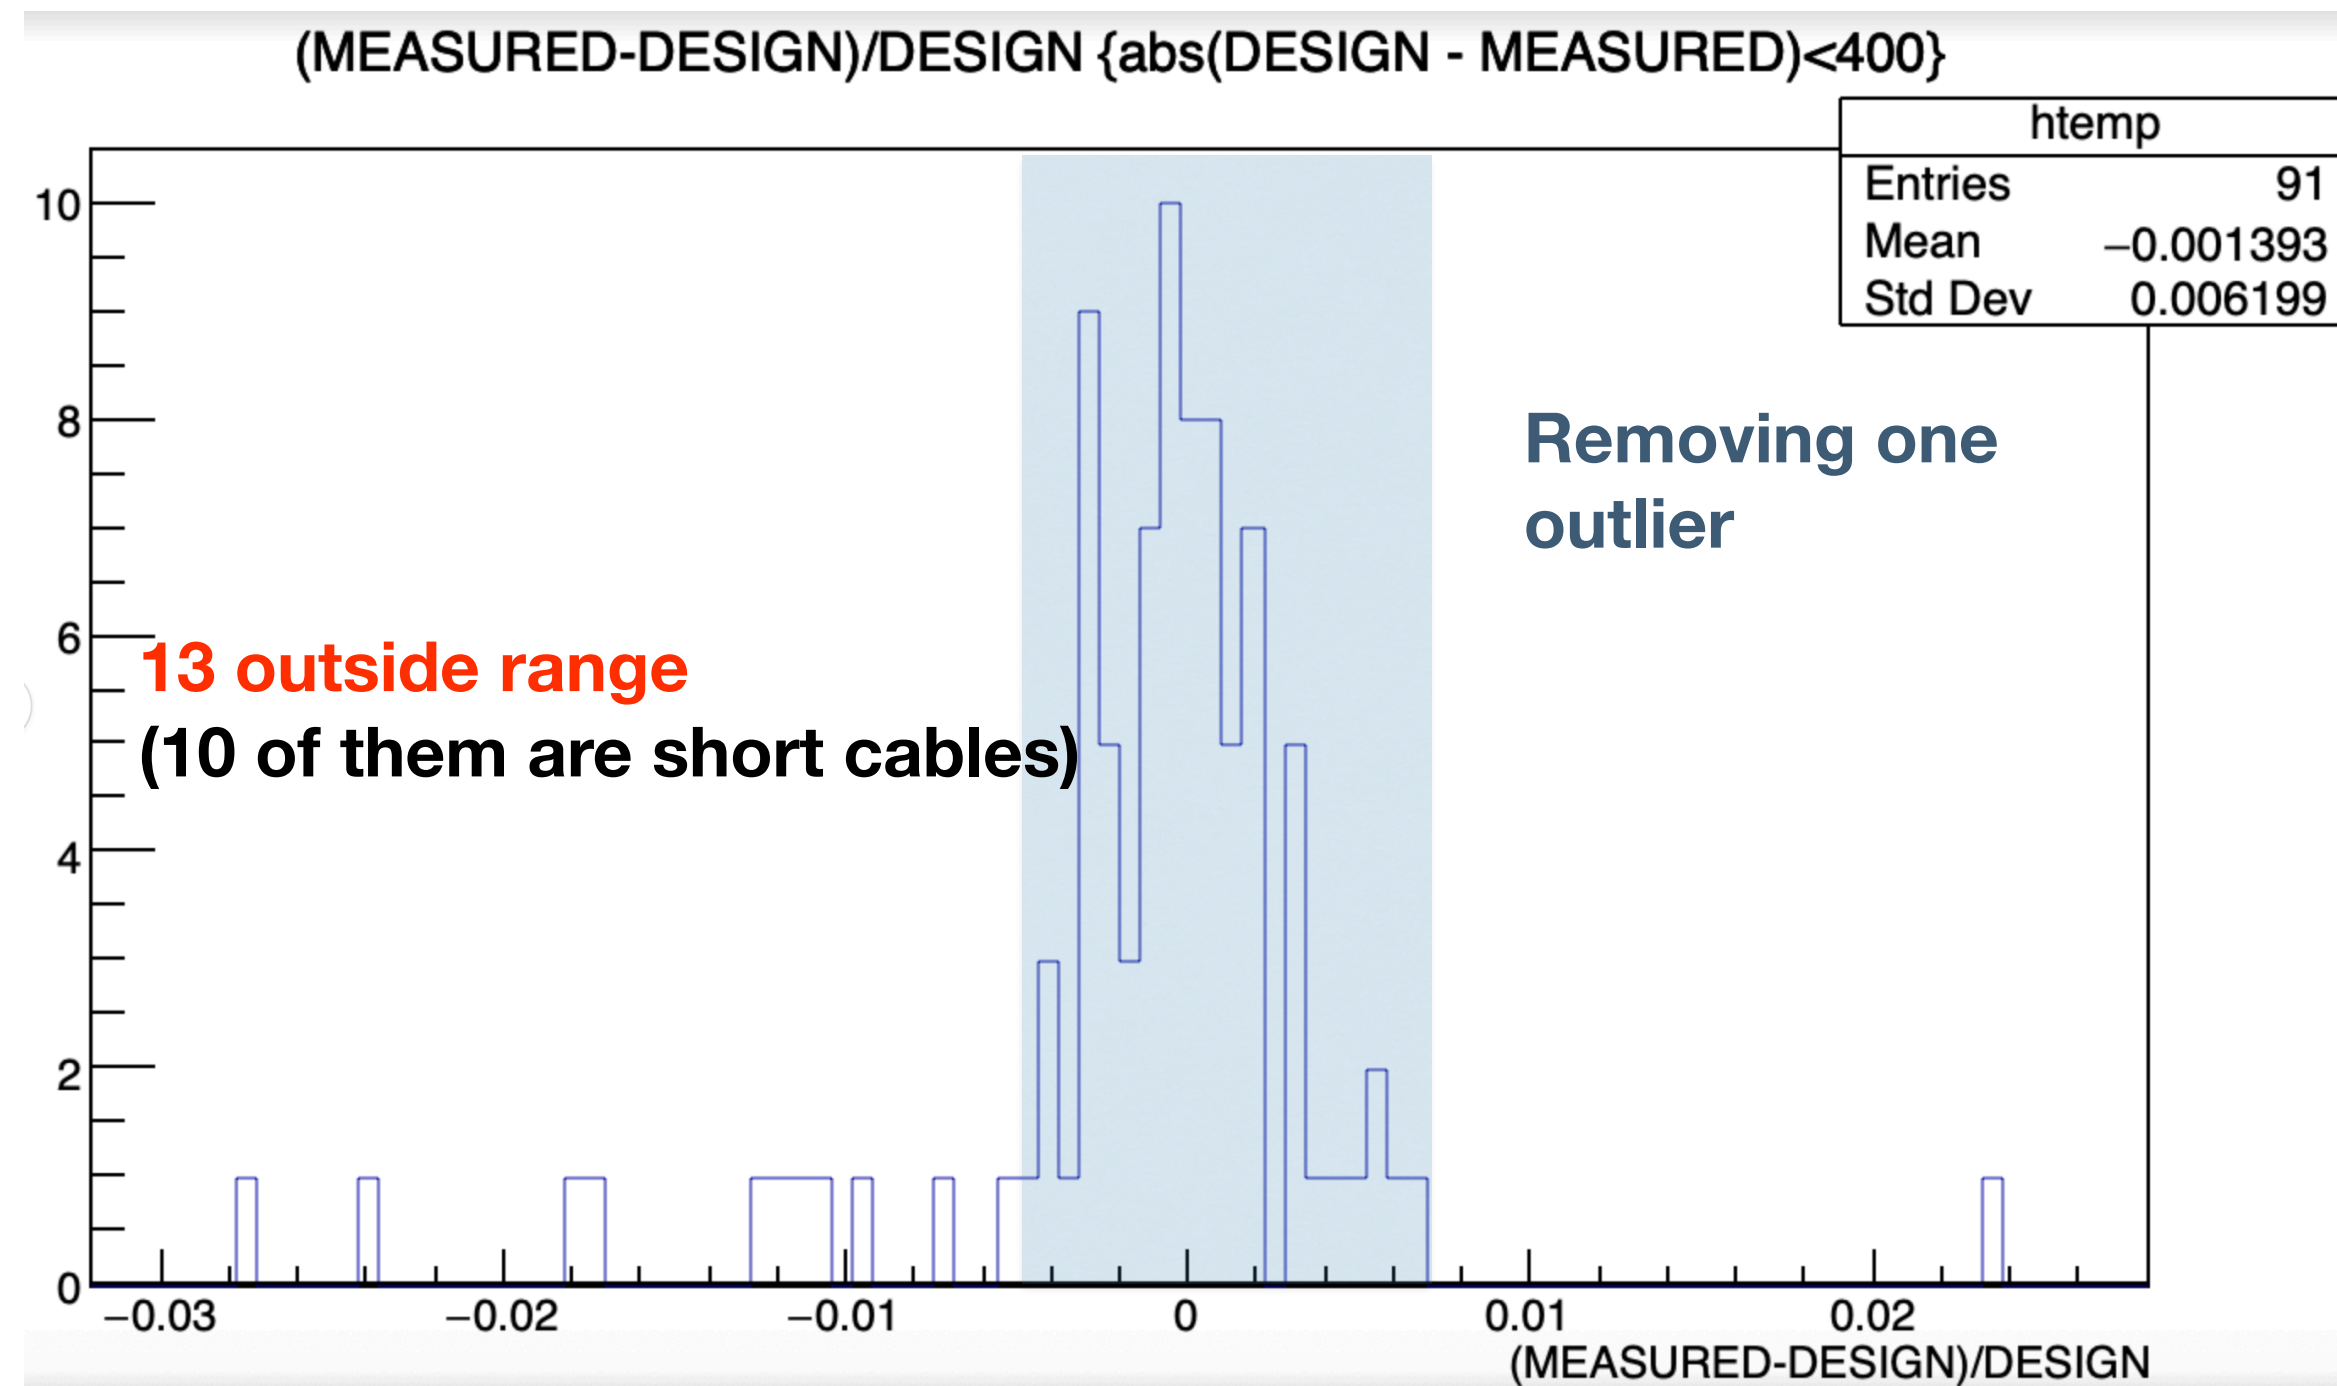
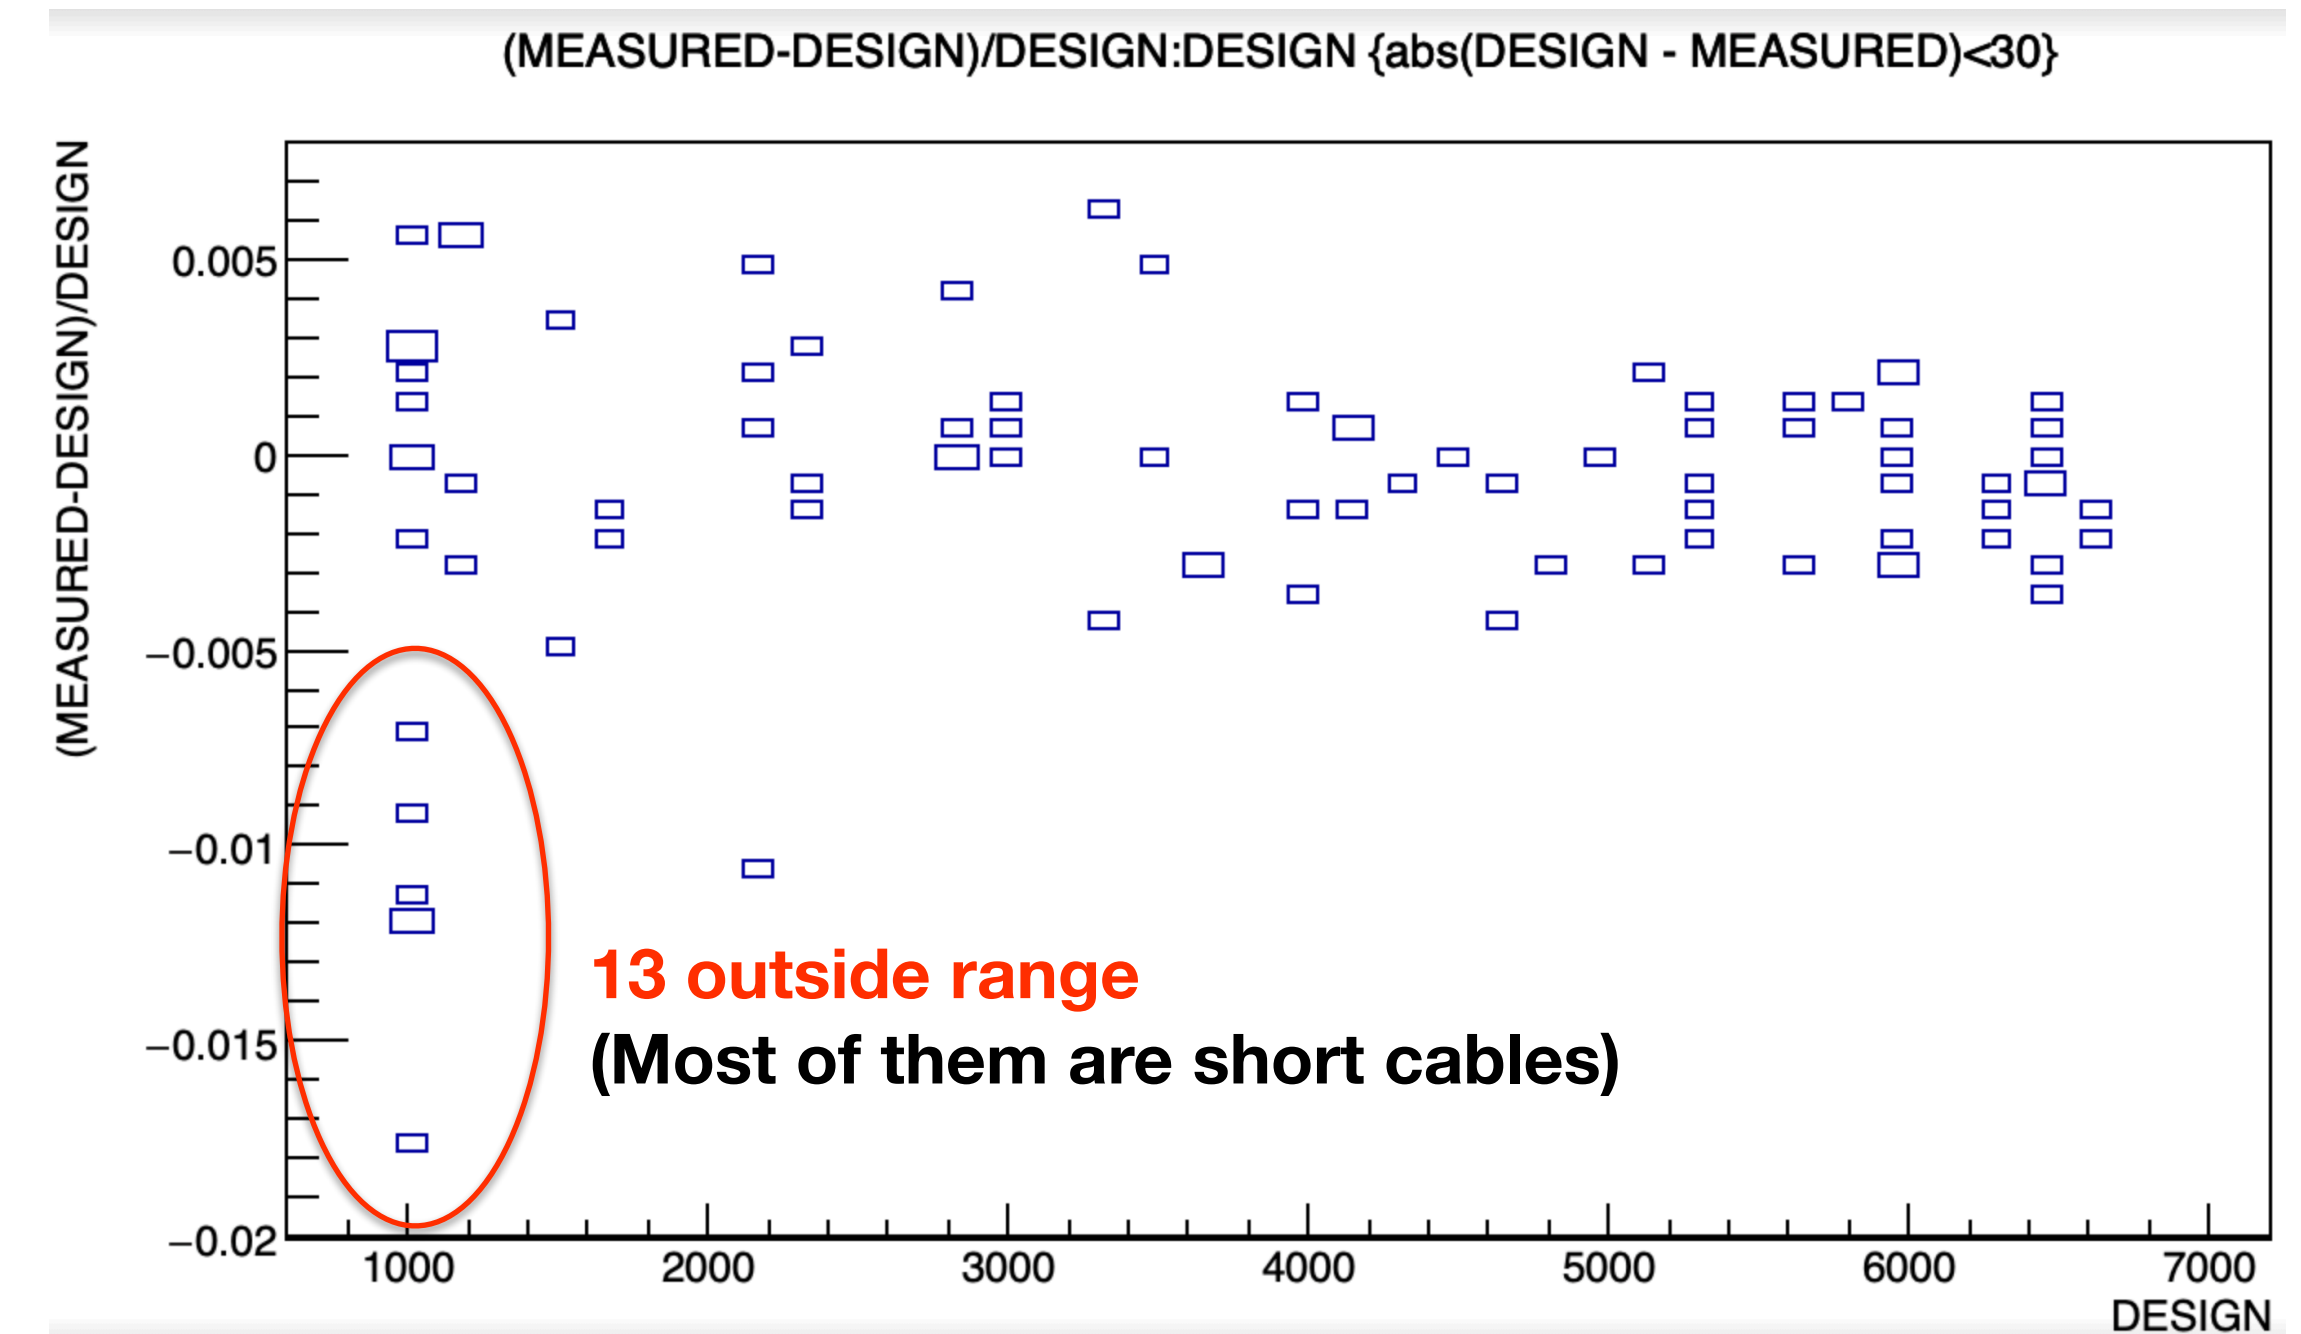
# Problem 7: Cable length

- Cables have 2% slack to account for contraction in cold
- When cutting, we used a 10m long tape measure on the floor
  - 0.5% tolerance is allowed
- We have cross-checked the lengths of 23 APA kits. Results available [here](#)

- Insufficient QC for cable lengths
- **Repair:** redo cables with lengths outside allowed range
- **Changes in production:** use a laser distance meter and proper fixing tools
- **Changes in QA/QC:** measure cables at several stages during production
  - When cutting them
  - After connectorising
  - Before packaging for shipment
