Temperature sensors on APAs

IFIC-Valencia

Introduction

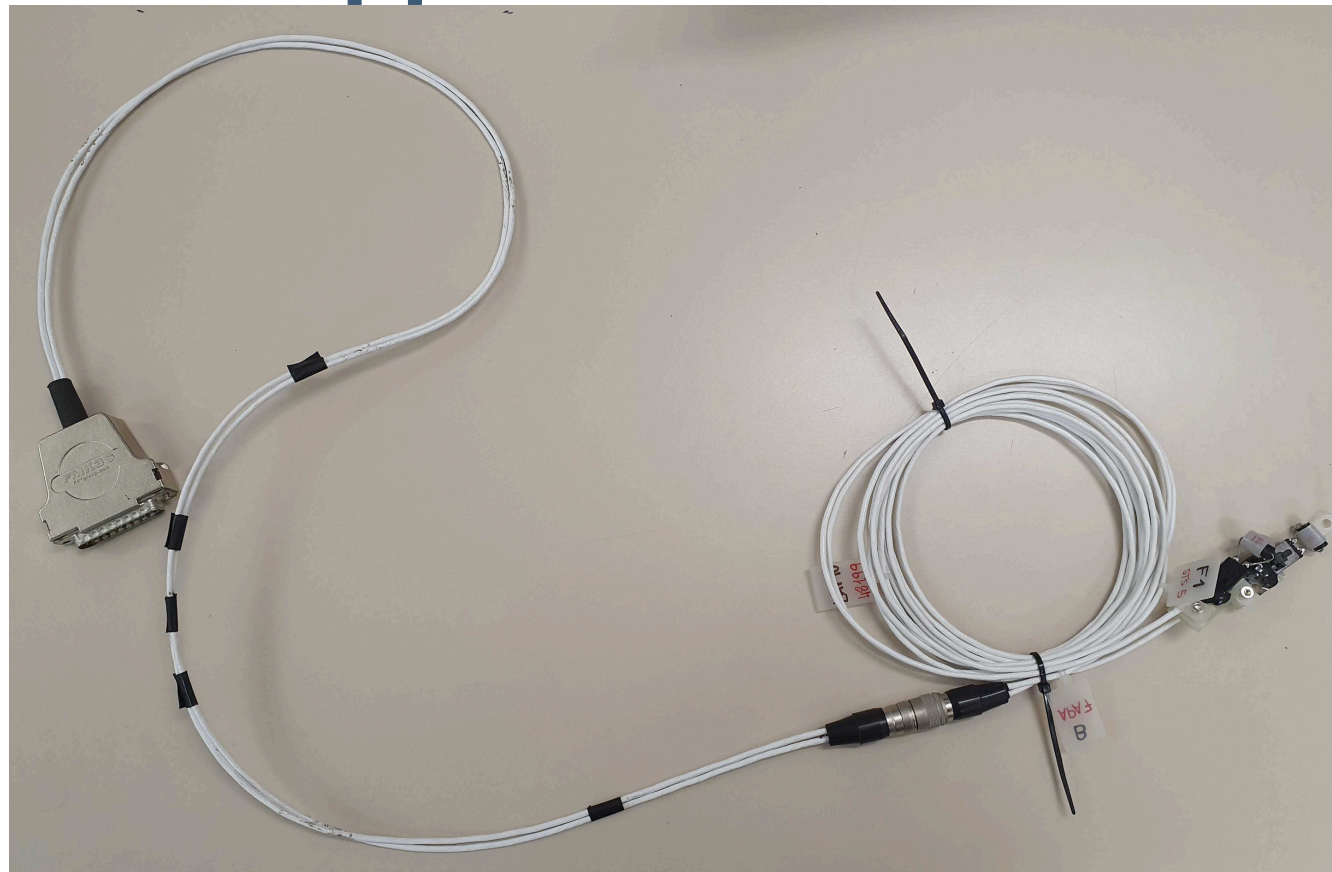
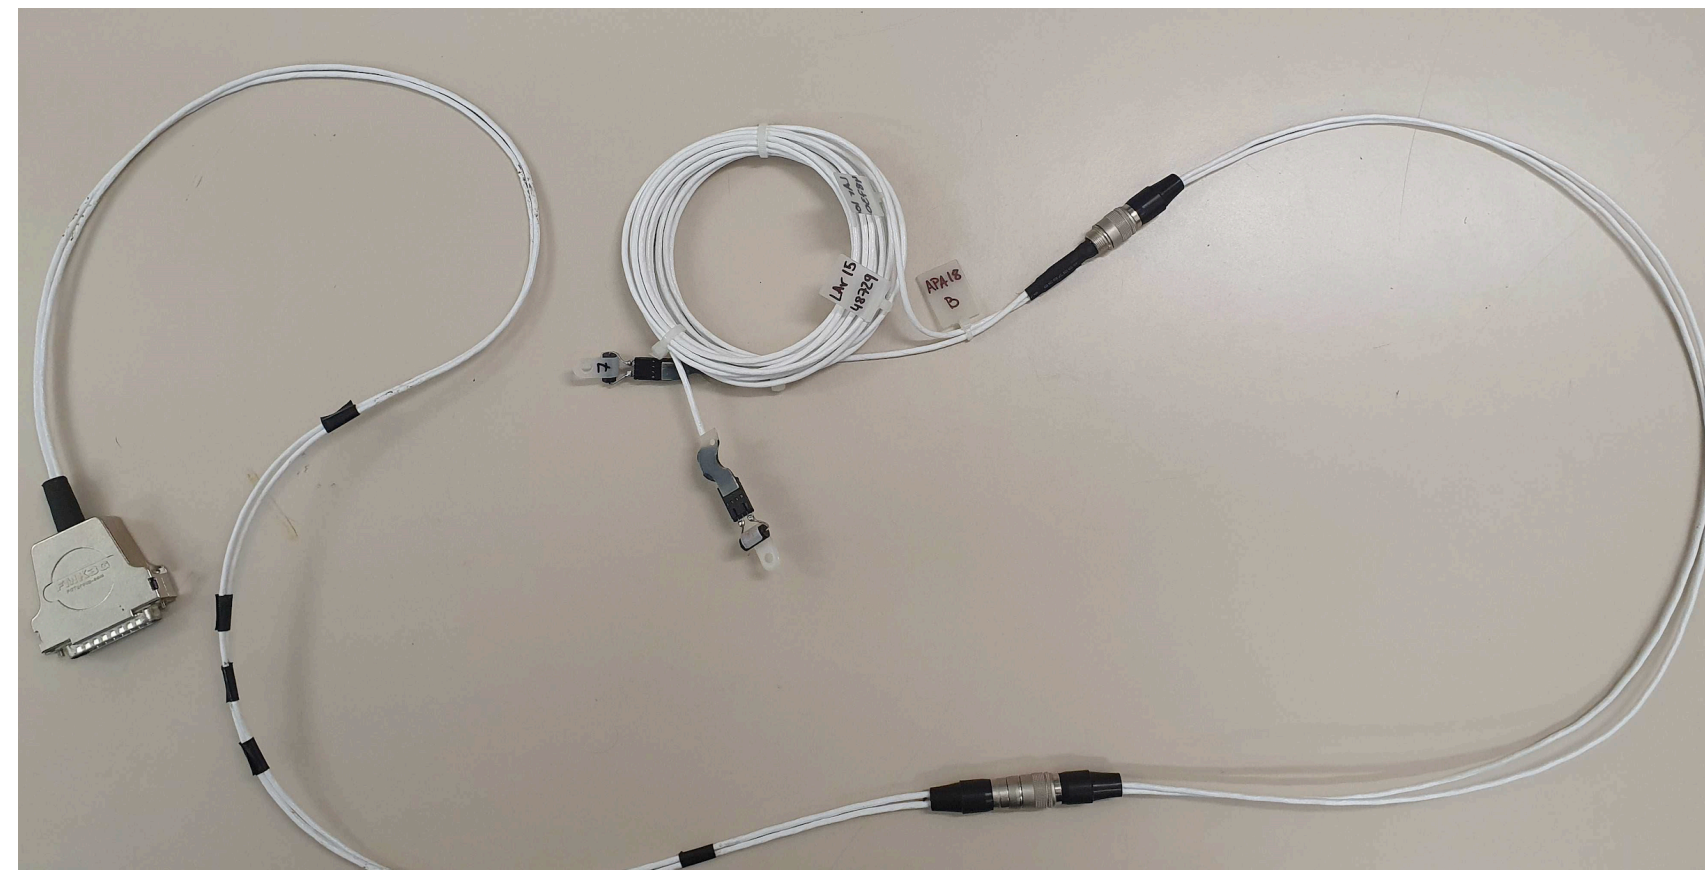
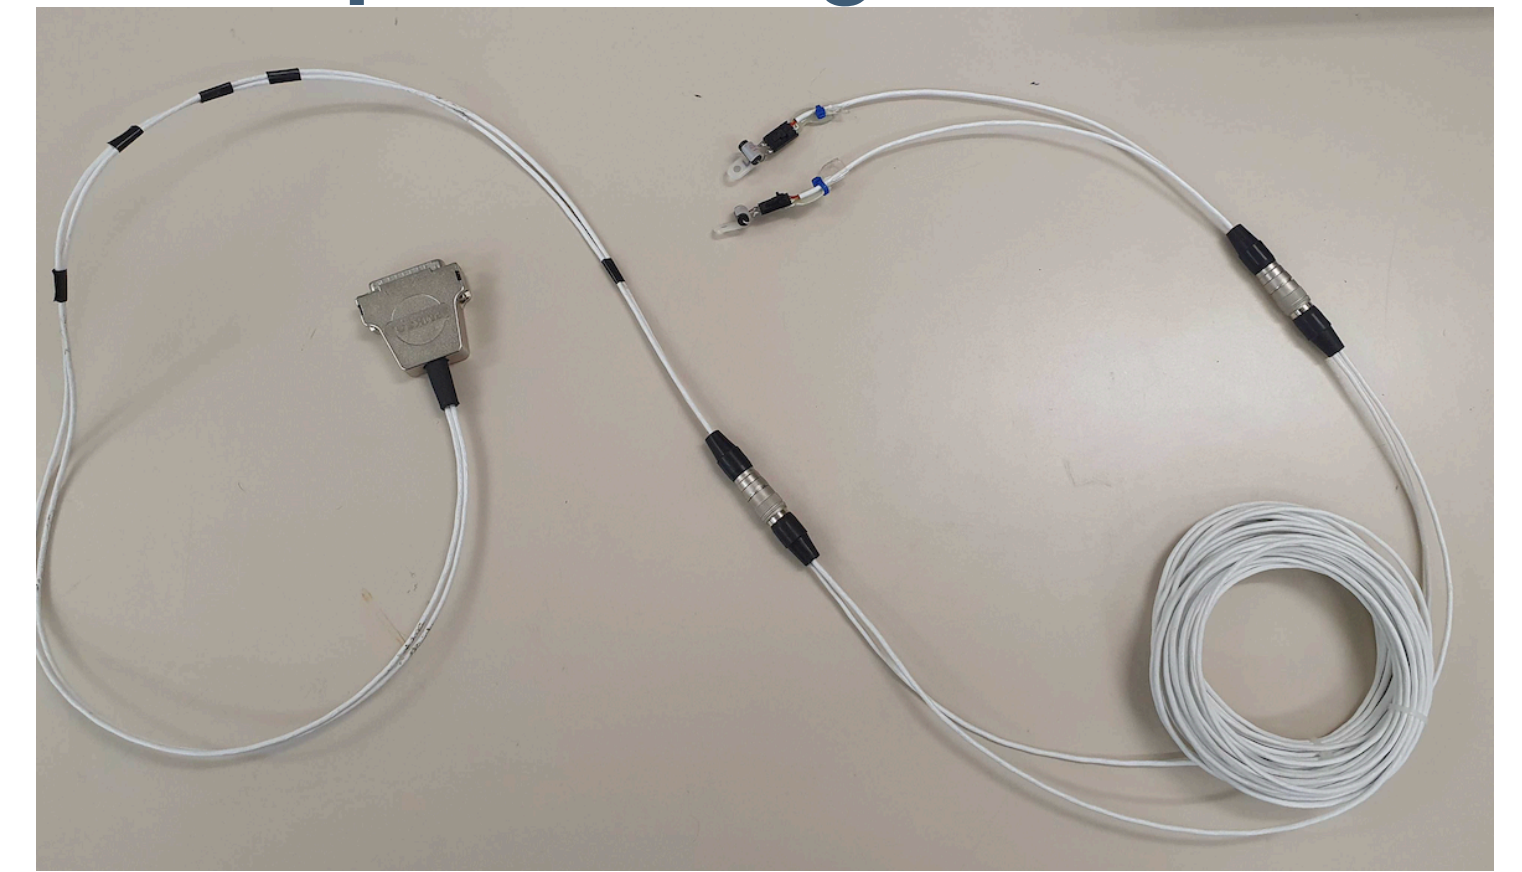
- Daresbury has reported electrical failures for many RTD cables
- We have retested all cables at IFIC and confirmed there is not a single failure
- Electrical tests were not foreseen at APA production factories and therefore there was not written procedure
 - All tests were done at IFIC before shipment, both in cold and in warm.
 - Probability of failure after shipment was estimated to be negligible
- We have now reconsidered this decision and will provide to APA production factories with the necessary hardware to quickly perform electrical tests in all cables

- **Repair:** none
- **Changes in production:** none
- **Changes in QA/QC:** electrical tests at APA production factories before and after installation

Substitute SUBD-25 connector by a PCB with 4 copper pads, two for each RTD

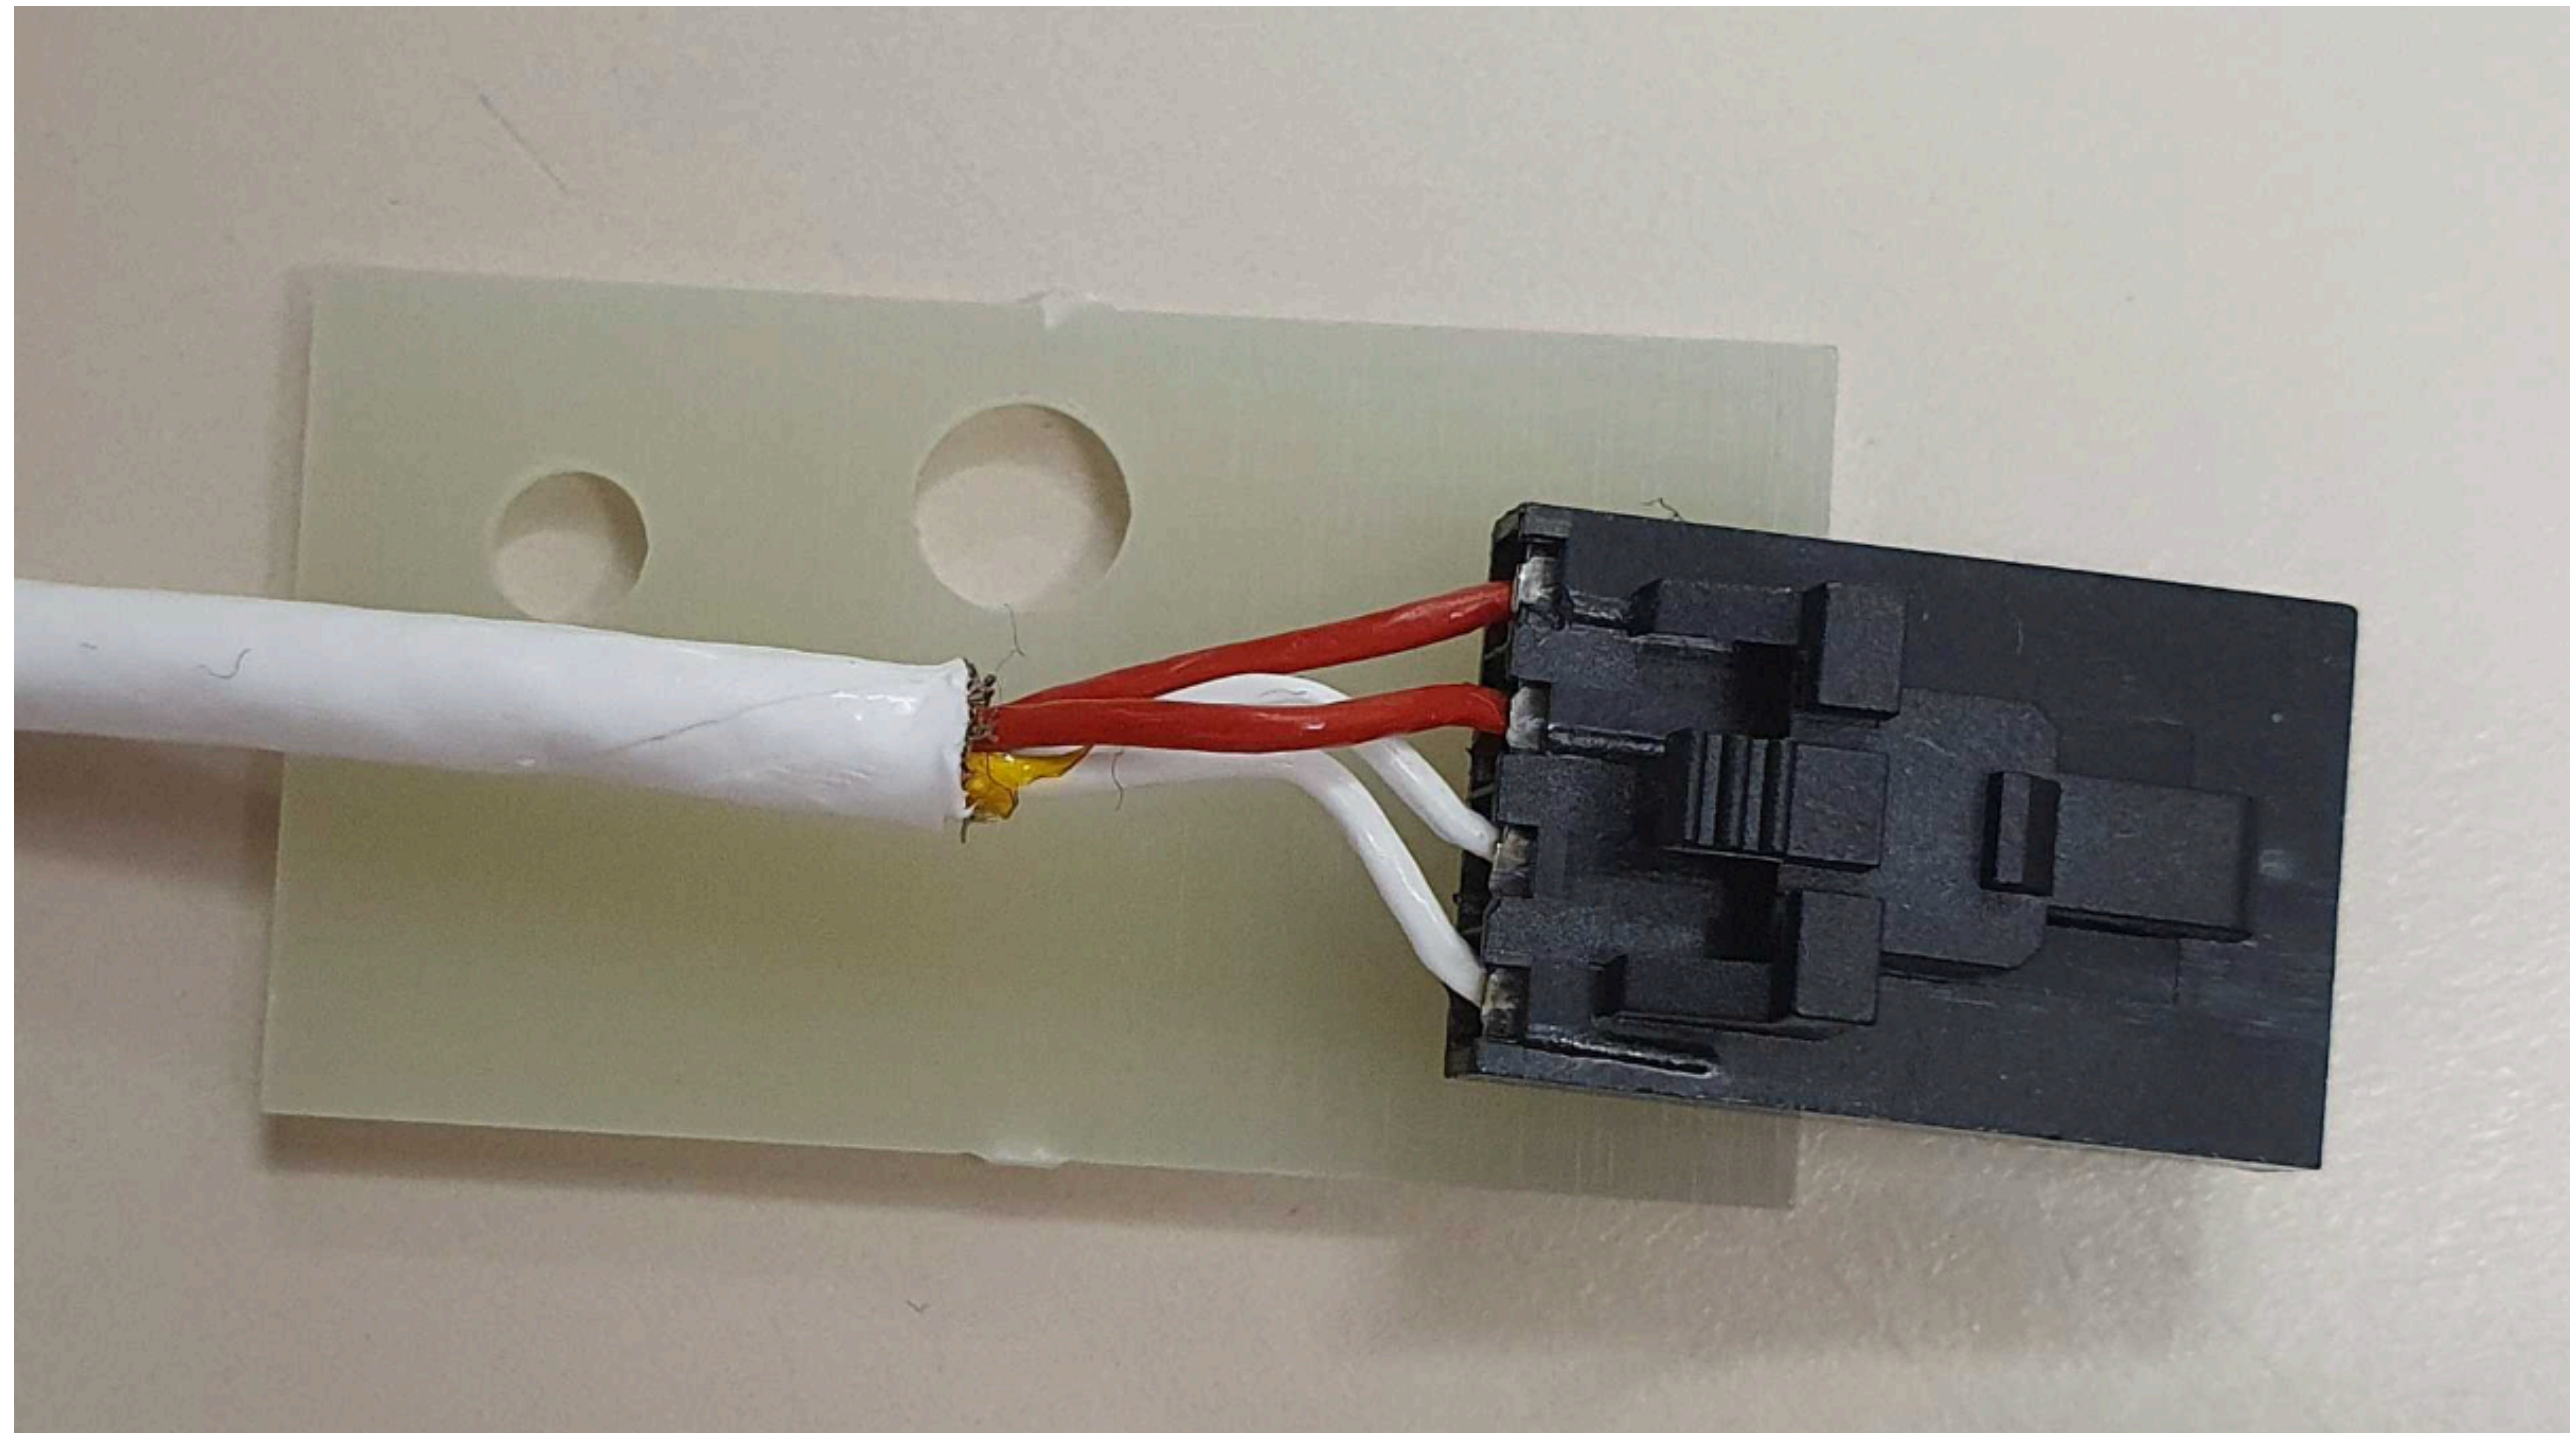
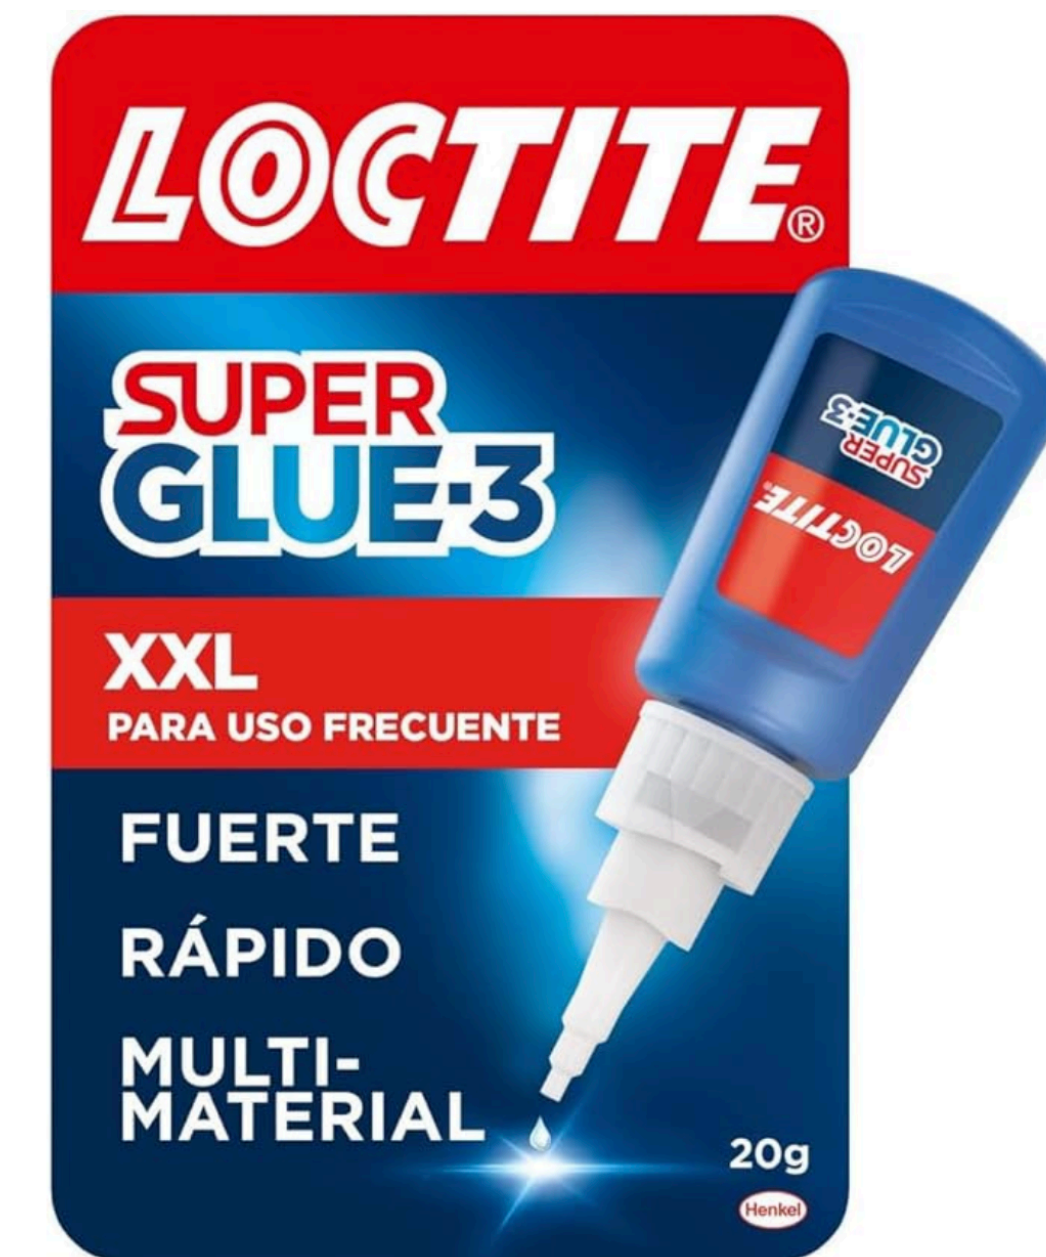
Problem 4: Misaligned holes in PCBs

- The IDC-4 female connector is glued with loctite super glue-3 on the cable PCB. This is done manually, and alignment is done by eye

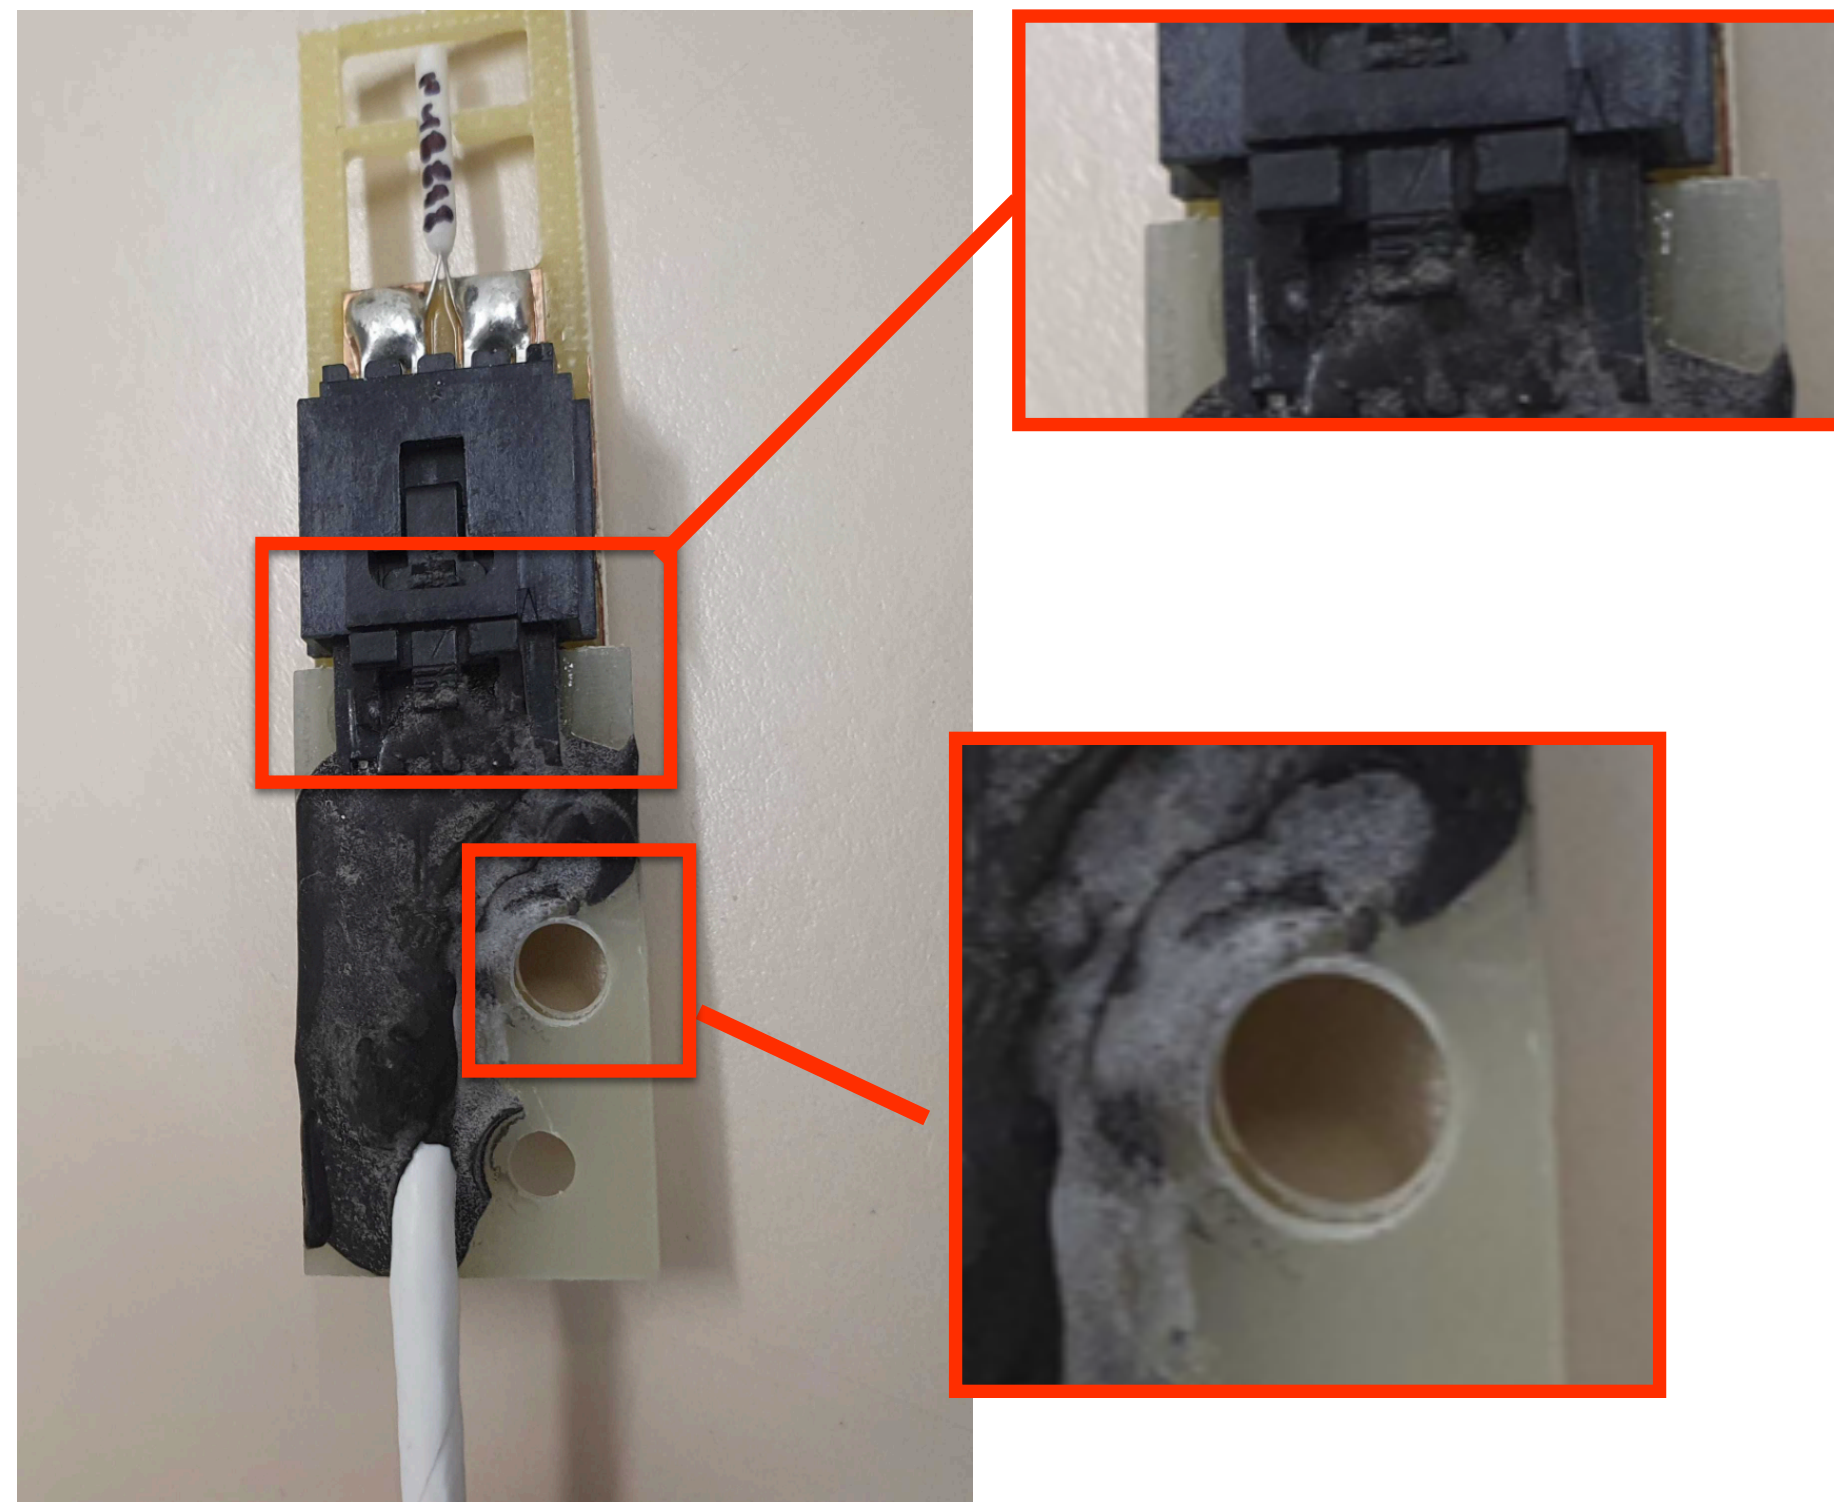
Good

- In some cases the alignment is not correct and once the sensor is plugged in the holes of the two PCBs doesn't match each other

- **Repair:** Use a cylindrical lime to increase the size of hole in lower PCB
- **Changes in production:** A special tool where the cable PCB and the IDC-4 female connector are placed before gluing is been fabricated
- **Changes in QA/QC:** Mount the entire kit
