# **CRP6 Coldbox Results**

Roger Huang, Cheng-Ju Lin, Volodya Tishchenko CE Consortium Meeting 12/5

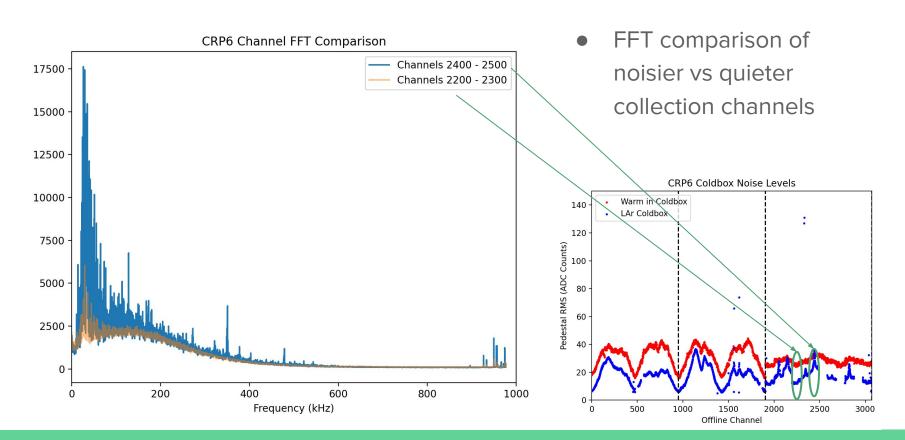
# **CRP6 Noise Comparisons**

- CRP6 has now been extracted from the coldbox
- The noise performance of CRP6 is notably worse than that of CRP4+5, with worsened grounding being the suspected culprit
- 3 (!) FEMBs had presumed cable-connectivity issues at cold
- Channel connectivity issues at cold from edge cards persist
- Next Steps:
  - Replace the bronze mesh with a solid copper plane again for another coldbox test in January
  - Investigate/replace the problem FEMBs and edge cards

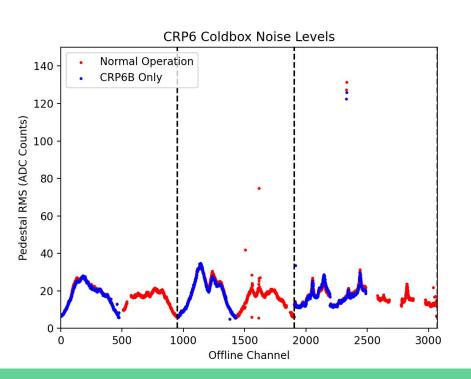
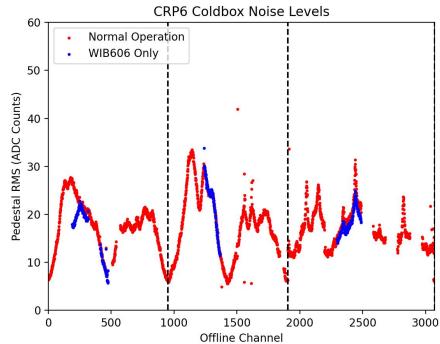
#### **CRP6 Noise Studies**

- Noise levels are better when only some subset of the FEMBs are powered
  - Consistent with power/grounding issues as the cause of excess noise
