# IERC Facility Update

Dave Pushka

IERC Managers Meeting

25 January 2024

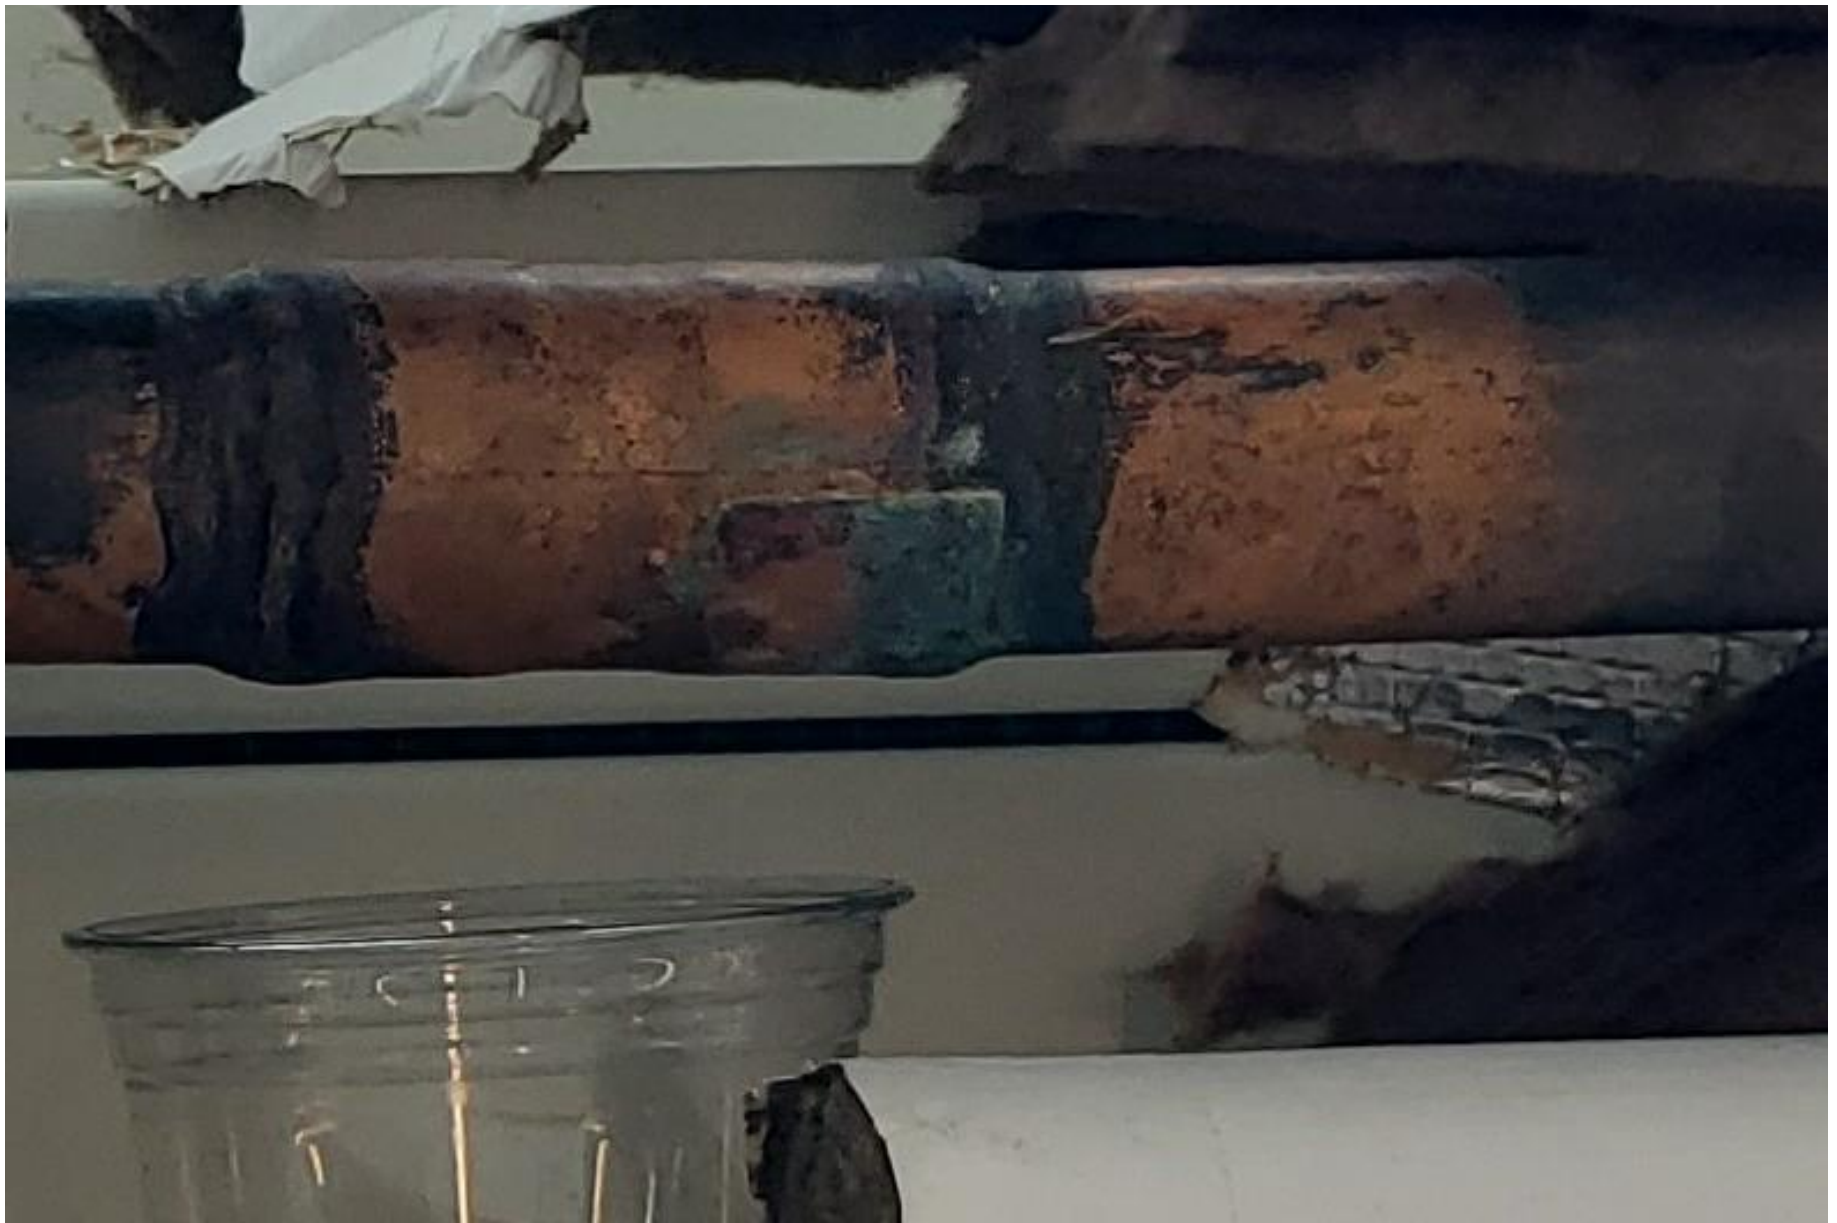
# Pipe Leak in IERC

**Behind the 1.5 Inch Brazed Copper Pipe is an elbow with a threaded connection. It may be that the threaded connection is where the leak occurred as a plastic cup is placed below the threaded connection.**

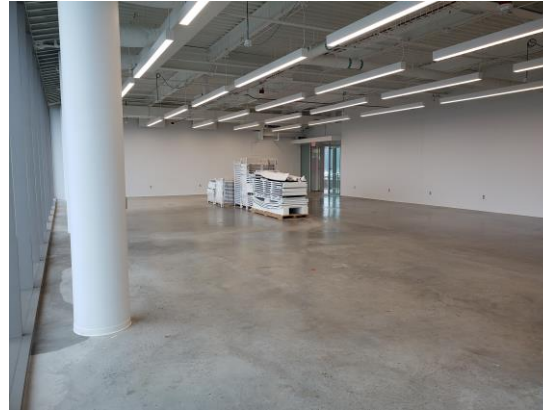
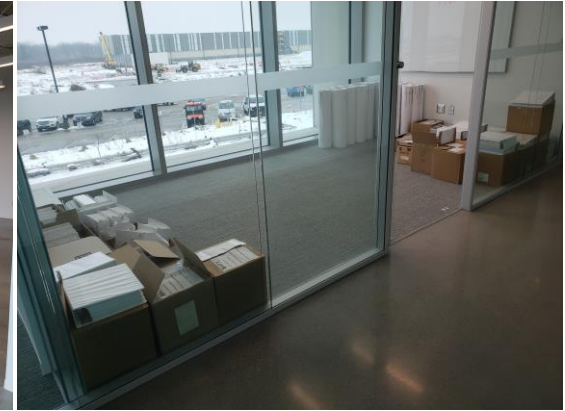
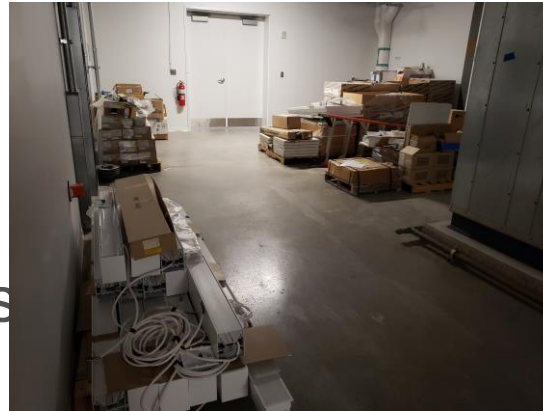
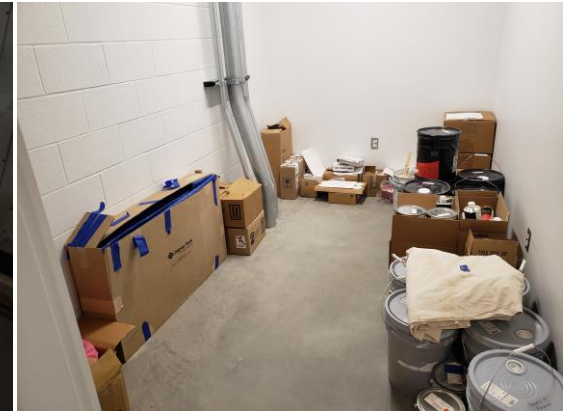
# Contractor Leftovers & Garbage removed from IERC

- Flammable Materials removed by ES&H waste team.
- Drawings move to an office.
- Junk hidden in a storage area.
- More junk and filters moved to mechanical room.
- Conf. room Cleaned by Clorica.
