Luis Manzanillas 2024.03.27 LAPP

Context

Parameters for QA/QC

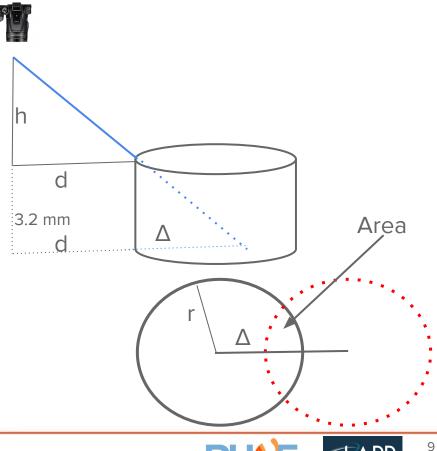
- Introduce a correction as described in previous slide
- If no problem we should have a "homogenous distribution

After correction

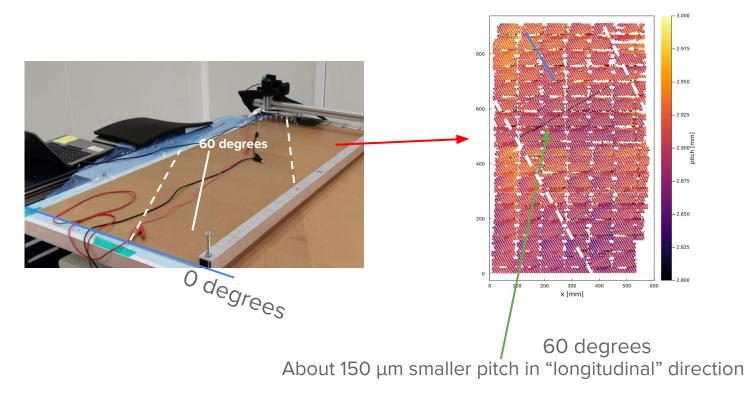
Pitch over large area

In general homogeneous everywhere

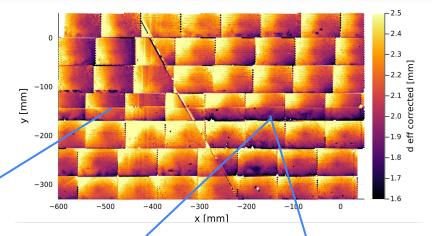
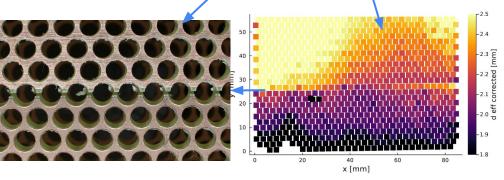
- Conditions less well controlled than when using setup in clean room
- Nevertheless:
 - A shift is clearly visible 0
 - Corresponds with pattern observed by Laura 0
 - The effective hole diameter in the worst part is 0 about 1.9 mm
