CRP6 BDE Updates

CRP Consortium Meeting 4/24/2024

CRP6 BDE-related Changes

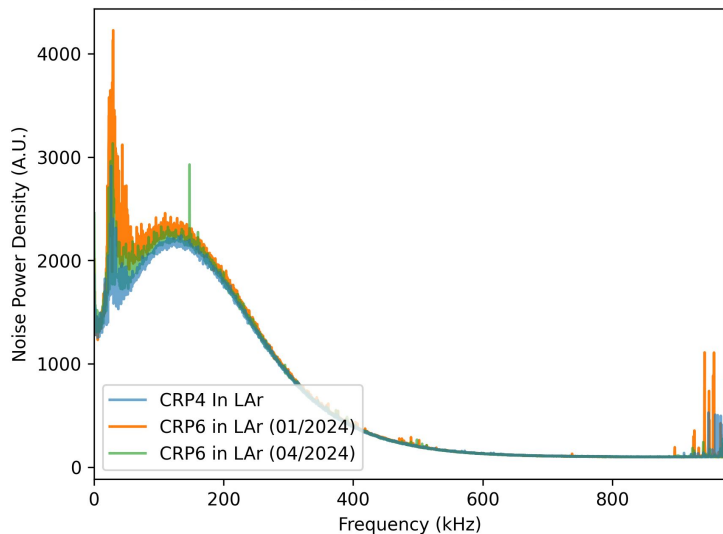
CRP4/6 Noise Power Spectrum Comparison
All Channels Summed

Comparison to Previous Runs

- Noise level on A-side is now comparable to best levels achieved in CRP4
 - This is the side where the new grounding plane was added

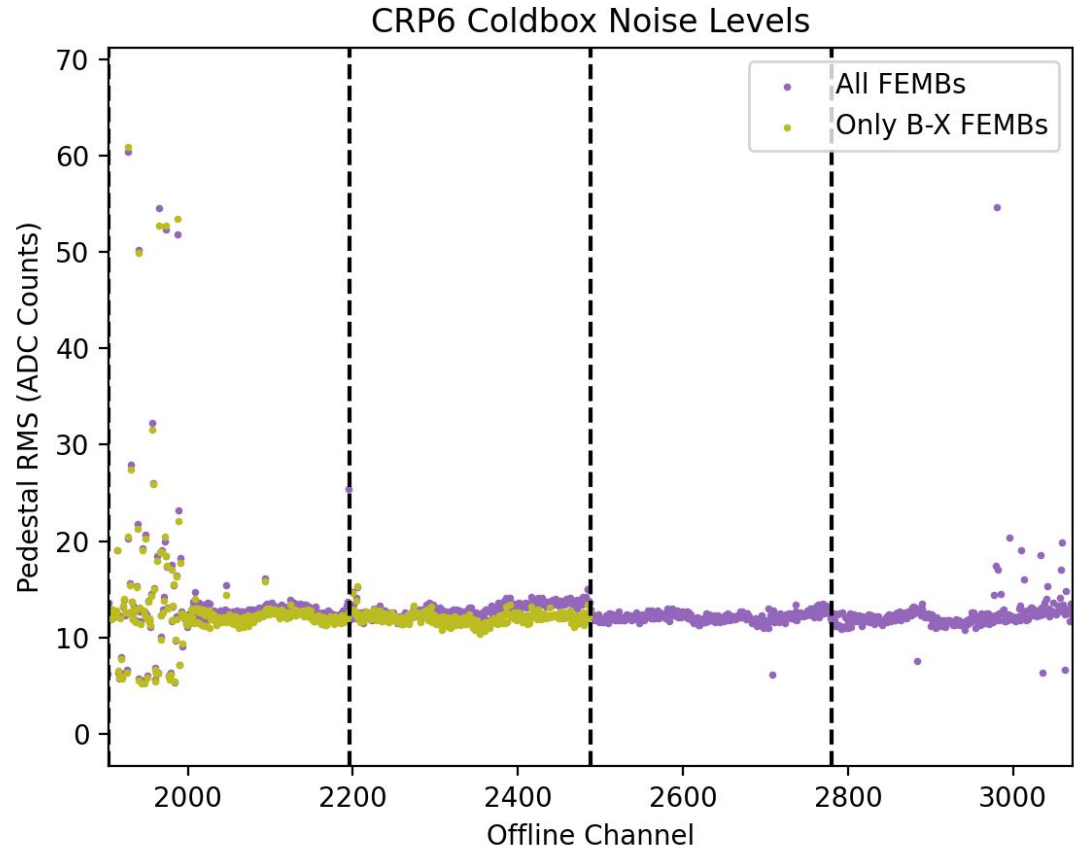
High/Low Noise Collection Channels

- The behavior of these scattered channels does not change with any electronics settings we have tried, including:
 - Powering only a subset of FEMBs
 - Differential/SE mode
 - Increasing LArASIC leakage current
 - Power settings

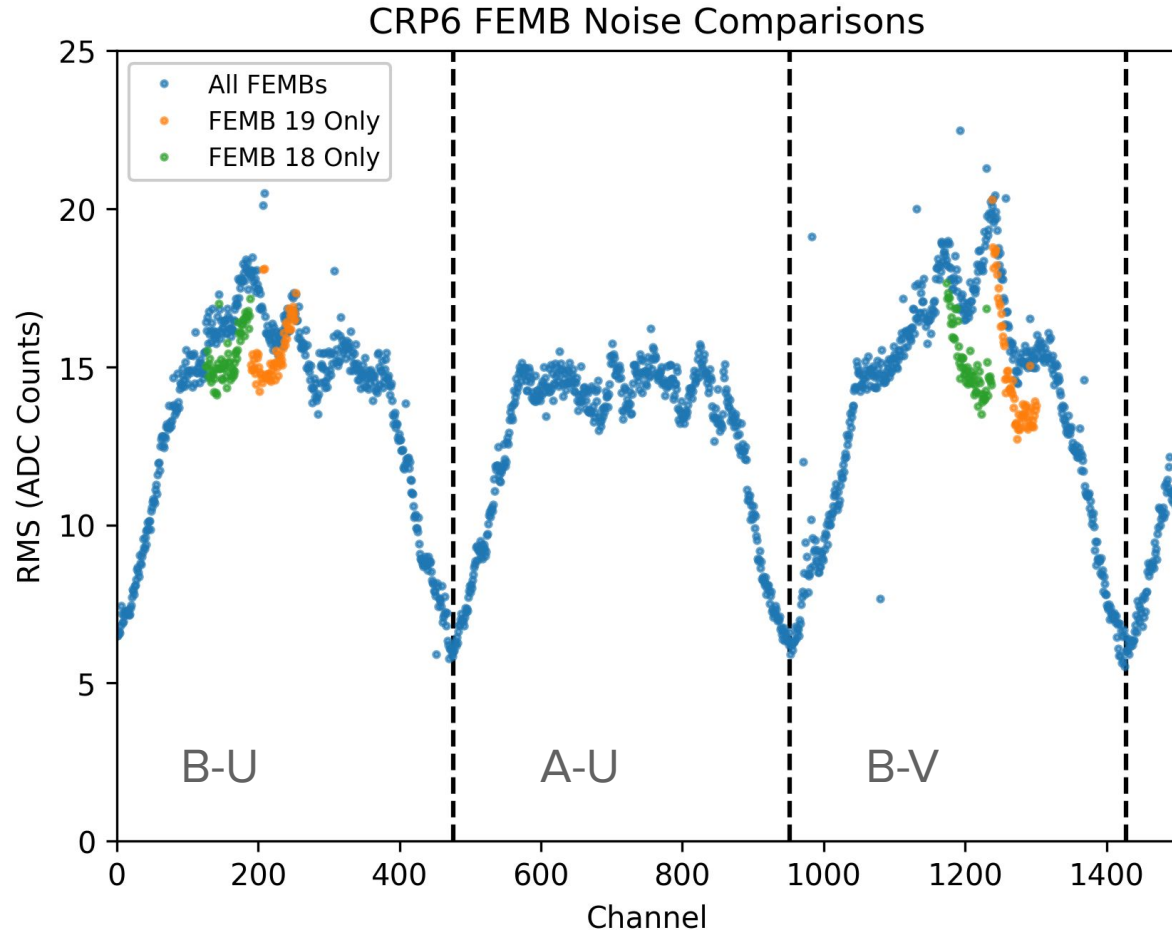
Single-FEMB Tests

- Powering only a single FEMB at a time suppresses noises in the regions with highest pickup
- But it does not eliminate the excess noise entirely

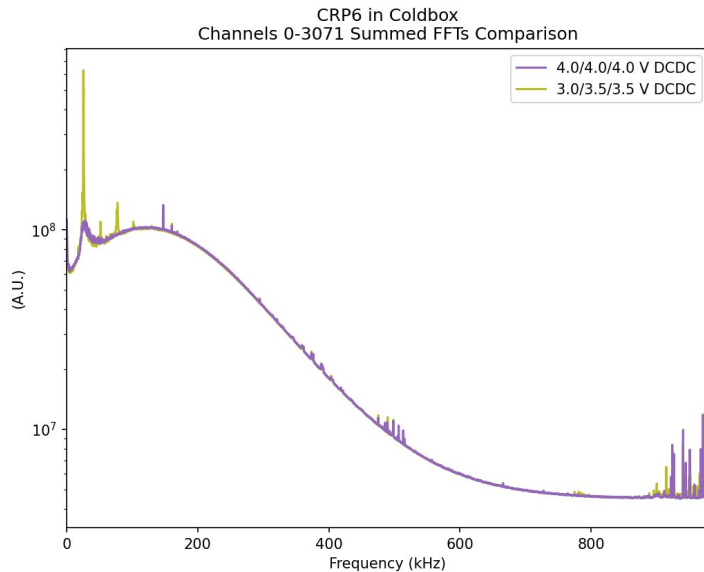
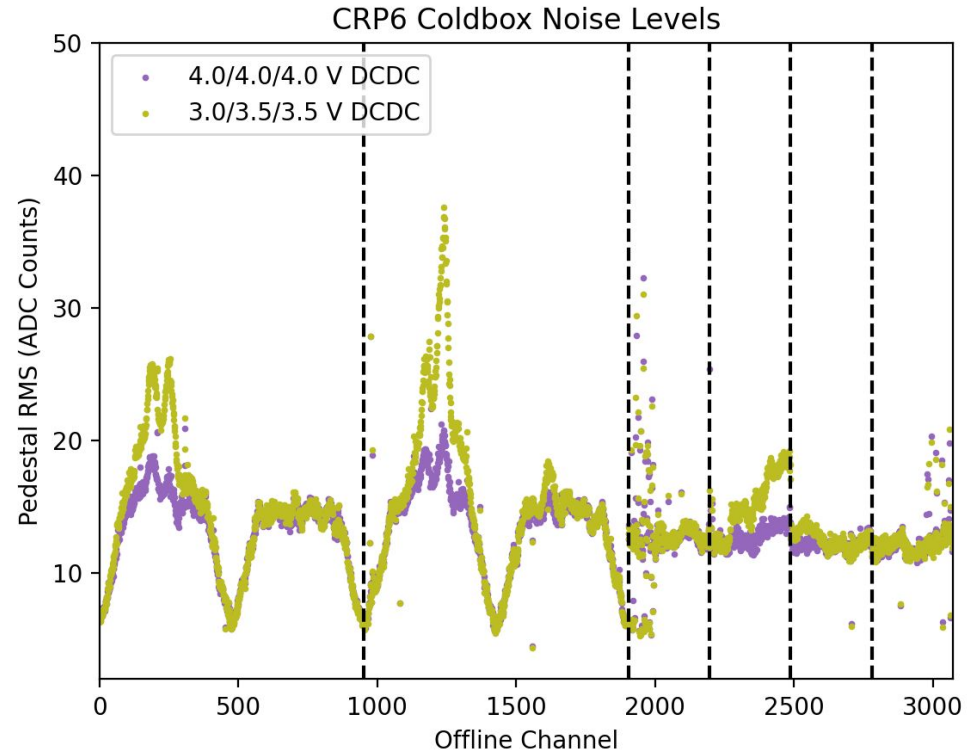
Effect of Power Settings

- Decreasing DC/DC power settings on the WIBs shows the usual effect of amplifying coherent noise
 - Note: little effect on A-side, where there was little pickup in the first place
