ProtoDUNE-II APA Commissioning Report

Pip Hamilton

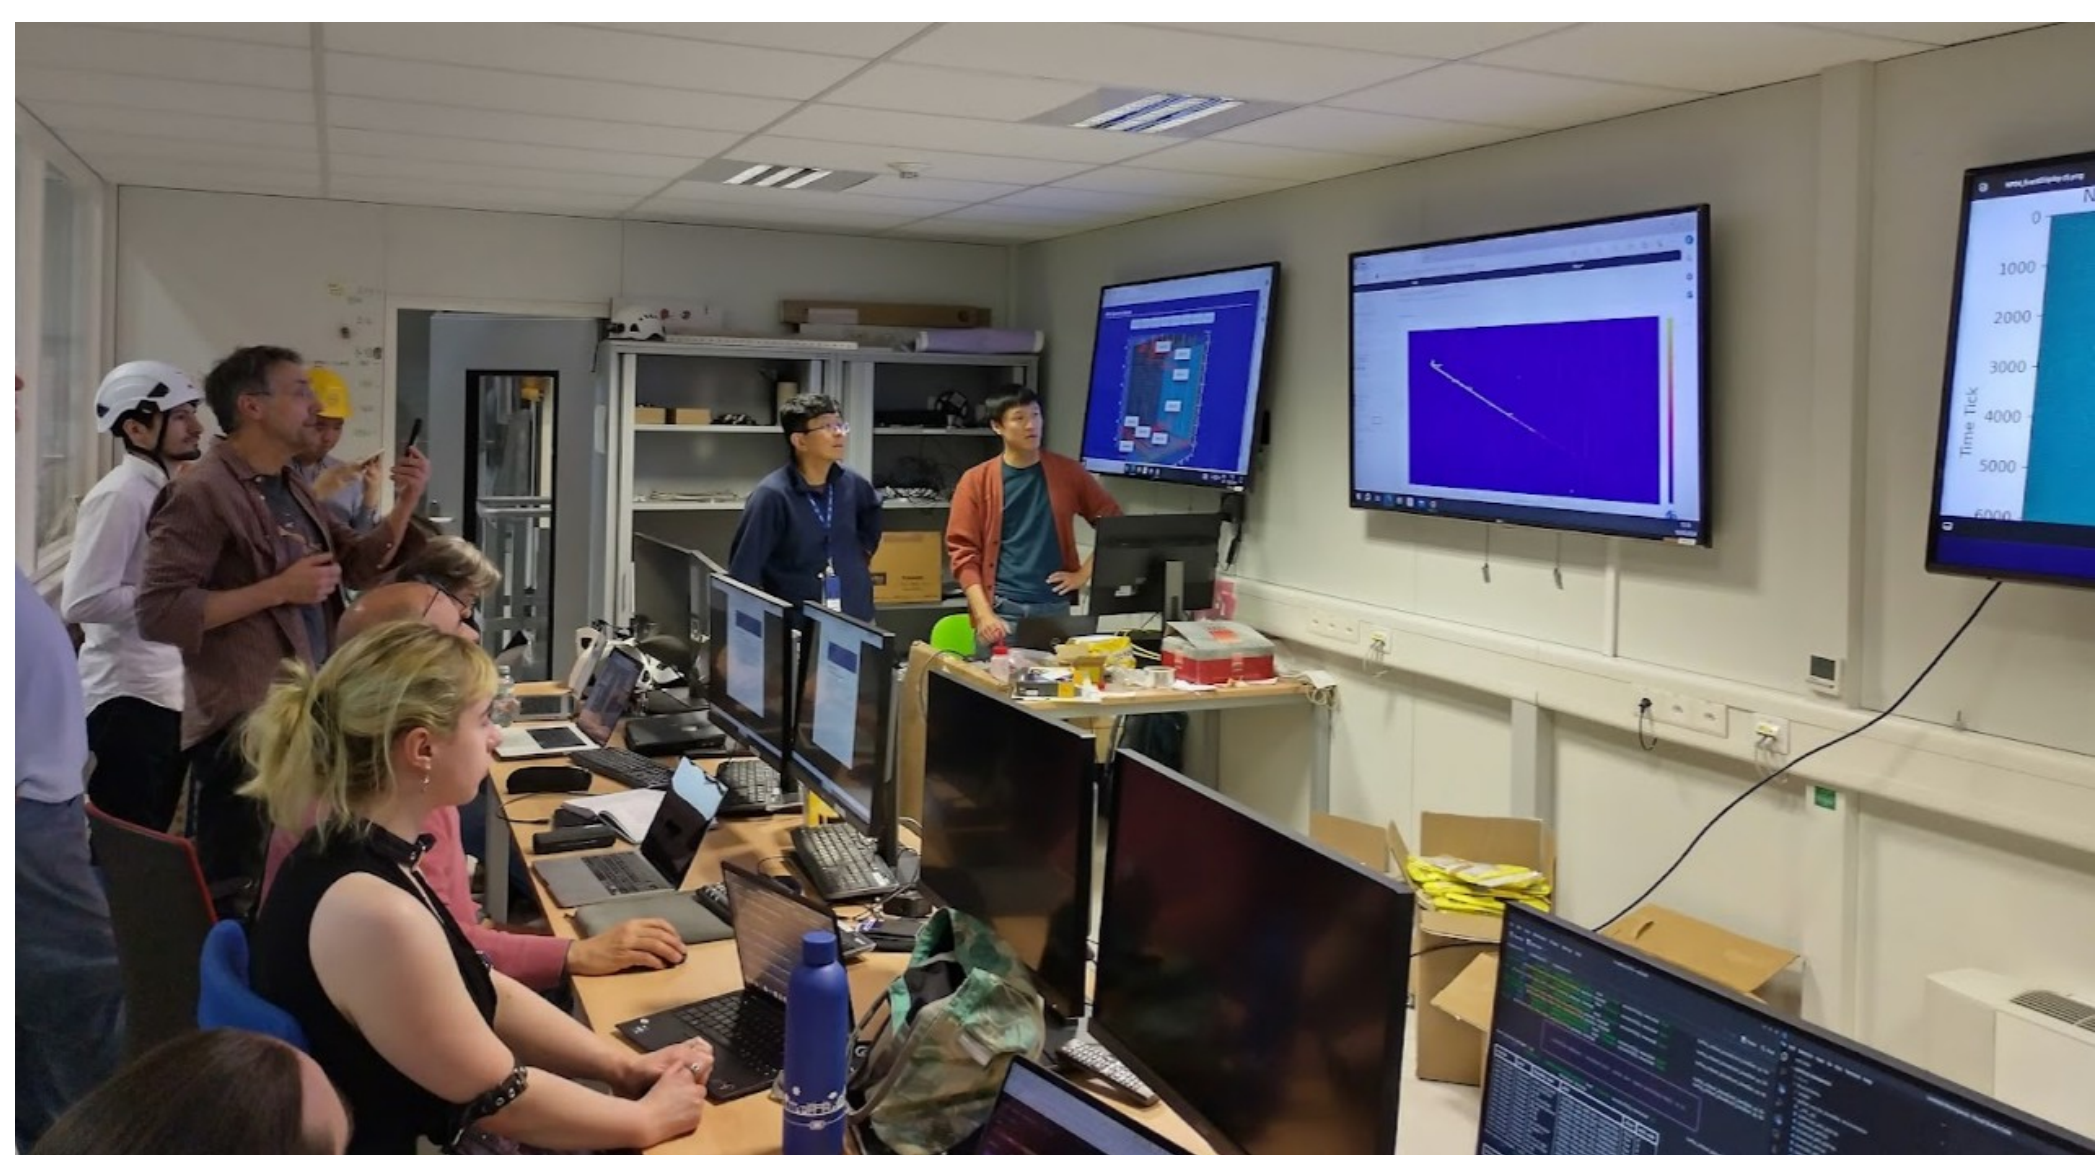
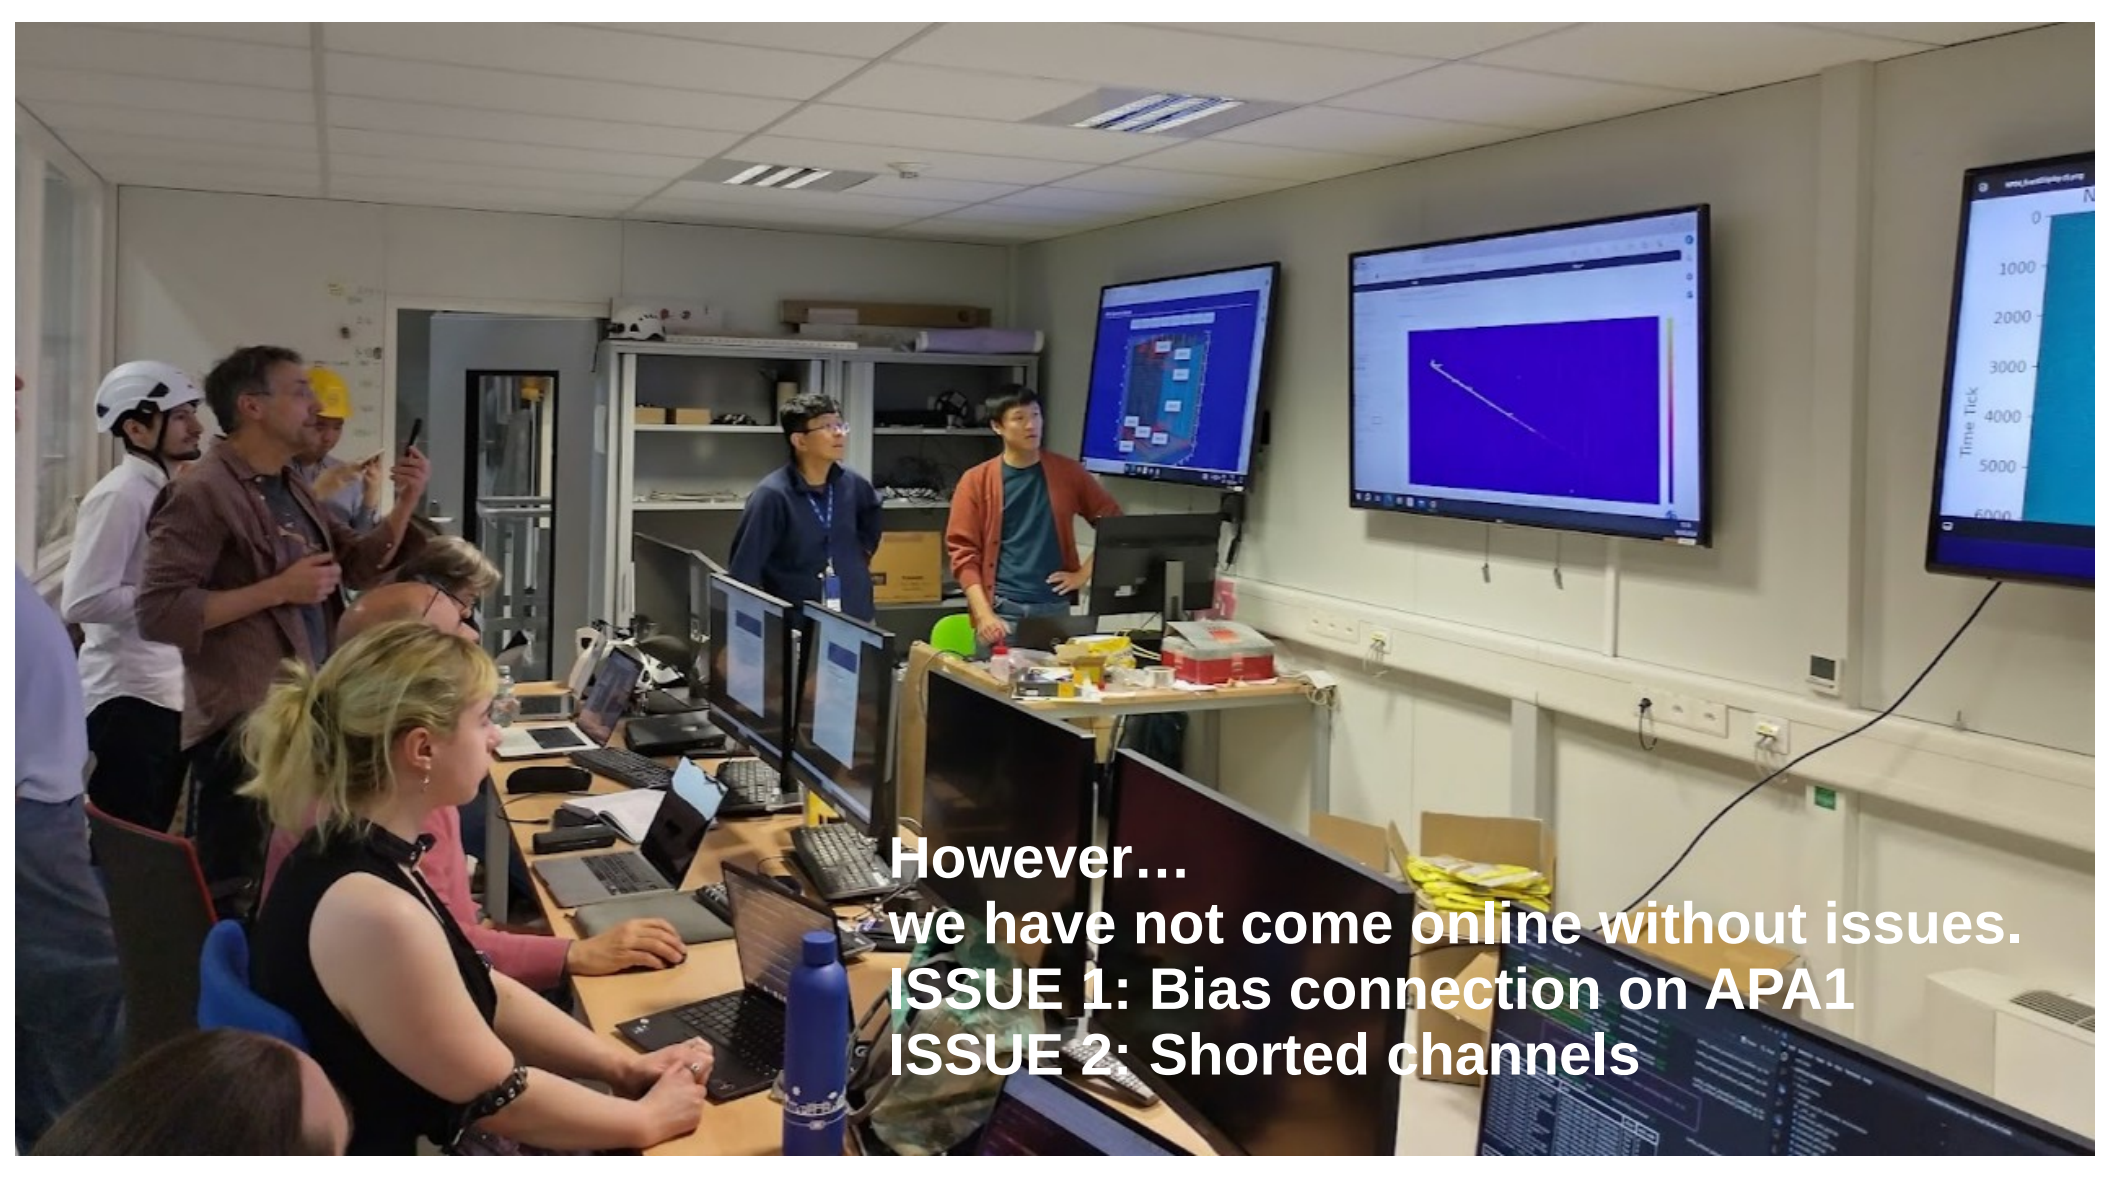
- 14 (out of 32) channels that were observed to be open (i.e. dead) during coldbox testing were observed to recover during the wire bias ramps.
- ProtoDUNE-II is now at full operating voltage (180 kV) and seeing cosmic tracks!
