Analysis of MQXFA13 Test Non-Conformity

US-HiLumi-doc-4958
Other:
Date: March 12, 2024
Page 1 of 18

US HL-LHC Accelerator Upgrade Project

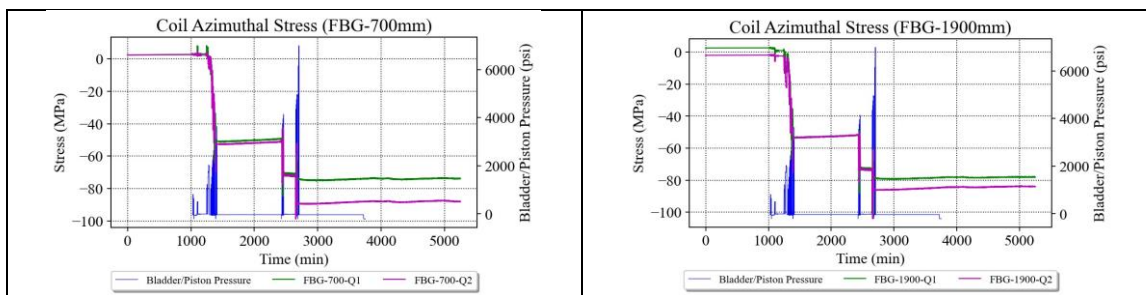
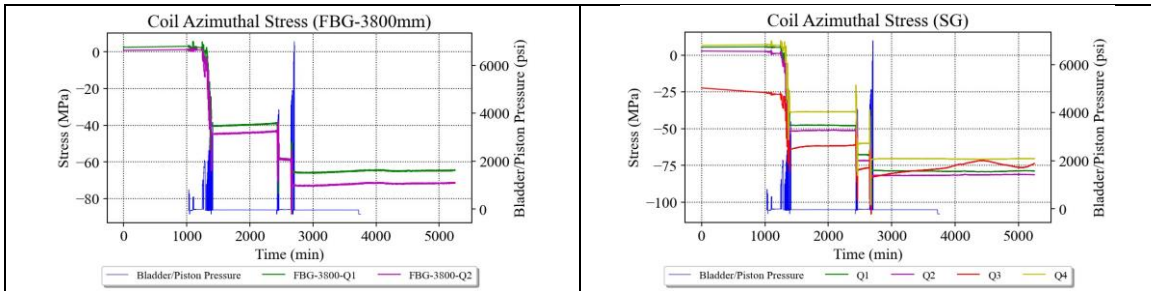
Figure 2.5: Coil azimuthal stress during bladder operation for the three optical sensor locations and the electrical strain gauge location.

According to the strain gauge measurements taken during magnet fabrication, coils, shells and rods were pre-loaded consistently to the target values (see figures 2.5 and 2.6), and the coil peak stress during bladder operation was maintained within the -110 MPa set as a limit in the magnet pre-load specifications. Coil Q4 was the least azimuthally-compressed coil.

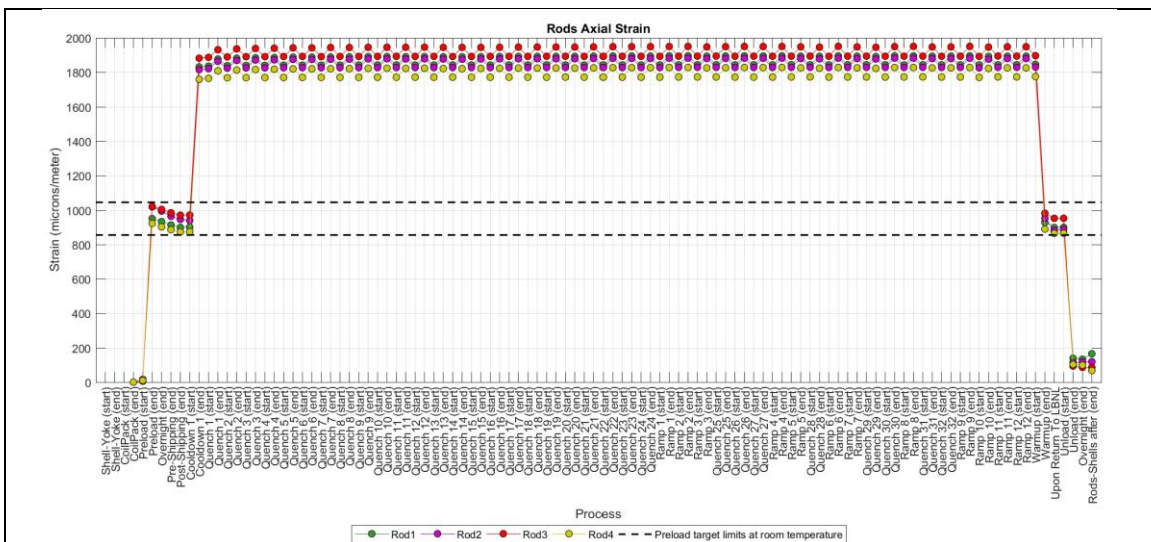
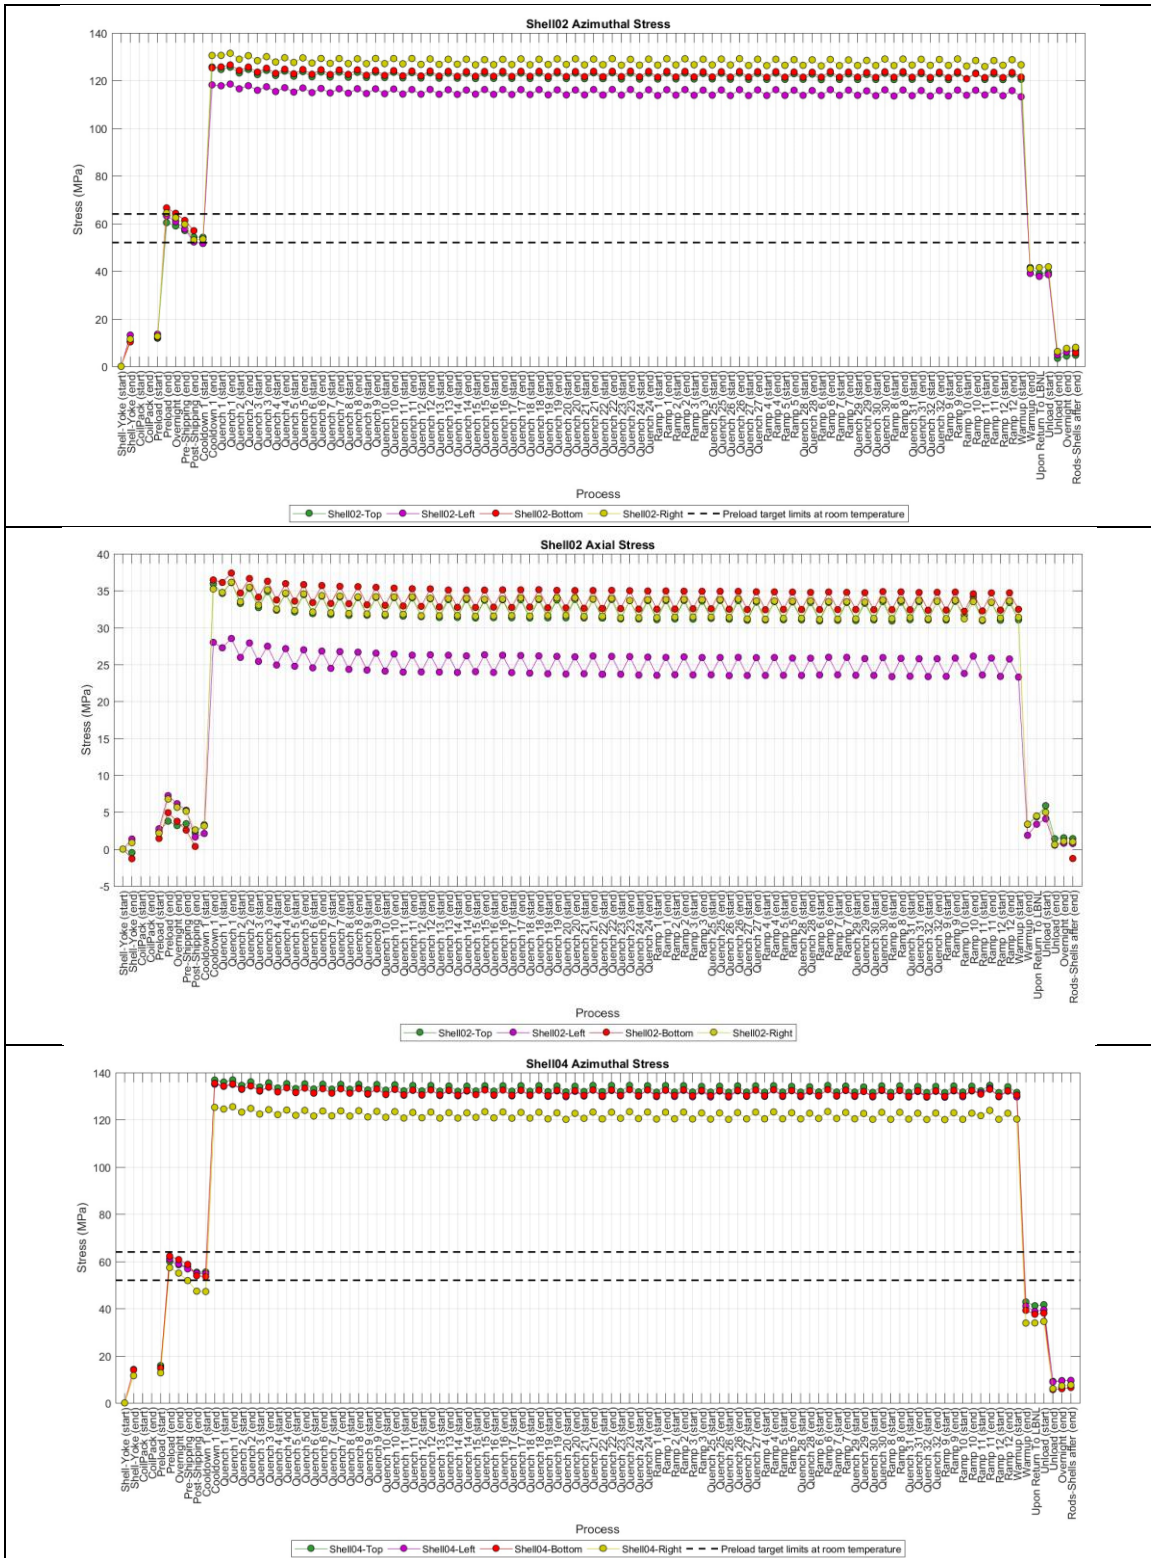
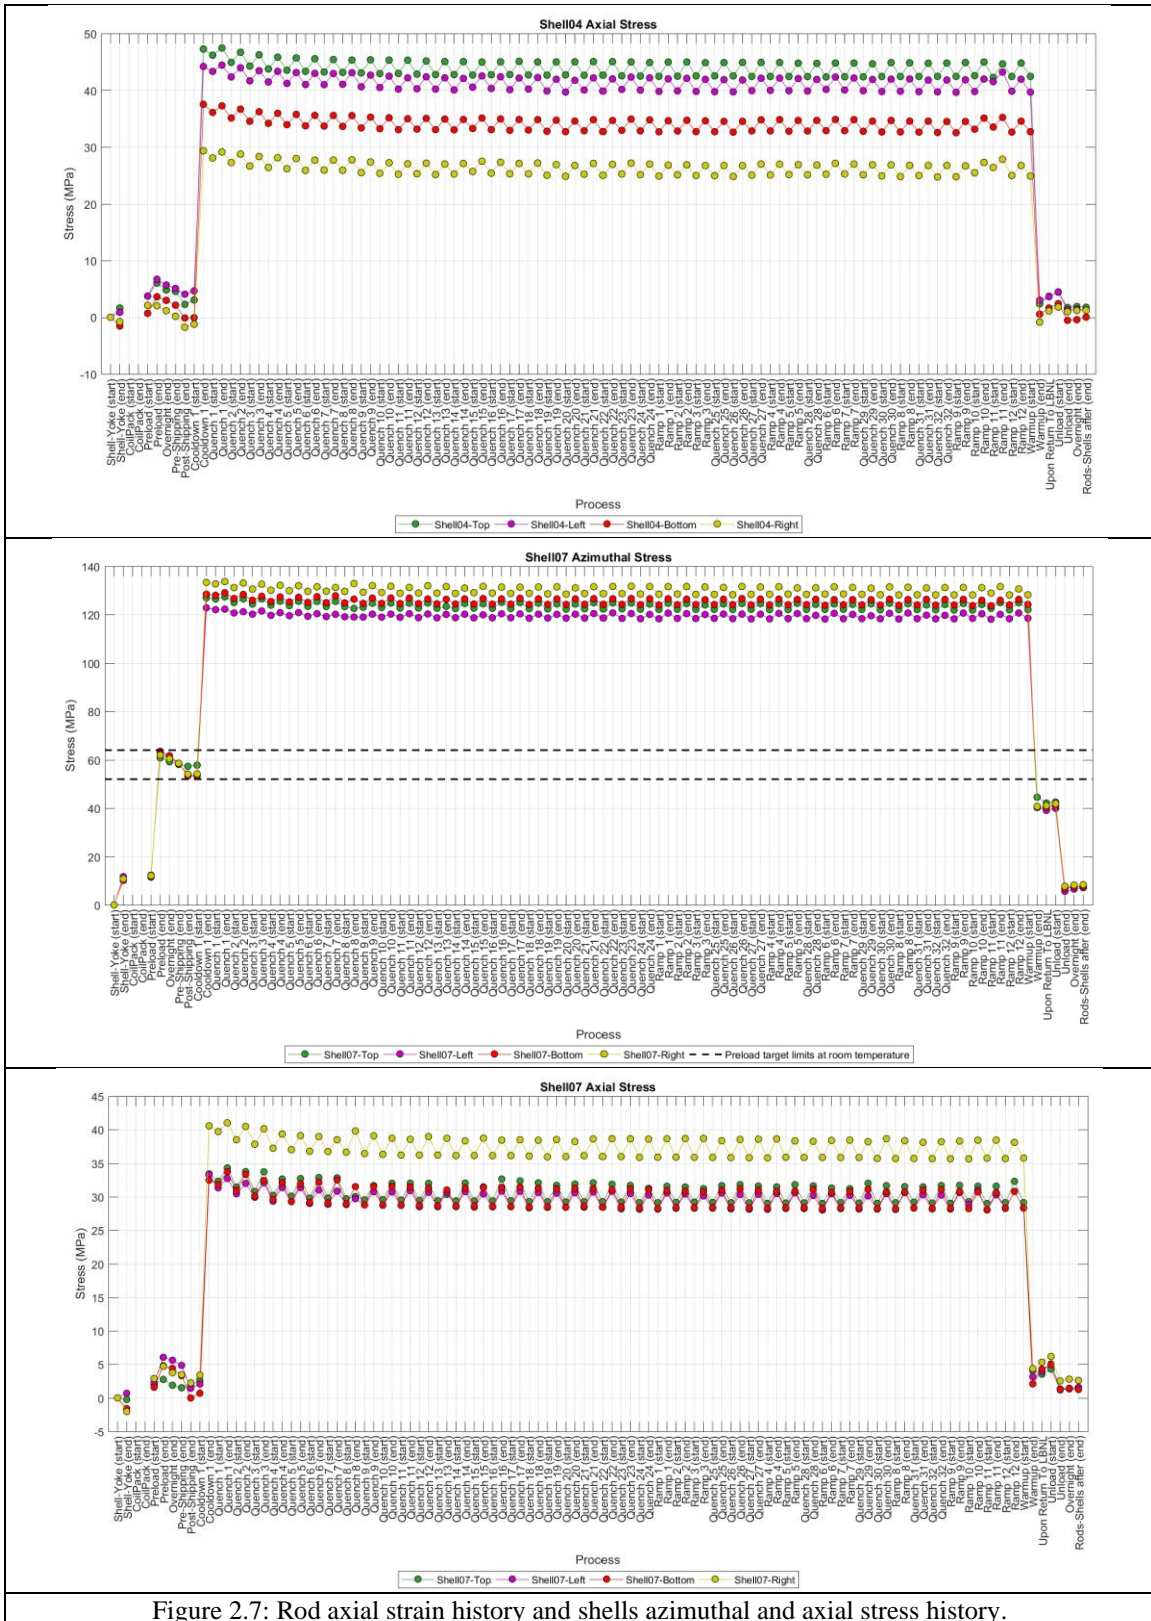
Figure 2.7: Rod axial strain history and shells azimuthal and axial stress history.

Coil strain gauges were disconnected before the vertical test. Therefore, there is no coil data during the test. However, rods and shells experienced a very consistent behavior with uniform delta-stresses during powering (see figures 2.7).

From the strain gauge data, there are no signs of abnormal behavior on coil Q1 by only looking at the rods and shell behavior. Since we do not have coil data during the test, in this case it was not possible to identify the potential mechanical causes of repeated quenches in coil Q1.

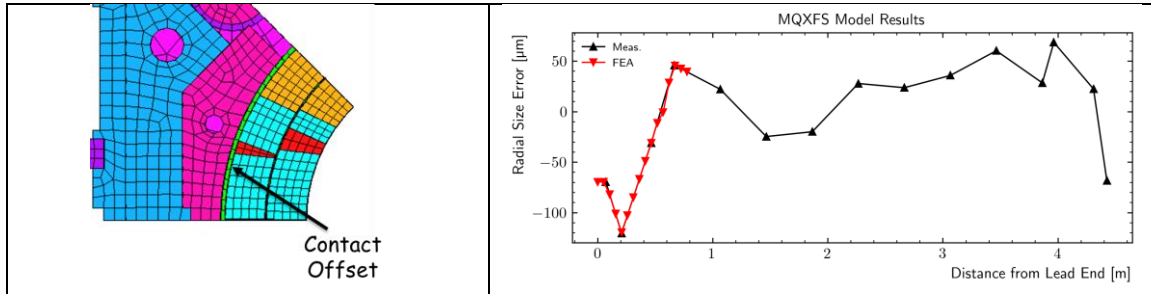
Figure 5.1: Left: Location of the contact offset used to introduce the local radial size error in the FE model. Right: Comparison between the measured radial size deviation and the FE contact offset input for the analysis.

In conclusion, this FE study shows how variations of coil size along the magnet length can affect the azimuthal prestress. When the coil ends are smaller than the average, this results in an increase of the peak longitudinal strain that might lead to conductor damage.

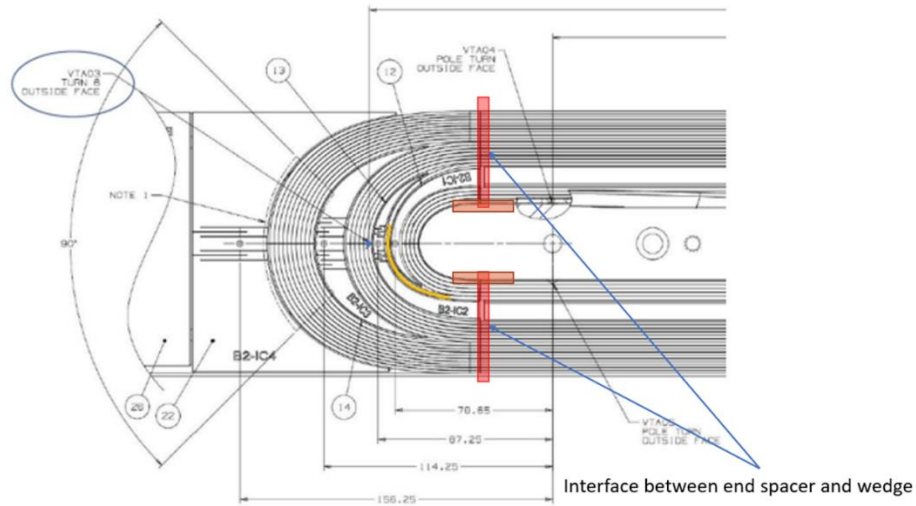
The metallographic inspection of coil 227 lead end was performed at CERN using methods and tools described in [8]. The volumes of interest for the inspection of coil 227 lead end are shown in Fig 6.2. The section extracted from the lead end is shown in Fig 6.3. The investigation started by looking at the cables facing the transitions between wedge and end-spacer. These samples are shown in Fig. 6.4.

Figure 6.2. Volumes of interest (highlighted by the red boxes) for the metallurgical inspection of coil 227 lead end.

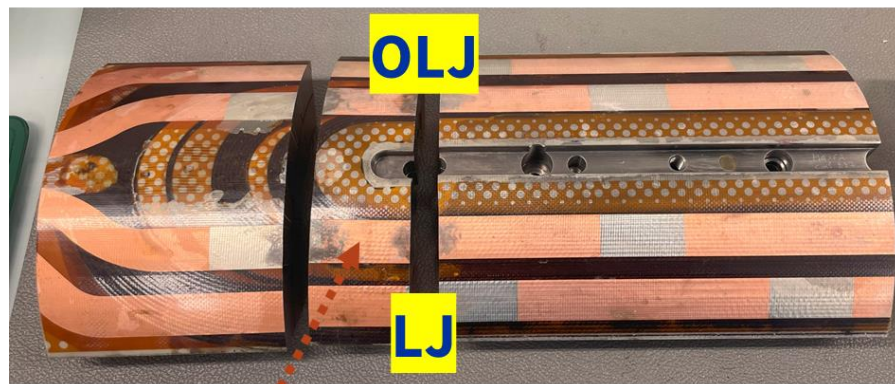
Extracted part

Figure 6.3. 43 mm thick slice including the transition between end spacer and wedge (in inner layer).

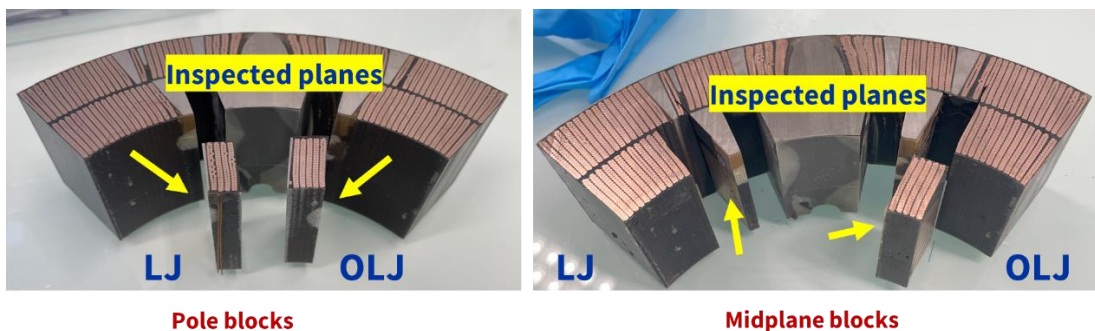
- 180 filament cracks (Fig 6.5 top) were found on the cable facing the wedge-spacer transition in the pole block on the layer jump (LJ) side.
- 210 filament cracks (Fig 6.6) were found on the cable facing the wedge-spacer transition in the pole block on the opposite side to the layer jump (OLJ).

- No filament cracks were found on both cables (LJ and OLJ) facing the wedge-spacer transition in the midplane block.
- All filament cracks are located in the short segments between the wedge and the end spacer as shown in Fig 6.5 bottom.

Figure 6.4. Samples extracted for looking at the cables facing the wedge-end transition.
