Measurements on APAs 14 and 15 September 30th to October 4th, 2024 Pre-Cold Test

Matthew Wright
UNIVERSITY OF MANCHESTER

Pip Hamilton IMPERIAL

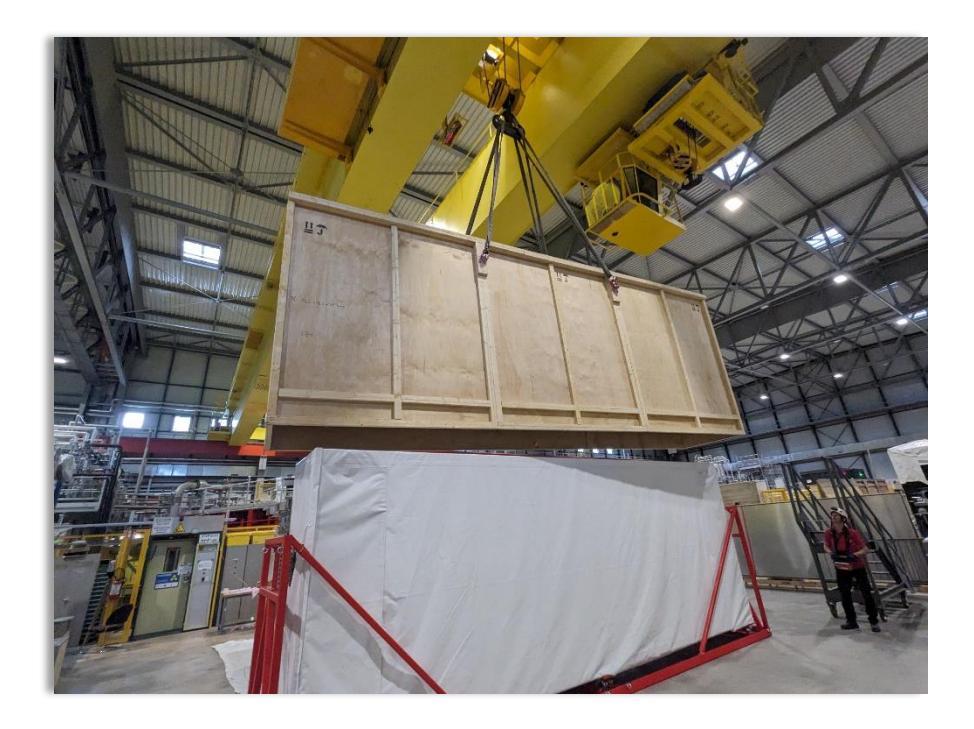
ASF was lifted and moved into measuring area using 2x eyelet bolts located on top centre of ASF.

The ASF was covered by a 'Top Hat' crate which needed to be removed. This required the location of an additional 2x eyelet bolts attached to top of ASF hidden under a top panel of the crate.

Once ASF was in position, all eyelet bolts were removed and fitted to 4x Eyelet bolt receptacles located on crate (two on either side), thus allowing removal of crate from ASF.

All of the above had to be quickly organised on Mon 30th September. Fortunately, the riggers were available to perform this work.

ASF must be delivered well in advance of any DWA operations. Arrangements for moving of ASF and removal of crate must be made in advance to ensure APAs are accessible for measurements when DWA operators arrive at CERN.

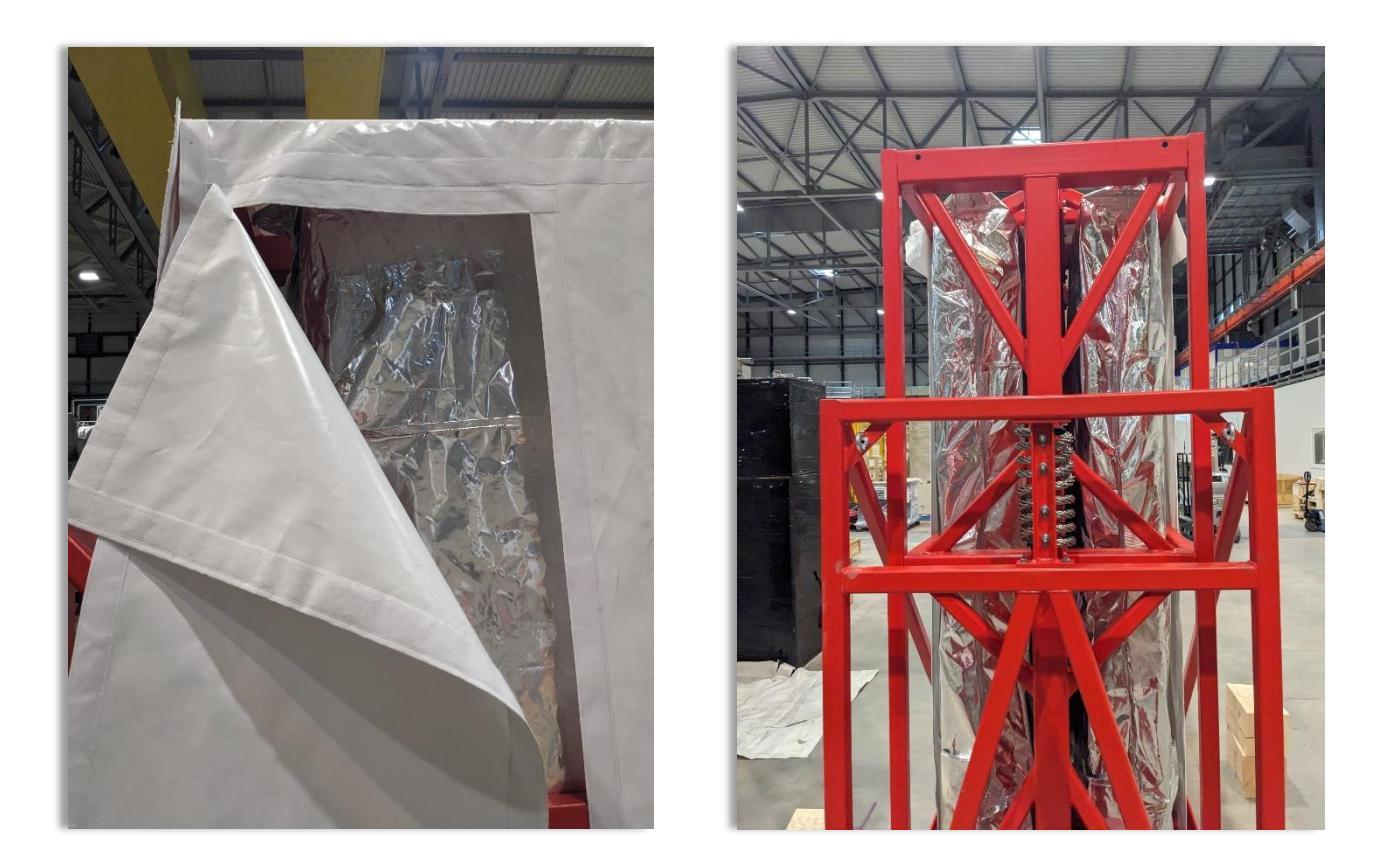
ASF covered by a Velcro sealed tarp. Opening of end sections of the Velcro seals was required, the end sections being rolled up and placed on top of the ASF. The side sections were taped back to the main part of the tarp structure. This allowed full access to the head ends of the APAs.

Note: The APAs are loaded side by side into the ASFs in a head-to-foot sense; the head end of one APA being adjacent to the foot end of the other. Hence both ends of the tarp need to be opened to allow measurement access to both APAs.

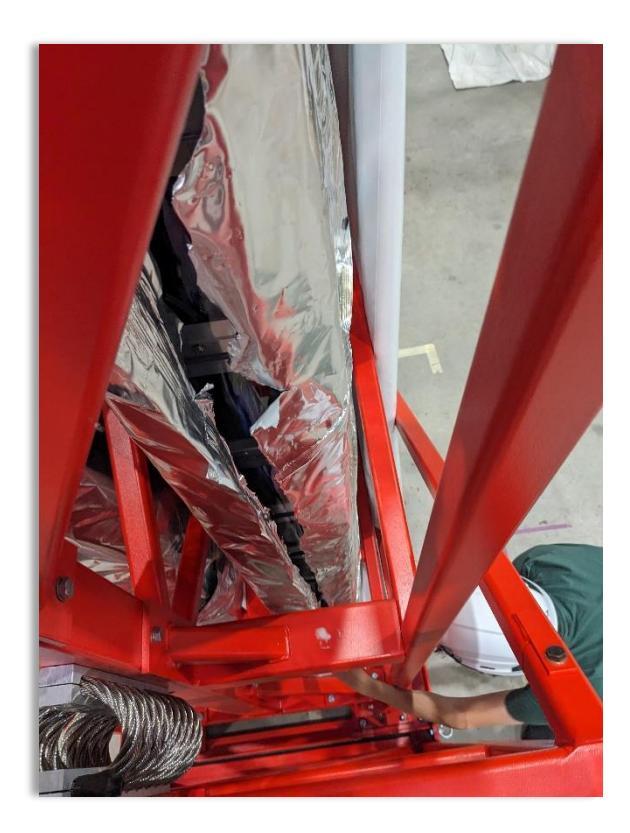
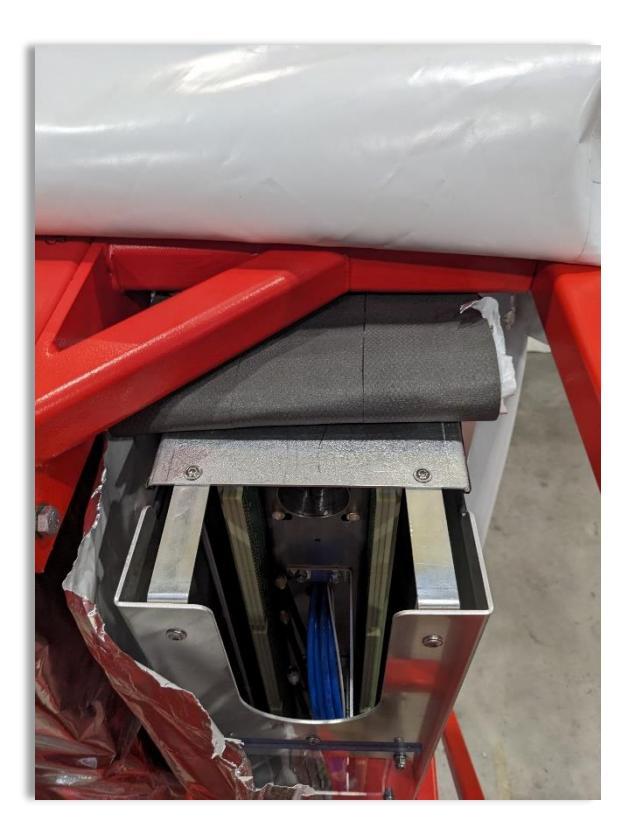
A box-cutter knife was used to pierce the covers at the head ends of the APAs. The first cut made was down the centre line of the APA from top to bottom, along the side of a heat-seal seam.

Two additional cuts were made at the top and bottom of the APA. These ran along the foam protection strips located underneath the top and bottom sections of the cover

These cuts created 4 flaps that could be pulled back to reveal the head end of the APA and fully expose the headguard. The use of masking tape helped to keep the flaps pinned back, where necessary.

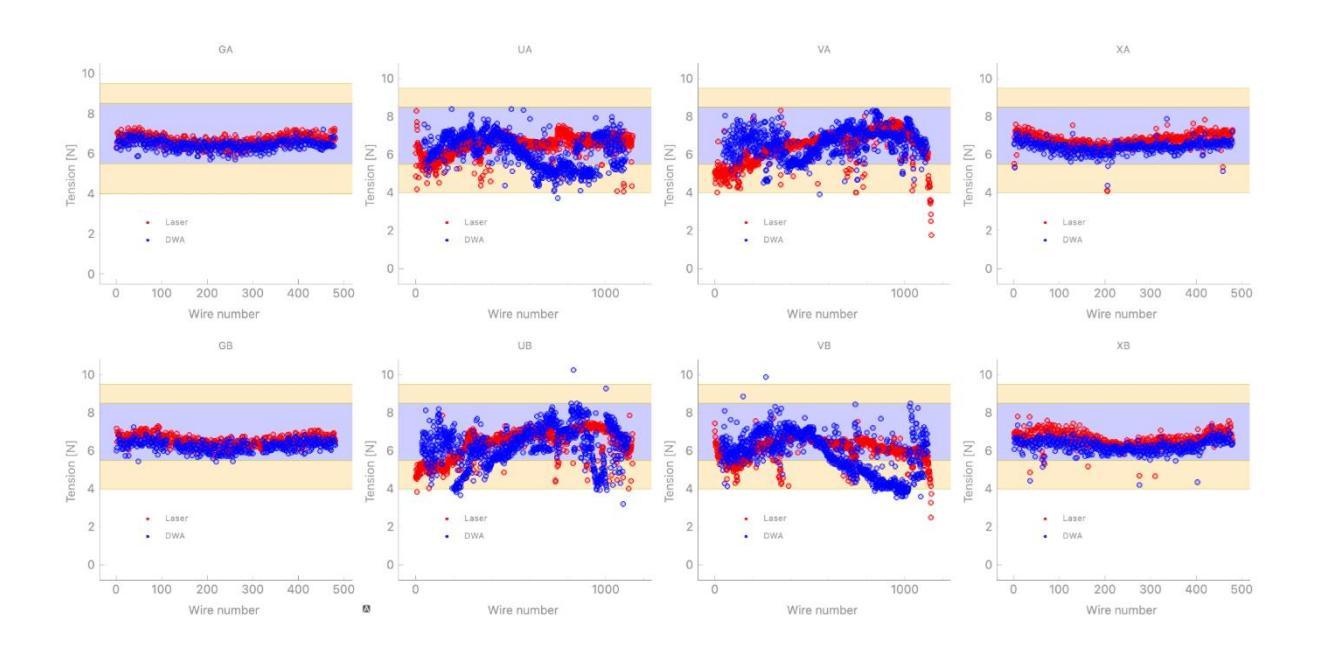
Pre-shipping data (Process Cart, Daresbury))

Sinusoidal-like variation observed in UA layer and VB layer tension data seen in preshipping data appears to have been suppressed in the post-shipping data. This may suggest the different mechanism of APA support in the ASF has altered the wire tensions in these layers (APA 'straightened out'??)
