# MICE Spectrometer Solenoid Repair

# MICE Spectrometer Solenoids

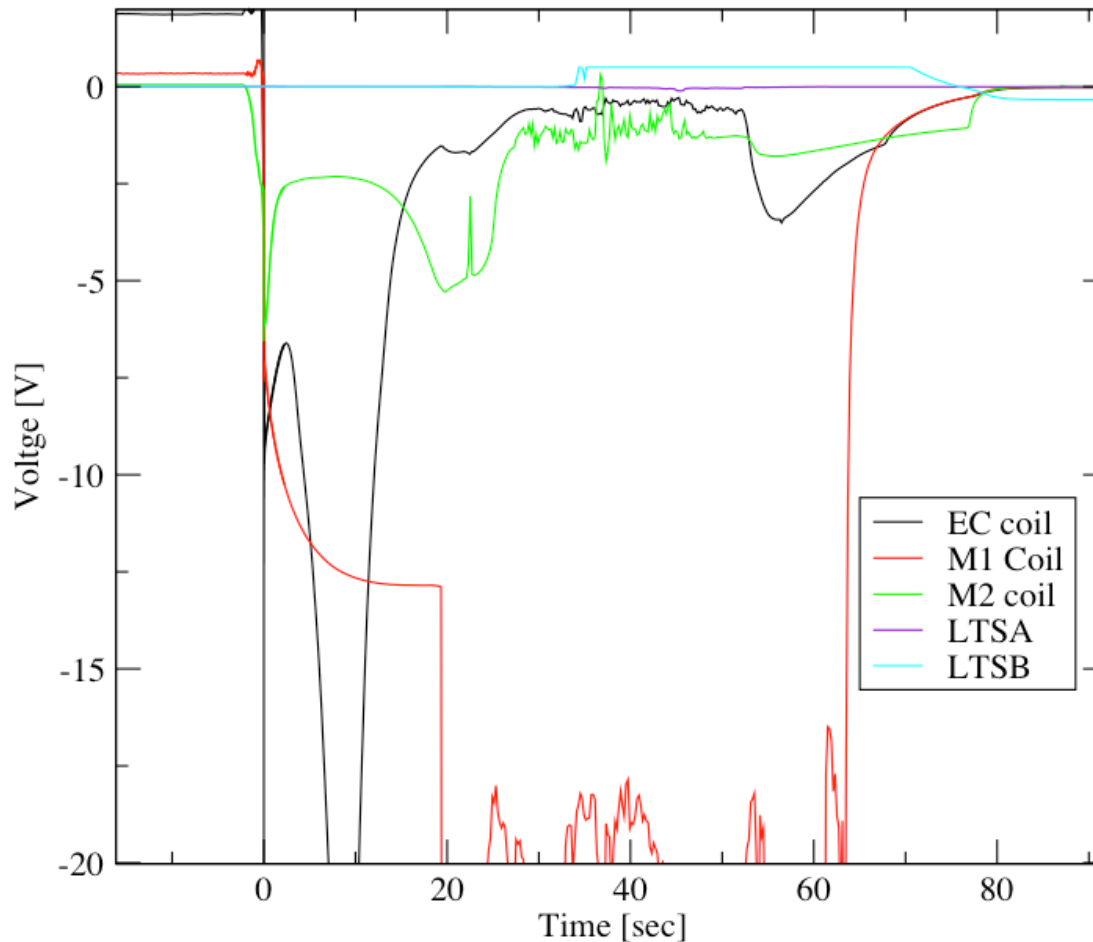
Quench on September 13th

- Quench initiated on ECE and initially proceeded normally
  - There is no evidence that any LTS leads were involved initially
- At  $\sim 20$  sec, the internal QP for coil M1 failed
  - The voltage on the coil increased rapidly and, it appears that an arc at the LTS power feed through (from vacuum to LHe volume) occurred which burned out the lead and effected M2 (the power leads for M1 and M2 utilize the same 4 pin feed through).
- What caused the QP failure?

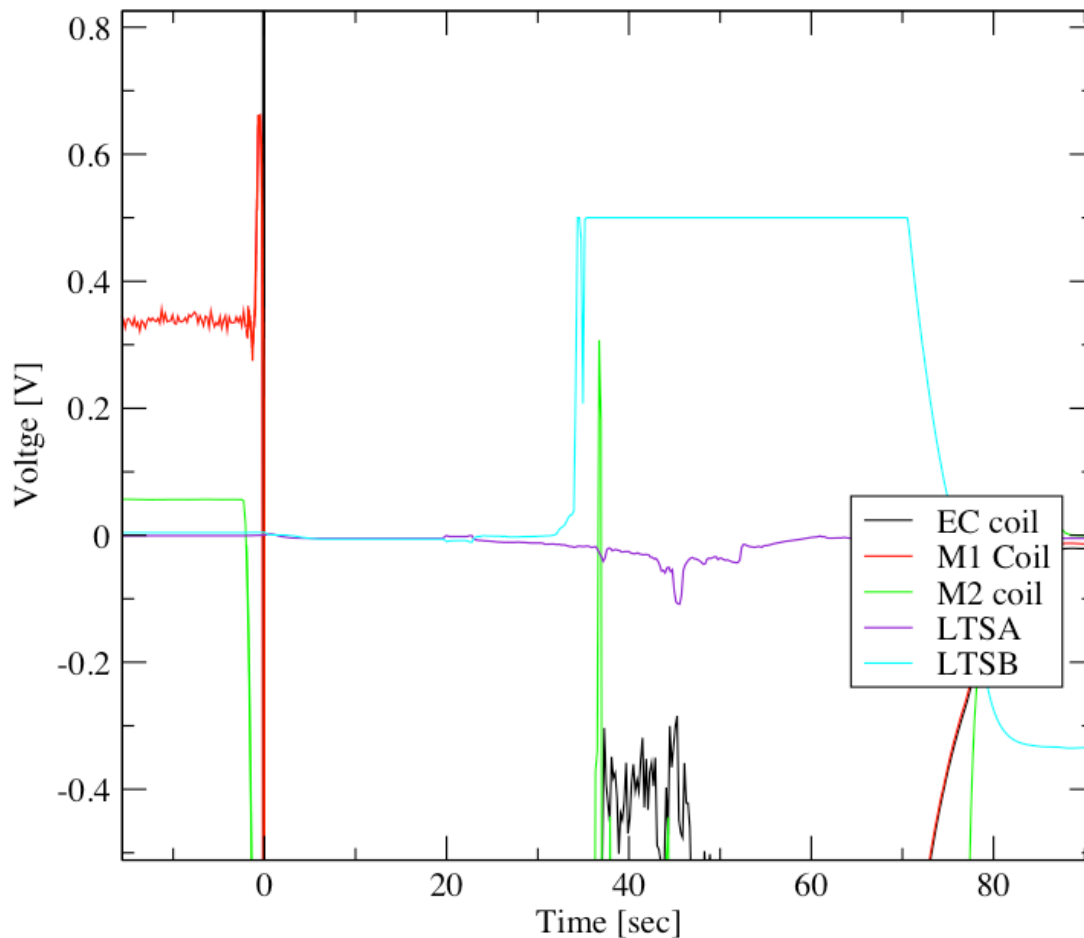
Quench on September 13th

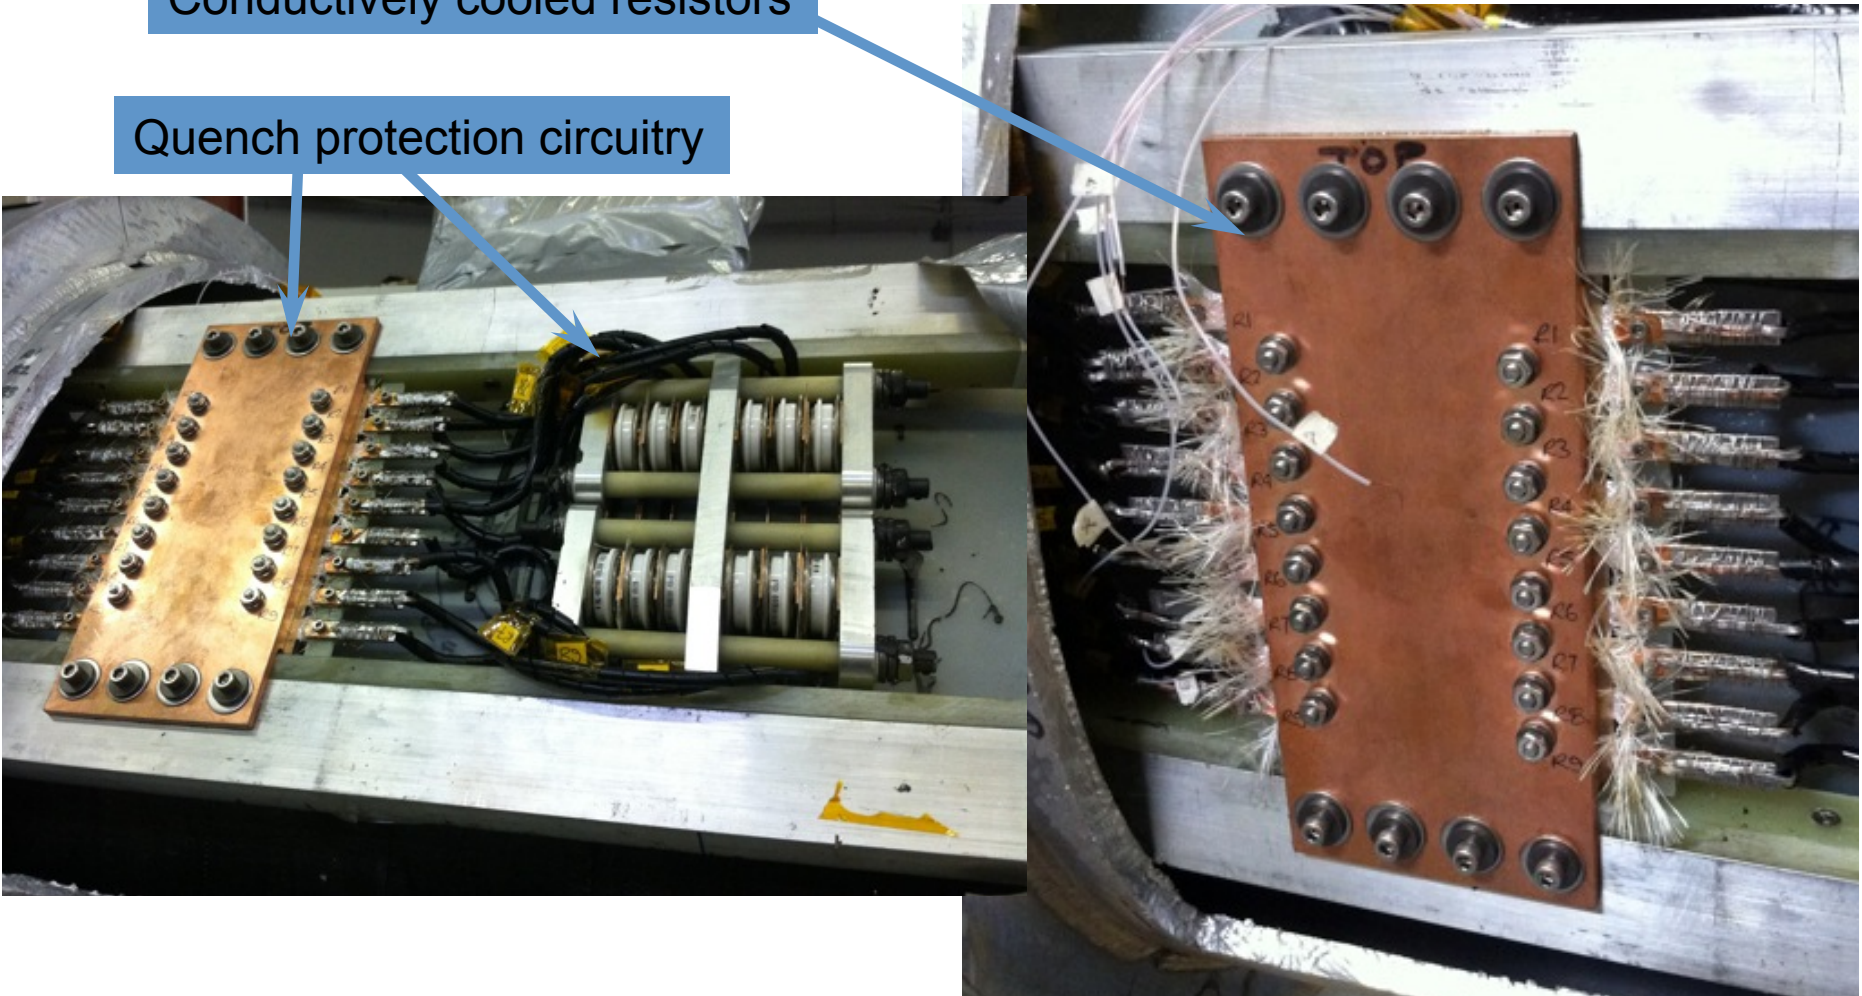
Picture of final configuration for SS2/SSU

Conductively cooled resistors

Quench protection circuitry
