MICE Spectrometer Solenoid (Pre-) Review Initial Impressions

Jim Kerby (ANL)
RAL, Oct 27, 2015

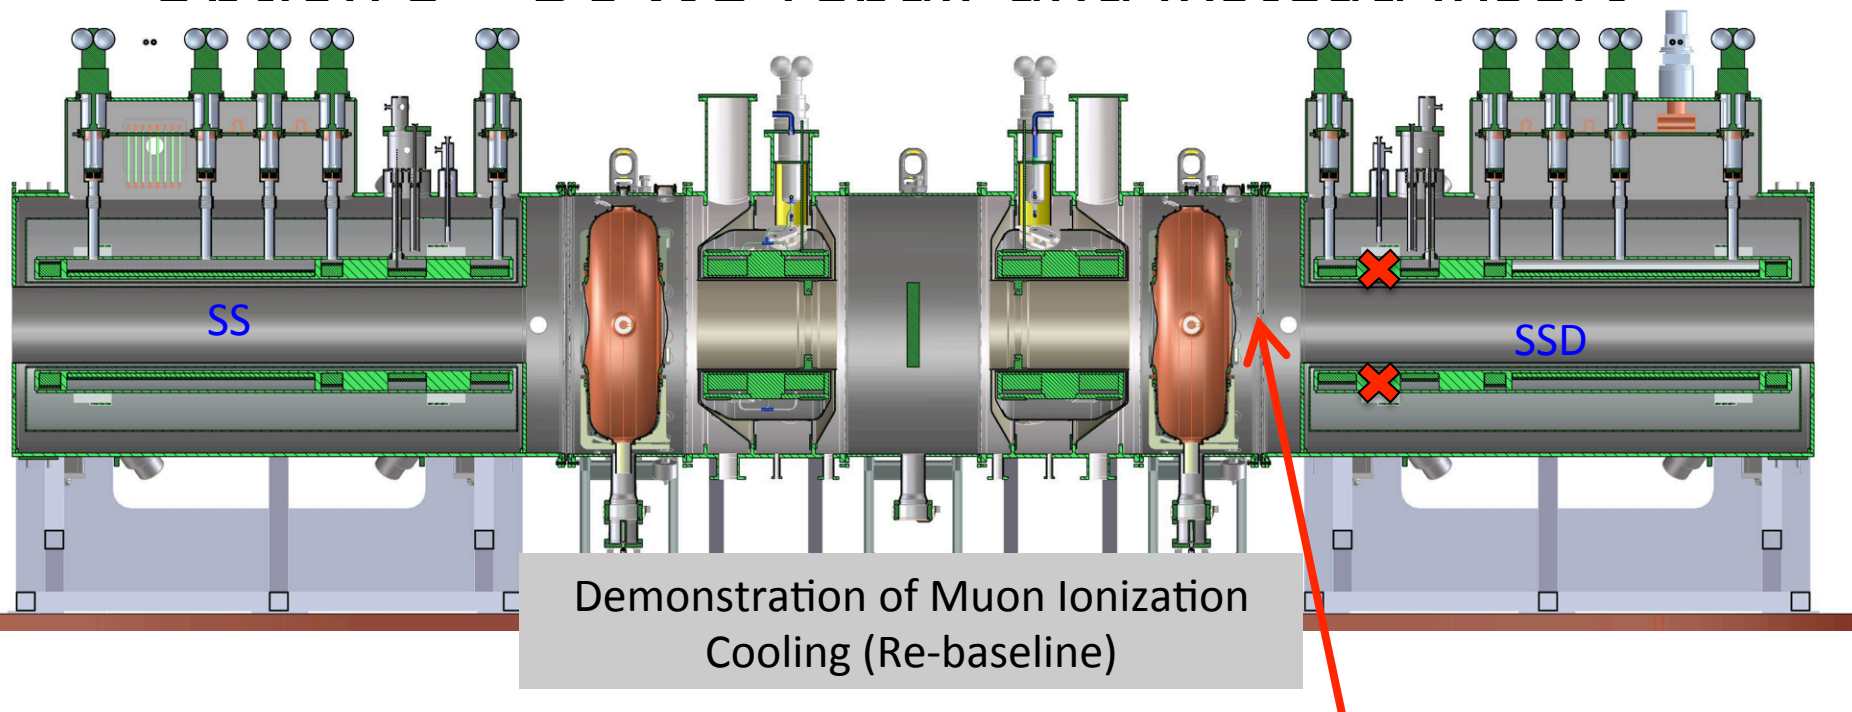
Insert 1- or 2-coil solenoid here
and develop new match optics
without SSD M1.

- Option 3 – Do **NO** repair and instead insert
