# Horn Stripline Feedthrough for He Vessel

# Introduction

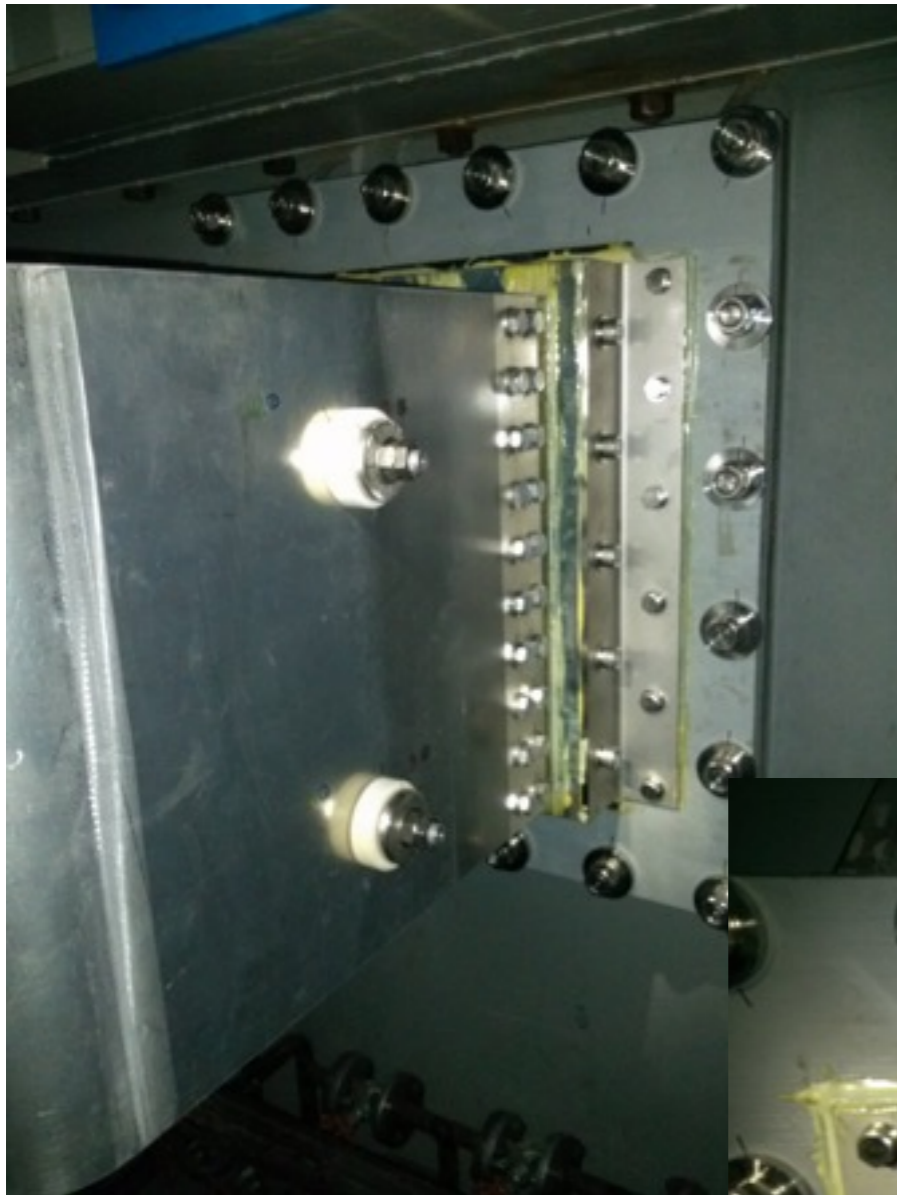
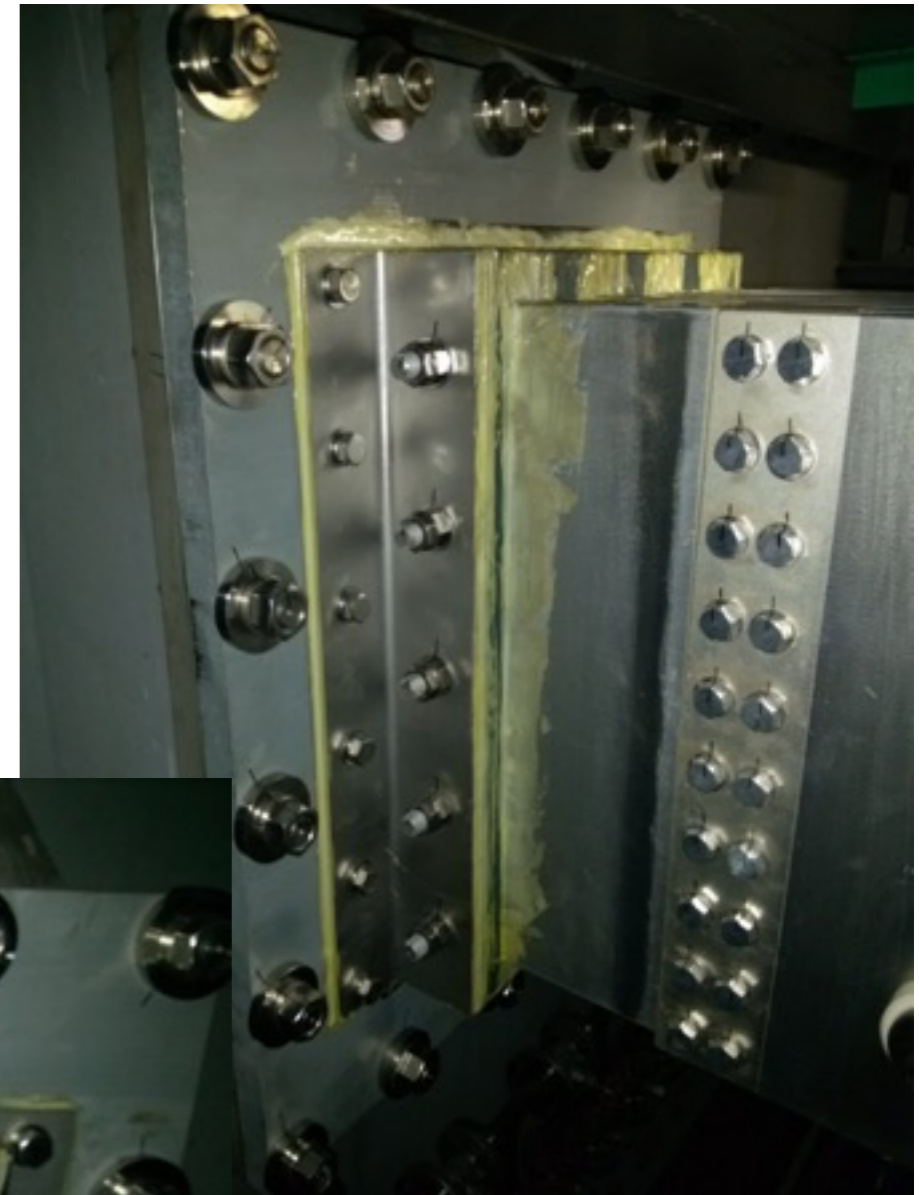
G10 insulators

- Striplines
  - 50cm width
  - 15mm minimum gap between striplines
- Insulation
  - G10 spacers
- Sealing
  - Sealing by epoxy glue for stripline part
  - Vacuum test @ 100 Pa
  - EPDM O-ring for iron flanges
- Radiation environment
  - at most ~1kGy/year  $\Rightarrow$  radiation tolerance of O(MGy)
