MicroBooNE Status

Status of Drift HV and FT1

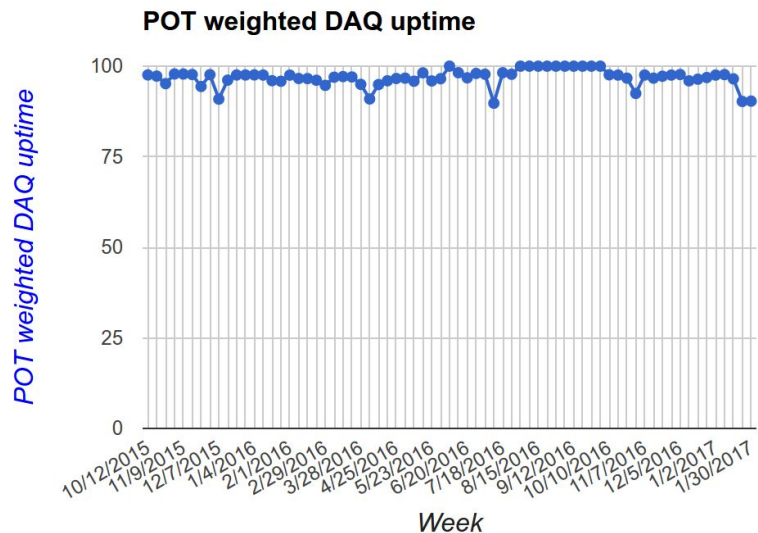
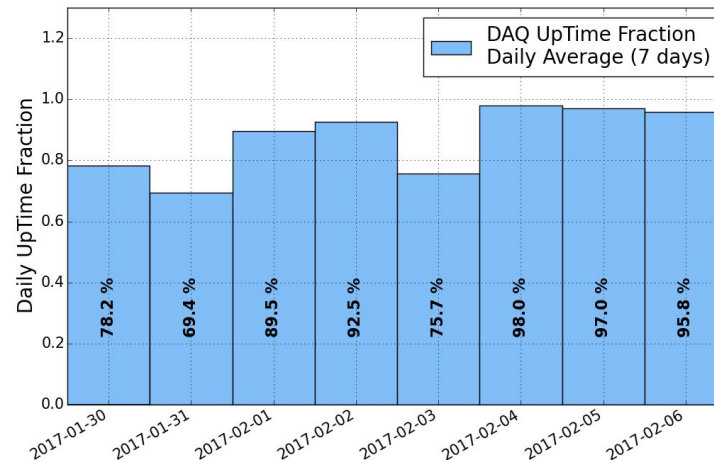
DAQ Uptime

Note: Results here reflect DAQ weighted uptime. BNB to ANNIE and MiniBooNE.
