Firmware Trigger Primitives Lessons Learned

Antony Earle
DUNE UK
12/01/2023

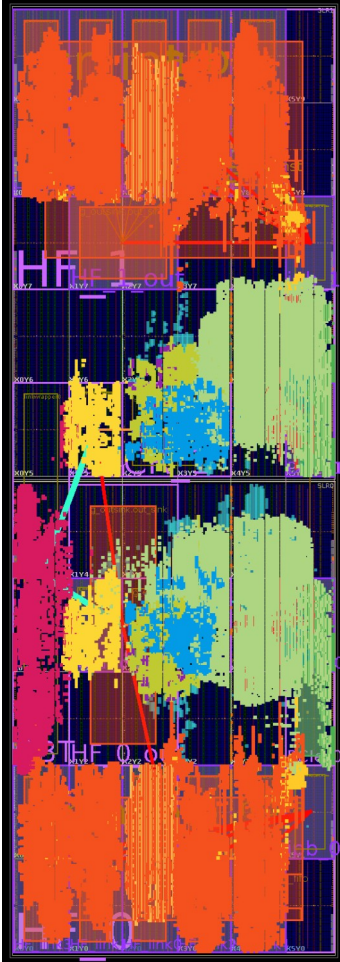
- Firmware Based Trigger Primitive Generation, (TPG), produces trigger primitives from streamed ADC samples when ADC values on a wire cross a specified threshold value

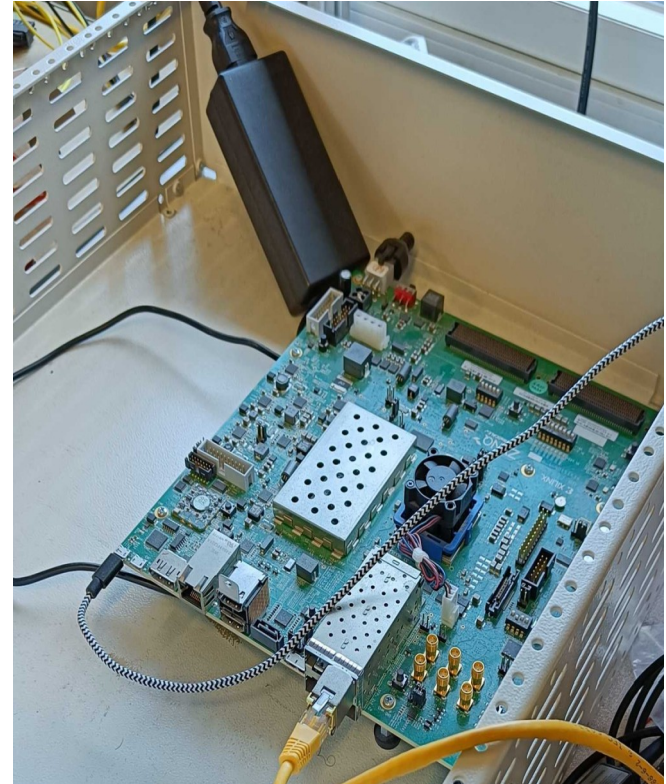
- Hardware test platform used ZCU102 development board
 - Had FW TPG blocks without the overhead of the FELIX infrastructure
 - Build time much shorter than FELIX, allows quick iterations for debugging
- Used to replicate issues seen in FELIX hardware
 - Channel masking issue was replicated on ZCU102 hardware and patch fix tested before deployment on FELIX

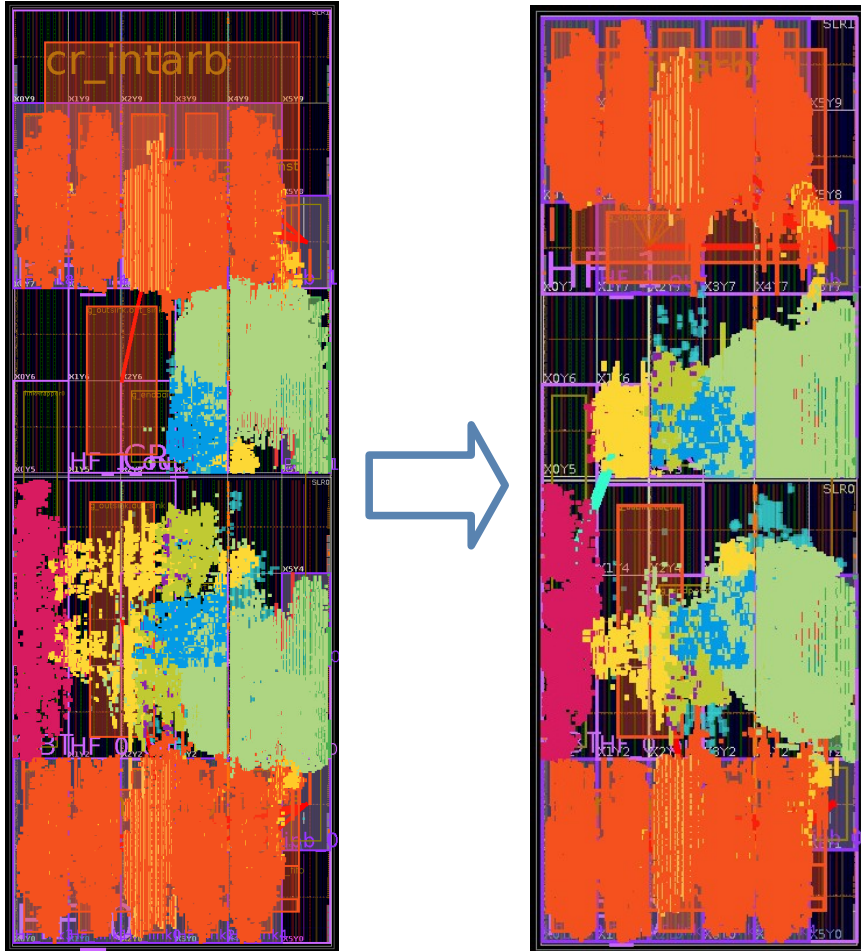
- Rebased FELIX FW to incorporate features provided by FELIX developers
 - Rebasing a bit of a lottery in terms of time required to implement
 - Changes could require updates to build scripting to make compatible
 - Large functional changes could require repeat build testing with adjustments to firmware block placement to ensure timing restrictions were achieved. Costly due to long build times of FW, (2-3 hours on a fast machine)

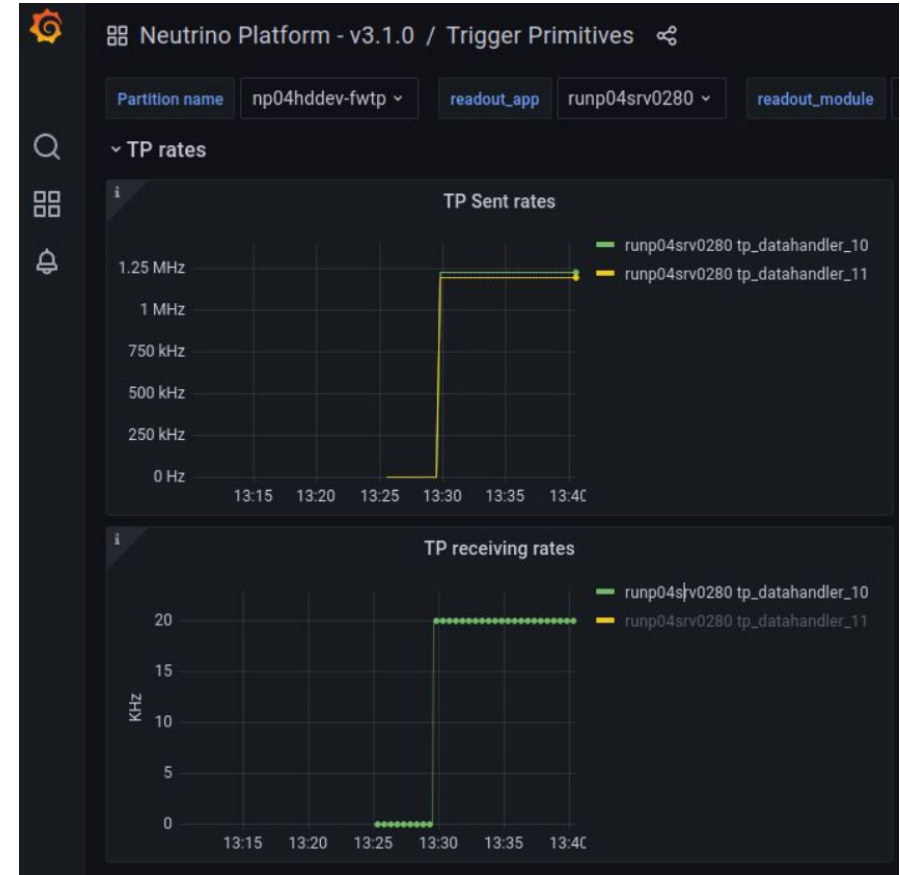
- Developed multiple firmware builds to support DAQ testing during the week
 - Having all developers on one hallway enabled quick turn around and discussion of issues
- TPG configuration streamlined and used as part of run control
 - Double edged sword as over-reliance on using run control config constrained testing in some aspects
- Monitoring and FW TP metrics added to Grafana dashboards for better feedback and monitoring

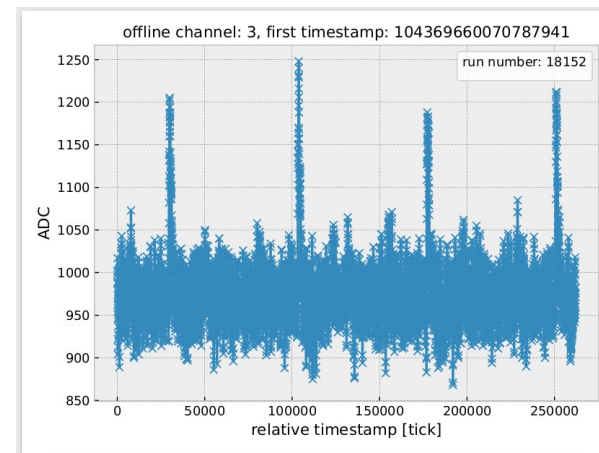
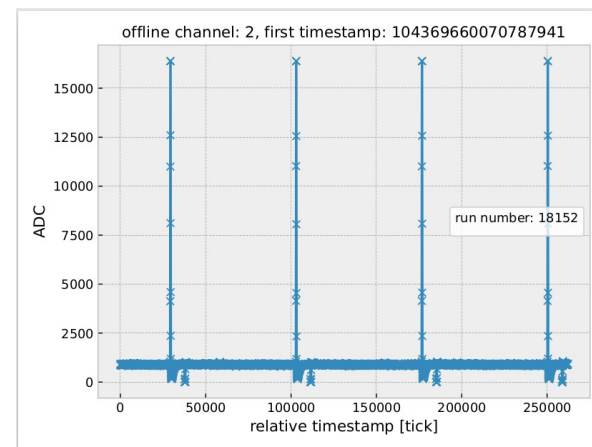
- Run config very streamlined by this point
- Good example of overall improvements in data feedback tools as these were used to confirm the misconfiguration of WIB calibration pulses and helped to remove some doubt around firmware functionality
