DUNE
Cold Electronics Cryo Testing
Update on RTS
(Robotic Testing Station)

Dean Shooltz, Kendall Mahn,
Carl Bromberg, Danielle Seppala
Liz Triller, Joe Walsh
Michigan State University
Nov 28, 2023

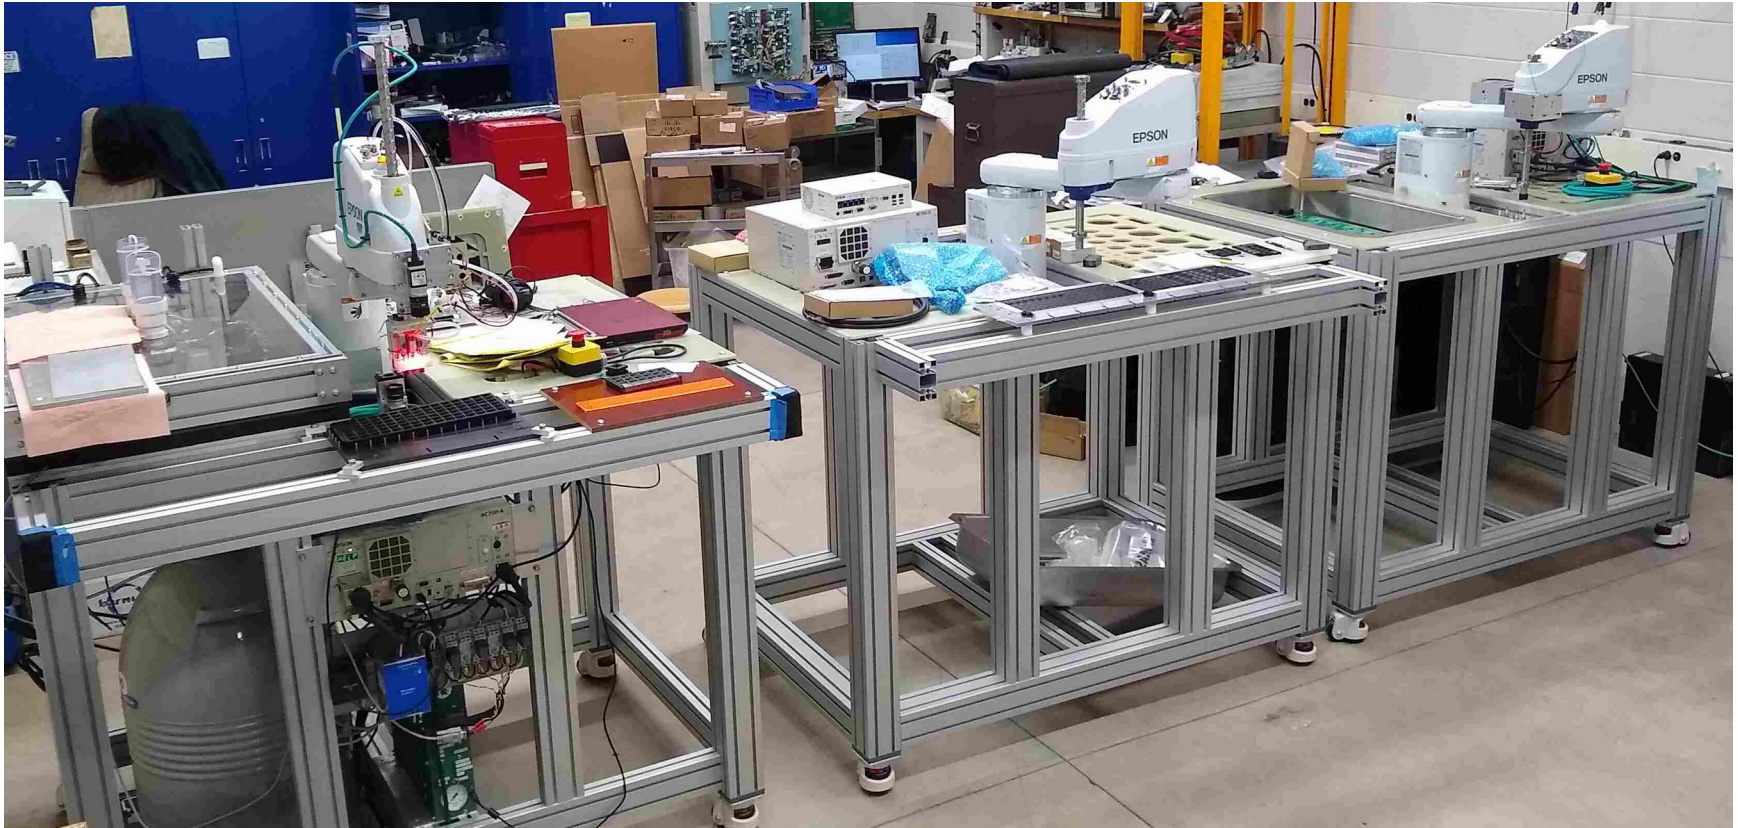
Three RTS are nearing completion.
