# STATUS REPORT ON SURVEY AND ALIGNMENT OF J-PARC AFTER THE EARTHQUAKE

N. Tani<sup>#</sup>, T. Morishita, S. Meigo, M. Harada, H. Stefanus, JAEA/J-PARC, Tokai, Japan M. Shirakata, T. Ishii, Y. Fujii, Y. Shirakabe, KEK/J-PARC, Tukuba, Japan

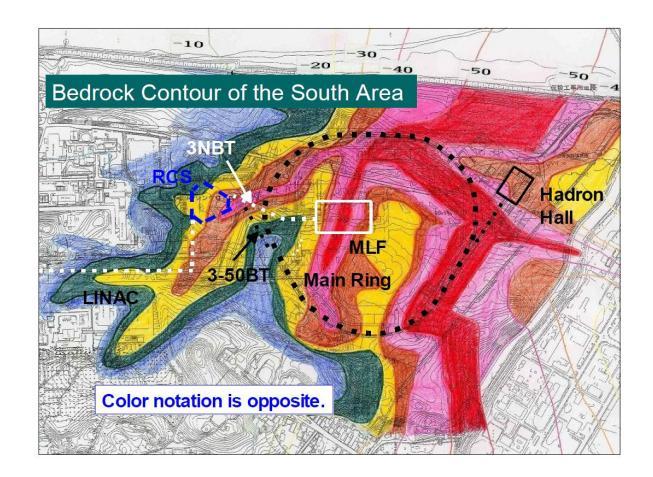
Figure 1: Bedrock contour around J-PARC facility.

Crustal shape around J-PARC facilities is complicated as shown in Figure 1 so uneven settlement was concerned from the beginning of construction. Main building differs in each facility and the main tunnel of the accelerator facility is held by driving piles into the basement layer (gravel mudstone layer). For each facility survey on the accelerator tunnel floor, reference points on the wall and magnets are carried out every two years to observe changes across years. As a survey work immediately after the earthquake, GPS survey which can observe ground deformation around J-PARC without entering the building often was implemented in April and the precise levelling was carried out in July. Also leveling, traverse survey, laser tracker survey was implemented for each facility to understand the situation in the accelerator tunnel and realignment was carried out where it was necessary.

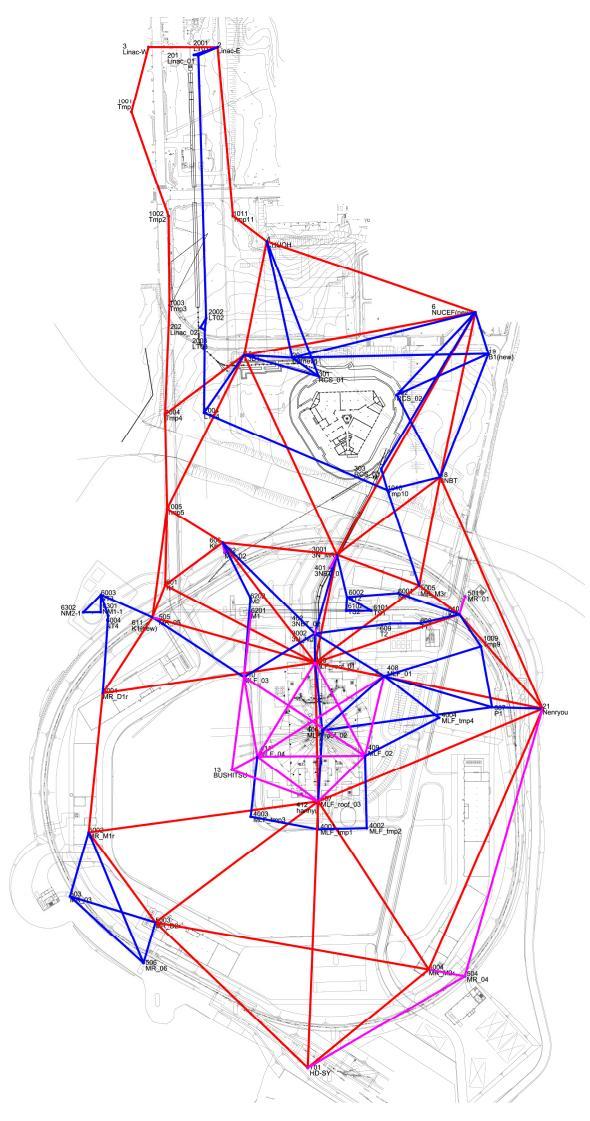
Figure 2: Observation network of GPS survey.

At J-PARC facility precise traverse survey and leveling are being implemented every two years. The last survey before the earthquake was in August 2010. After the earthquake GPS survey whose result can be quickly obtained was carried out at first in order to make use of it for recovery work of each facility [3]. Figure 2 shows an observation network of GPS survey. This observation network is the same as that of the precise traverse survey in 2010. Red line shows primary reference points and blue line shows the secondary reference points. Survey time is 4 hours and 2 hours respectively. However points set in the building using the secondary reference points were used for traverse survey using Leica TDA5005 and horizontal position was evaluated using the reference data obtained in the GPS survey.

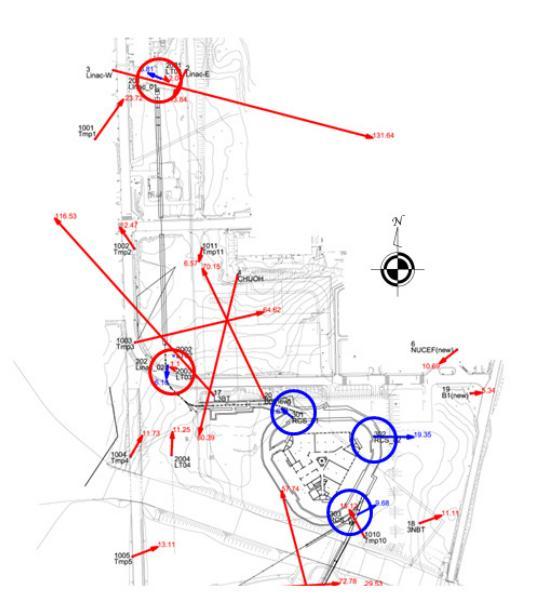
Figure 3 shows displacement vector of reference points around Linac and RCS obtained in the GPS survey and changed between August 2010 and April 2011. Red displacement vector shows reference points above ground and on the roof of the building and blue displacement vector shows reference points in the tunnel. Survey accuracy of GPS is  $\pm 5$  mm.

Reference points circled in red shows displacement of reference points set in Linac tunnel and on the 1<sup>st</sup> floor of the building. As maximum displacement was 6.81 mm it was found out that the reference points did not move largely due to the earthquake.

Reference points circled in blue shows the reference points in RCS tunnel. As maximum displacement was 19.35 mm it was found out that the tunnel expanded in east-west direction.

Figure 3: Result of GPS survey around Linac and RCS.

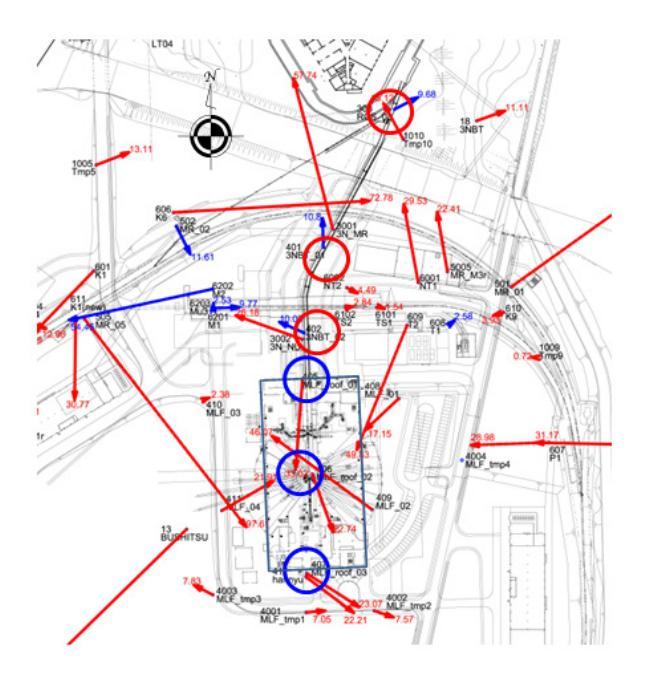
Figure 4 shows displacement vector of reference points

around 3NBT and MLF. 3NBT is transport line of proton beam from RCS to MLF. MLF is an experiment facility of neutrons. Points circled in red show reference points set in 3NBT tunnel. Each point moved about 10mm toward RSC side due to the earthquake and rotated clockwise. Points circled in blue are reference points set on the roof of MLF and show displacement between 22 mm and 33 mm. The building moved about 20mm due to the earthquake and rotates counterclockwise.

Figure 4: Result of GPS survey around 3NBT and MLF.

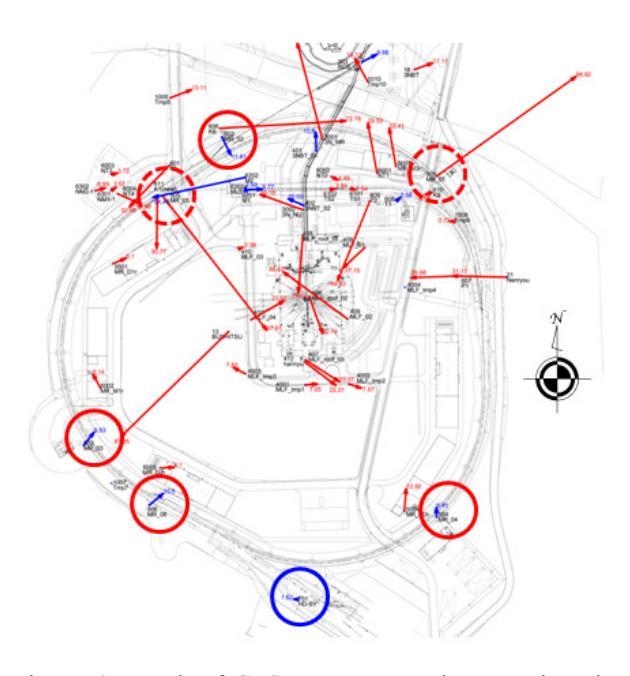
Figure 6 shows displacement vector around MR and Hadron facility. Points circled in red are reference points set in MR tunnel and shows displacement from 11.61 mm to 5.41 mm. MR has 6 reference points. Among these, 2 points circled in a dashed line are the points that cannot be observed using through-holes. Displacement of these 2

points showed the maximum value. As direction of each displacement vector differed, it was figured out the tunnel largely deformed.

Figure 6: Result of GPS survey around MR and Hadron facility.

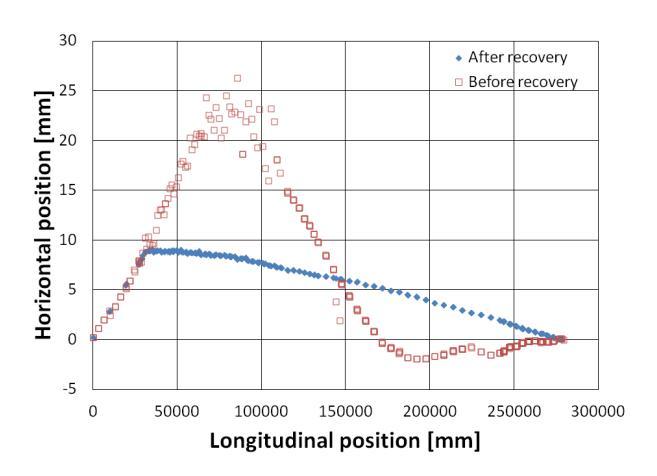
The cavities and magnets were measured by using a laser tracker. Horizontal and vertical displacements are shown in Figs. 7 and 8 respectively [4]. There is about 25 mm horizontal deformation at the straight section. The vertical displacement is consistent to the floor elevation. There are local settlements at the DTL/SDTL sections (more than 40 mm) and at the end of the ACS section (about 20 mm).

Figure 7: Horizontal position of the Linac in the straight section.

The blue line shows the result of the measurement after the re-alignment line of the straight section. It was necessary to move the DTL cavity by 20 mm or more to align the whole area of the straight section on the ideal straight line toward the dump. However, the range of the DTL movement is a few millimetres without re-wiring DTQs. Therefore aiming at an early restart of the beam operation, it was decided to steer the beam horizontally and vertically at the steering magnets located downstream of the DTL section. Longitudinally the accelerator tunnel of Linac extended about 9 mm at the upstream part of the SDTL section, and 1 mm at the downstream part of the ACS sections. This extension was absorbed smoothly by adjusting the magnets interval at the matching section between SDTL and ACS (about 15 m).

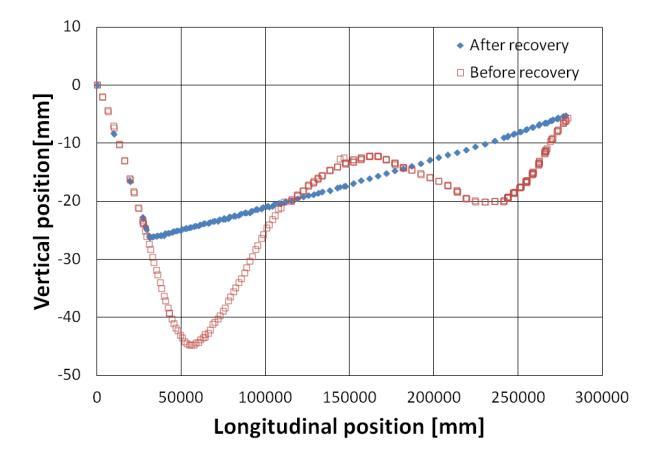
Figure 8: Vertical position of the Linac in the straight section.

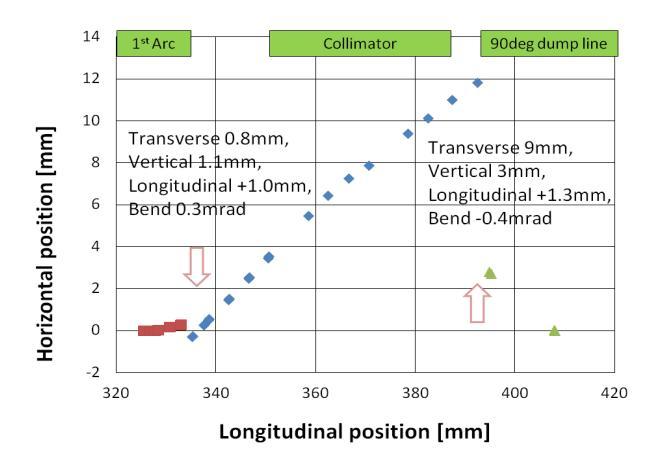
Figure 9 shows the relative position of the magnets after the first arc to the 90 degree dump. Displacements at the expansion joints are as follows:

- 0.8 mm in transverse, 1.1 mm in vertical, + 1.0 mm in longitudinal, 0.3 mrad in bend at the exit of the first arc.
- 9 mm in transverse, 3 mm in vertical, + 1.3 mm in longitudinal, -0.4 mrad in bend at the exit of the collimator section.

Figure 9: Relative position of the magnets after the first arc to the 90 degree dump.

The beam transport section (from the first arc to the injection line to RCS) was adjusted to maintain the proper injection angle and position to RCS.

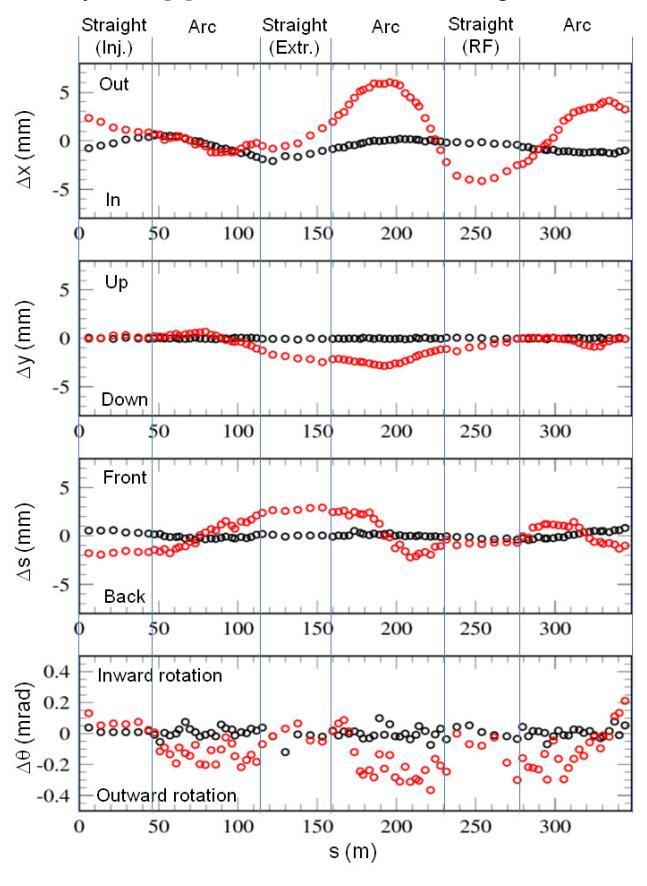
At RCS survey of magnets using a laser tracker was implemented from May 2011 and precise leveling started in July 2011 [5]. The results are shown in Figure 10.

Figure 10: Misalignment of RCS magnets before/after the earthquake. Black dots are values taken before and red dots are values taken after the earthquake.

After that an orbit analysis using the measurement results was implemented. It was confirmed that even with the magnets placement after the earthquake, 300 kW beam operation same as before the earthquake was possible by COD correction. 3GeV RCS restarted its beam operation in December 2011.

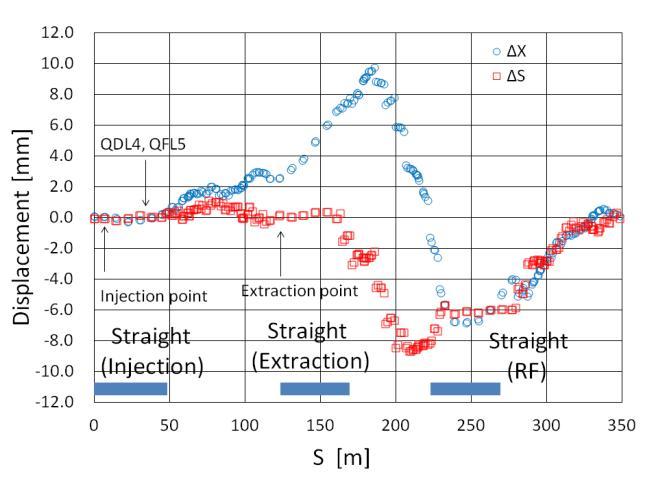
Figure 11: Displacements of magnets in horizontal direction which is standardized based on the injection straight.

The realignment of RCS magnets is planned from summer through fall in 2013. As for realignment, the most difficult part is adjustment of magnets (QDL4 and QFL5) near the injection collimator. Workability of this area is very low due to the shieldings installed to avoid high radiation dose this area caused by beam loss. Therefore for realignment it is planned for vertical direction to adjust QDL4 and QFL5 to the reference and for horizontal direction to evaluate and adjust displacement of each magnet so that misalignment of magnets at the injection straight section becomes as small as possible. The displacement of each magnet calculated from the result of the measurement in May 2011 is shown in figure 11 and 12. It was necessary to adjust the magnets about nearly 10 mm in horizontal direction. This displacement can be adjusted sufficiently within the range of the magnets movement.

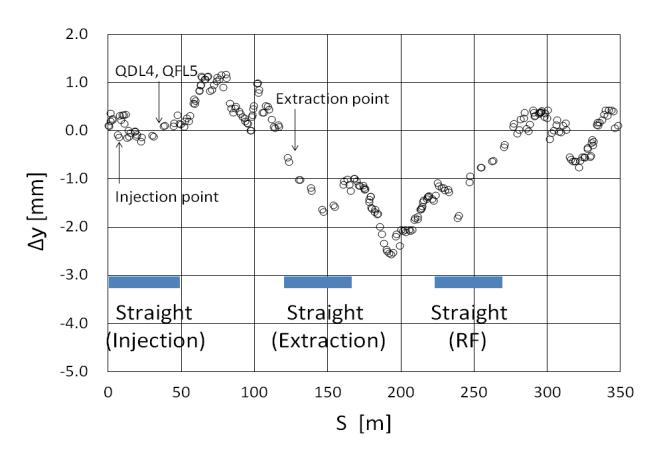
Figure 12: Displacement of magnets in height direction which is standardized based on the height of magnets near collimators (QDL4 and QFL5)

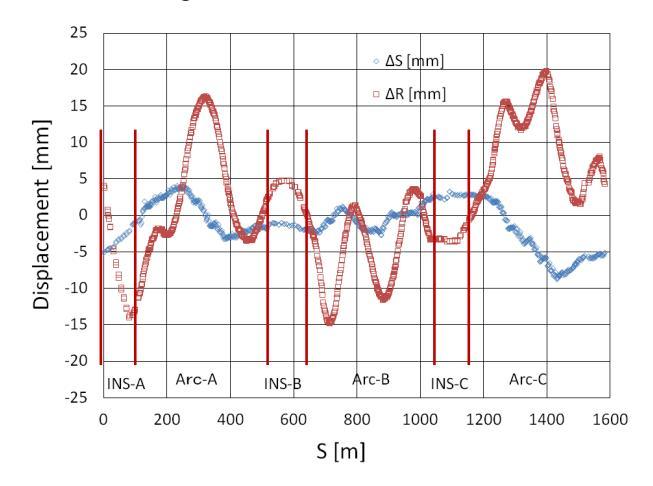
At MR survey of magnets using a laser tracker was implemented from May 2011. Figure 13 shows displacement in horizontal and longitudinal direction [6]. As a result of comparison with design values, the displacement range of horizontal direction was maximum 35 mm and longitudinal direction was maximum 13 mm.

Figure 13: Displacement of horizontal plane of MR magnet.

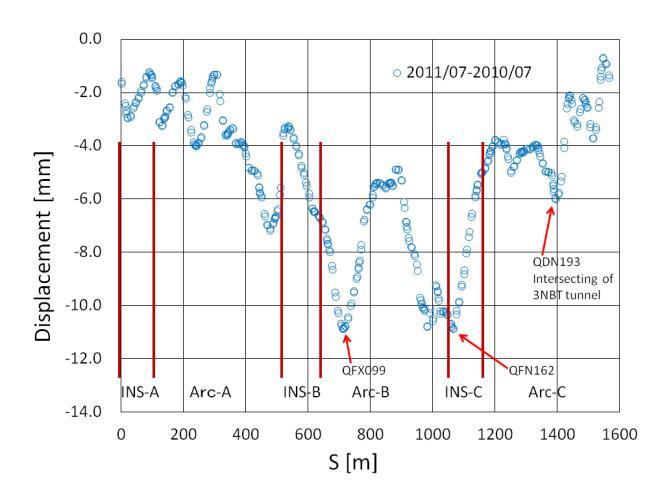
Figure 14: Displacement of vertical direction of MR magnet.

Leveling of the magnets was carried out in July 2011. Figure 14 shows displacement in height direction from July 2010. It is seen that the whole beam line showed settlement of about 2mm. Around the injection straight line (INS-A) is the highest and the part from slow extraction beam line (INS-B) to QFX099 via Arc-B and the part from the end of Arc-B to the middle of first extraction beam line (INS-C) show large settlement. Compared this part to Figure 1, it is found out that change of height from QFX099 and QFN162 corresponds to the relief of basement layer. Settlement seen at QDN193 corresponds also to the lower part of basement layer located at the slightly upper part of the cross section of 3NBT line. Only the upper part of INS-B seems to be against settlement but this is considered because this part is supported by two buildings from both sides. As there was a large displacement throughout MR, alignment of the all magnets was implemented from August through November 2011. As for height of MR beamline it was decided not to change height of extraction sesptum magnets of First extraction and Slow extraction. Figure 15 shows the result of confirmation survey carried out after the alignment.

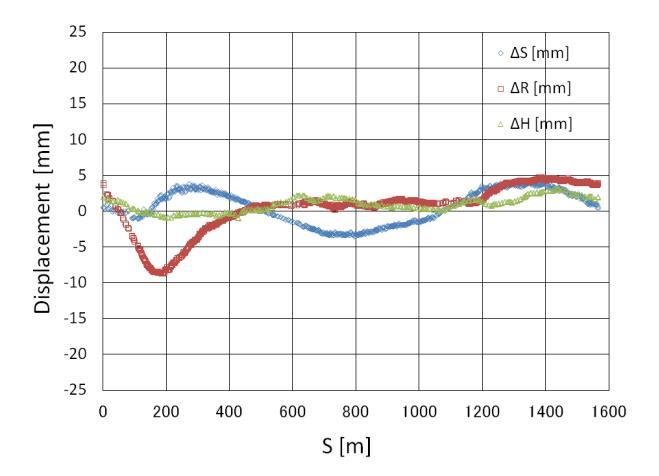
Figure 15: Survey result after alignment of MR.

For horizontal direction, displacement of about 8mm occurred regardless of the alignment. When survey data is analyzed, usually through-hole data (6 points) measured by traverse survey is included. However this time through-hole data measured by GPS survey was used and among the 2 points could not be used due to the earthquake. Therefore it was considered that sufficient data accuracy could not be obtained. Effect of aftershock was also considered but the levelling data of the floor reference points implemented before/after the alignment (July and November 2011) showed displacement range of the tunnel of 0.7 mm so it was difficult to think of displacement of several mm in a horizontal direction.

Luckily the result of COD measurement without correction after restart of beam operation was better than that of before the earthquake so it was considered that the alignment status was good enough. The final conclusion of MR alignment will be made based on the result of the survey in summer 2012 carried out after through-holes are recovered.
