Testing of High Density Interconnect Circuits for the CMS Forward Pixel Detector Upgrade

High Density Interconnect (HDI)

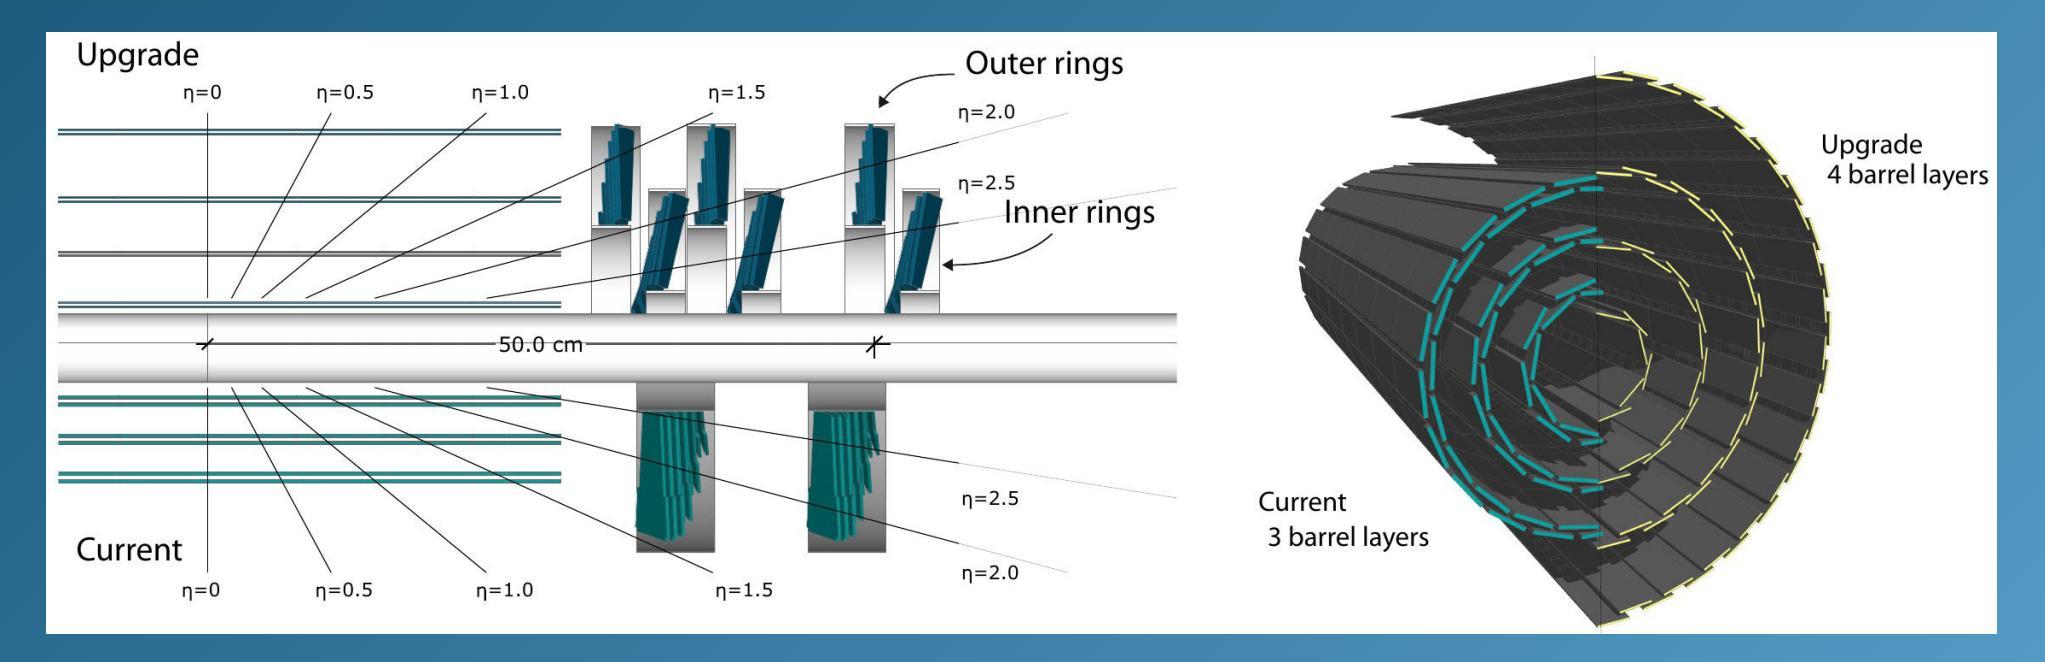
Phase 1 Pixel Upgrade

- 66M Pixels (18M in Forward)
- 2(3)-Hit Coverage up to pseudorapidty of 2.1
- Innermost layer at 4.4 cm
- 40 MHz Analog Readout
- Varied Pixel Plaquette Designs

- 123M Pixels (44M in Forward)
- 4-Hit Coverage up to pseudorapidty of 2.5
- Innermost layer at 3.0 cm
- 160 MHz Digital Readout
- Uniform Pixel Plaquette Design

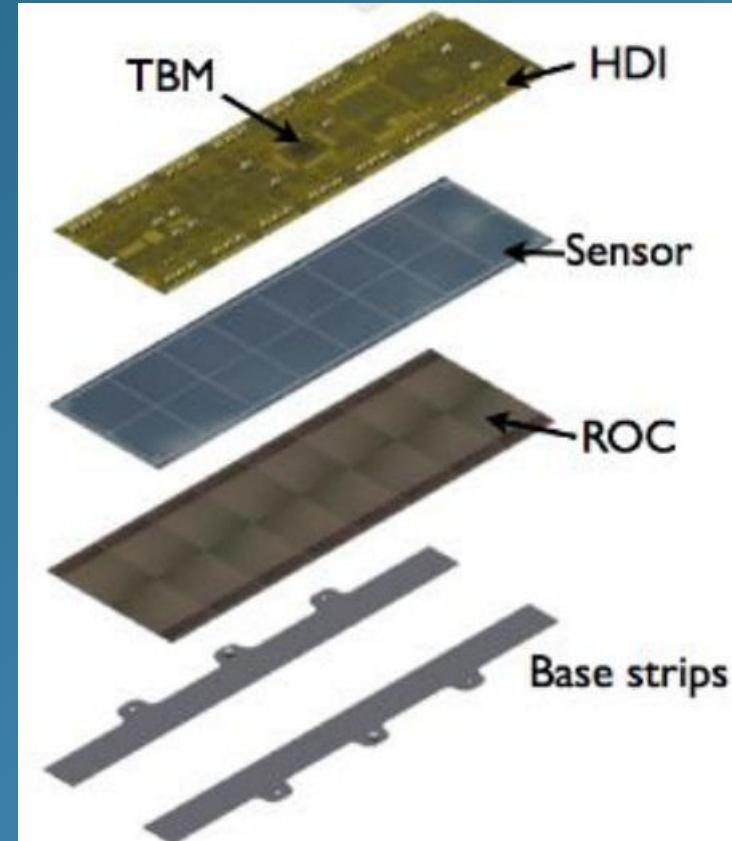
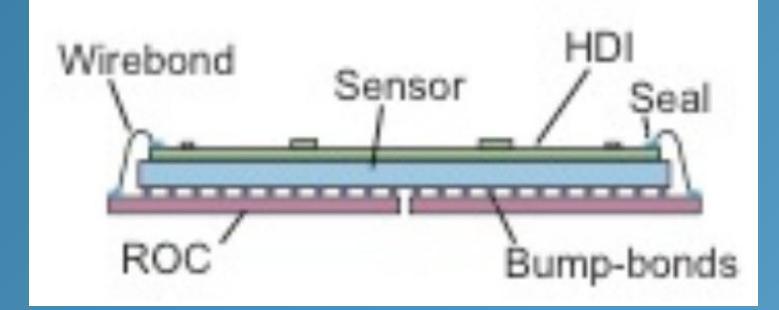
Pixel Module

- Silicon Sensor segmented into 2x8 chips.
 - 52 x 80 Pixels, 100 x 150 µm Pitch
- Bump-bonded to 16 Read-Out Chips (ROC)
- High Density Interconnect (HDI) glued to opposite side of sensor, wire-bonded to ROC.
- Token Bit Manager (TBM) bonded to HDI, manages read-out of sensor information from ROC.
- Collected signal read out through connector to DAQ system.

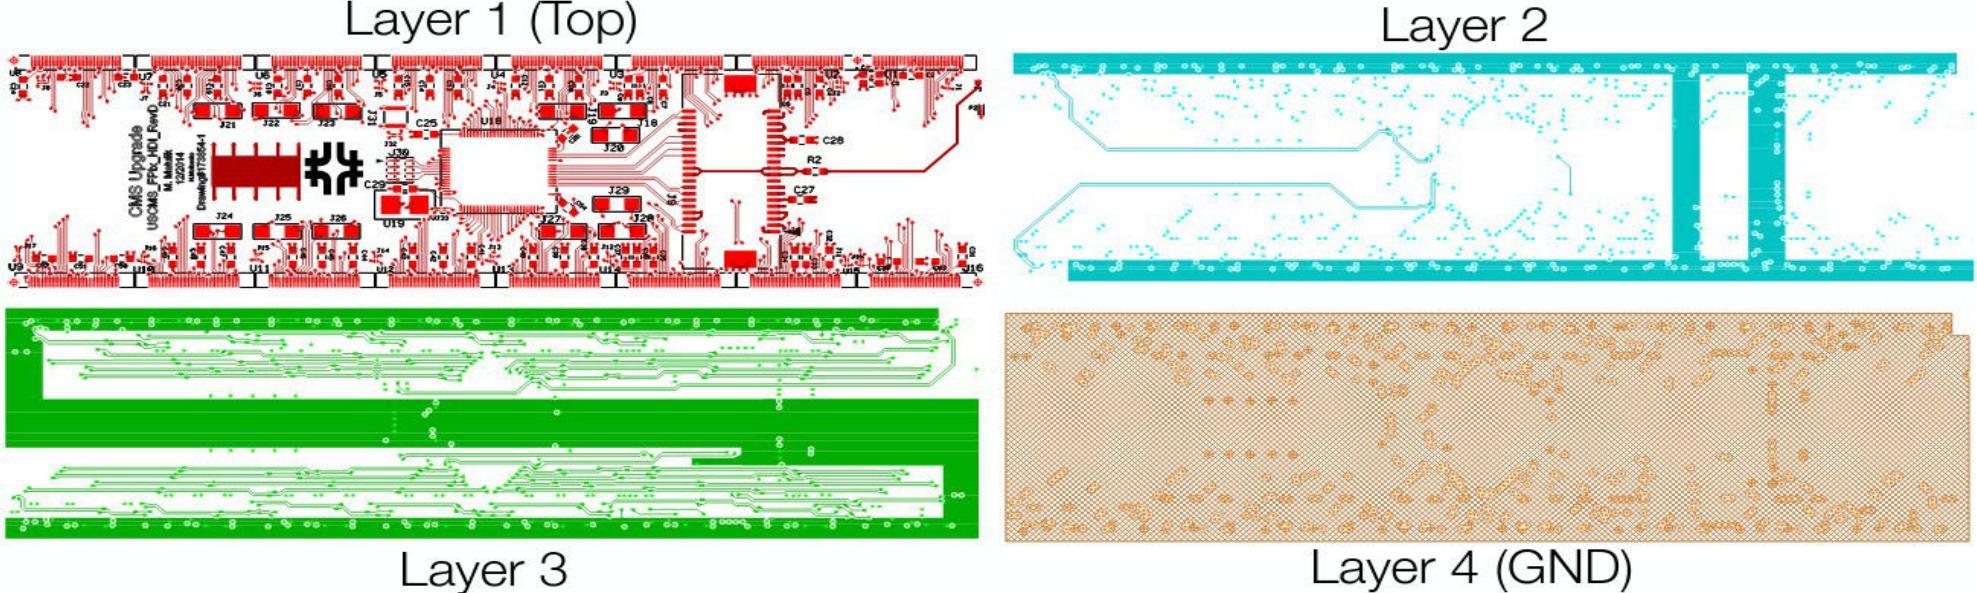
Layer 1 (Top)

HDI_revD

4-Layer Copper Flexible Printed Circuit

- 200 Nets
- ~900 Pads
 - 622 VIAs
- 6.6 cm x 1.9 cm x 0.027 cm

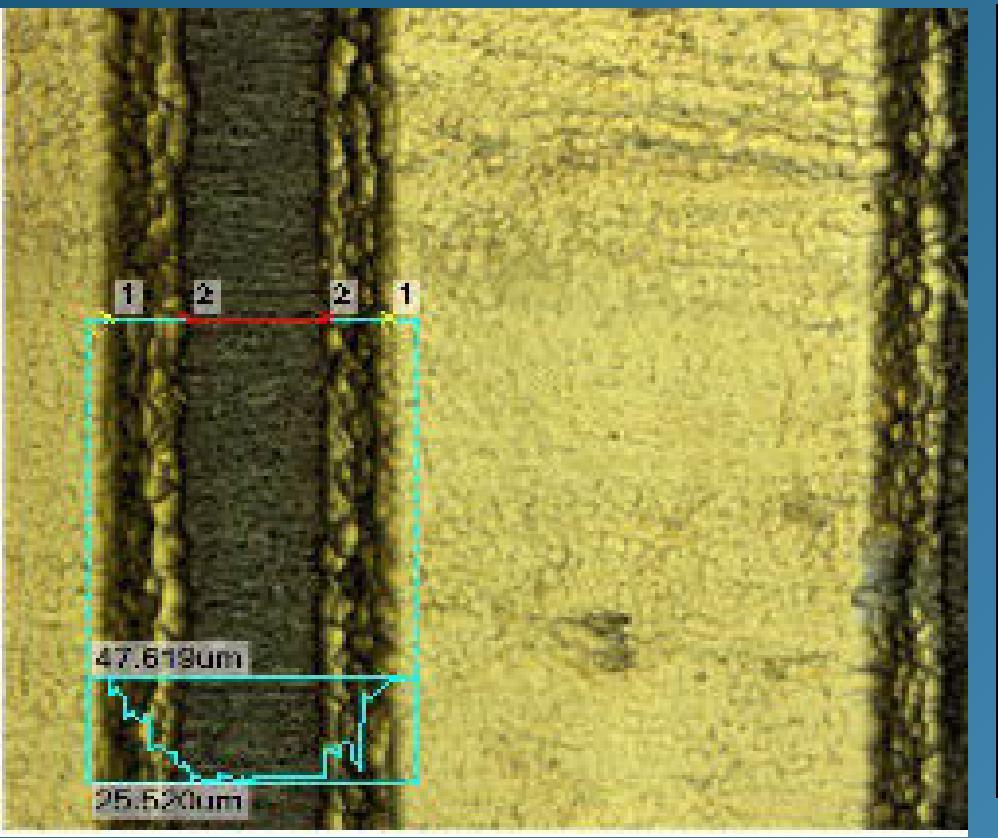
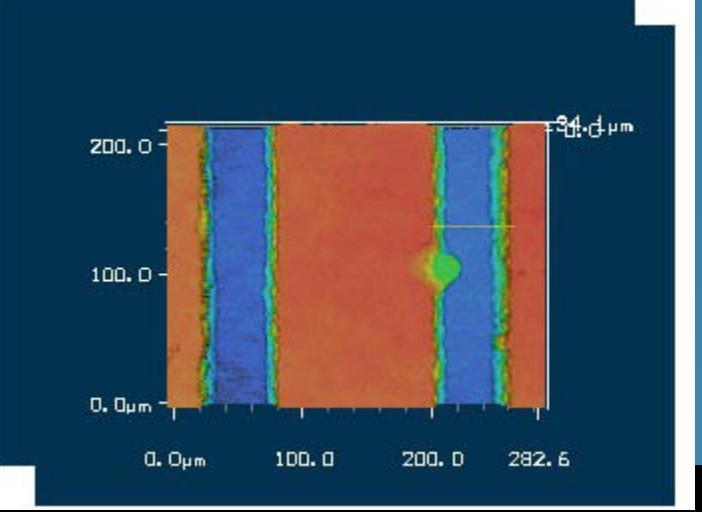
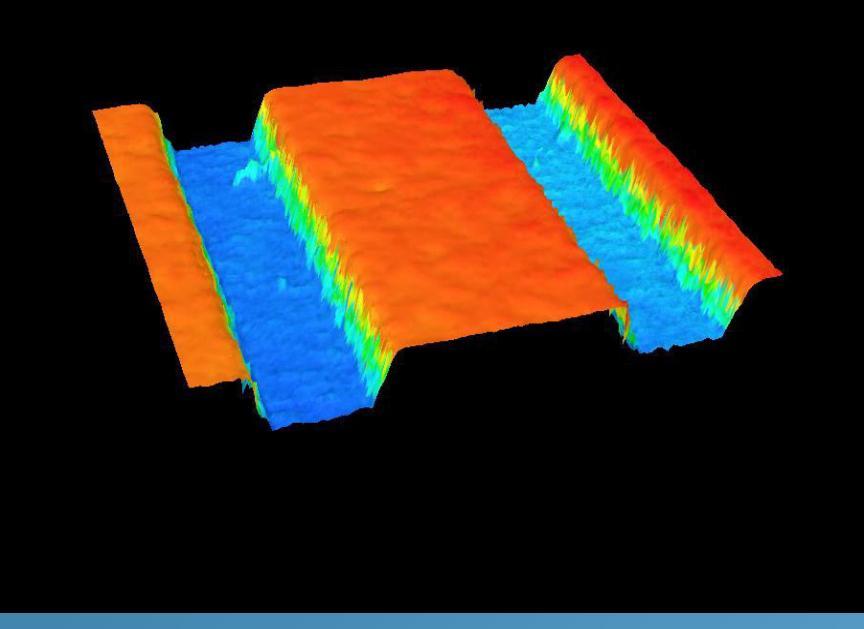
Confocal Laser Scanning Microscope

Under-Etching

- analysis of topographical features
 to 10 nm resolution
- 30-40 microns between the gold deemed to be sufficiently safe for operation

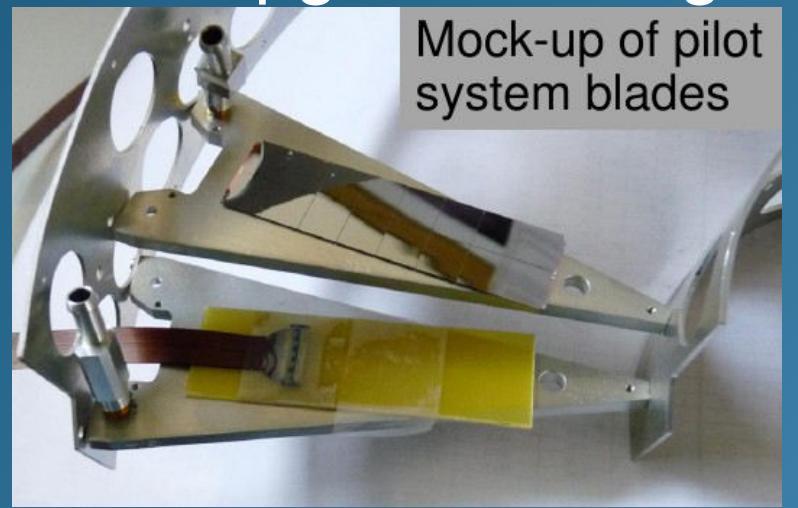
Pilot System

- Installed in 2014 for Run 2
- 8 Modules w/ Digital ROC
- Mixture of new & old components
- Good test of modules, DAQ, before installation of full upgrade during LS3.

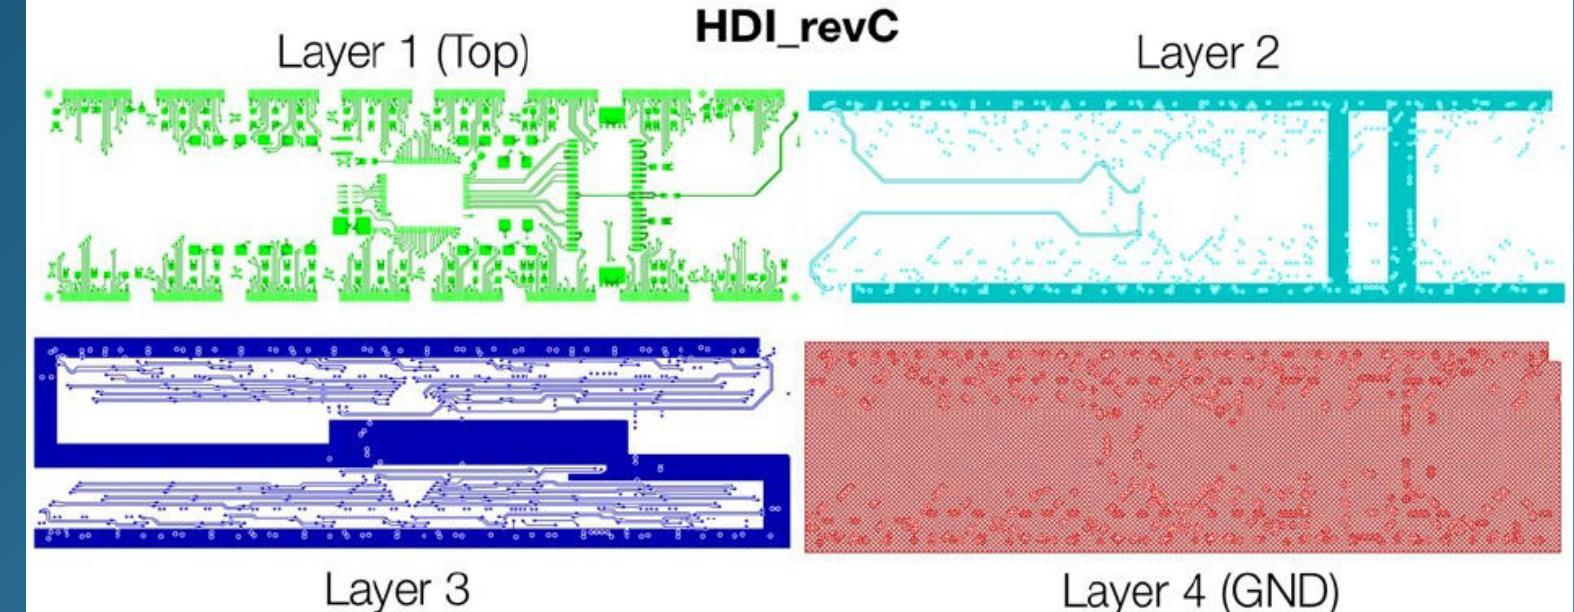
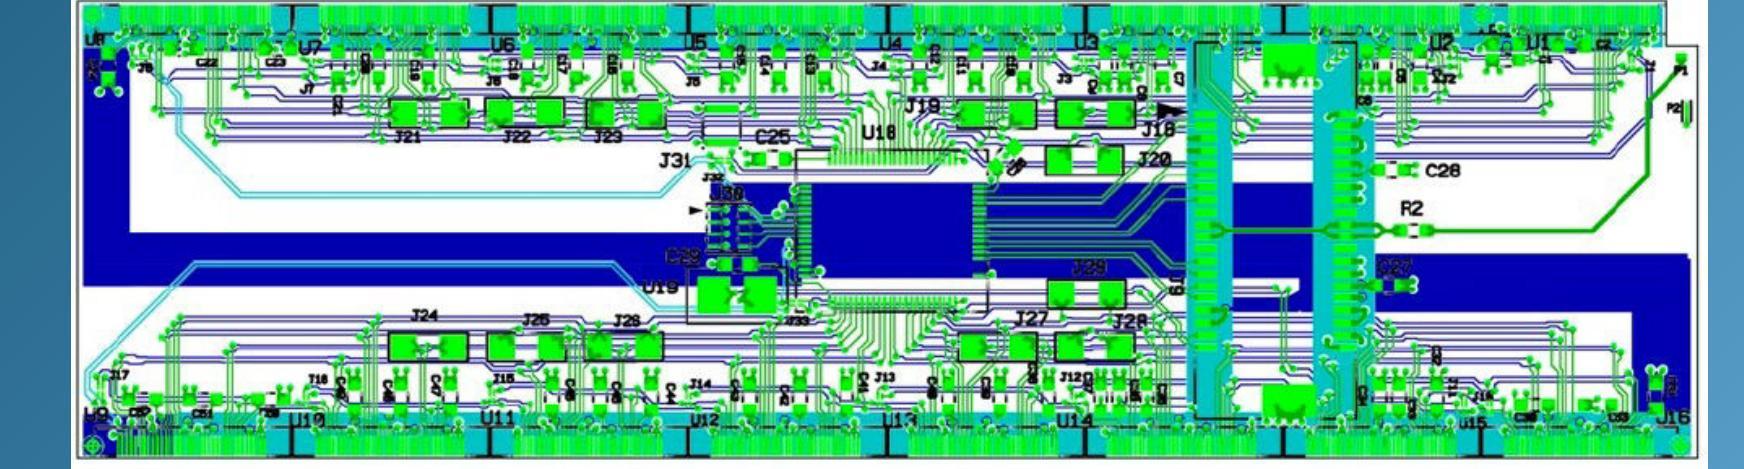
Combined Layers 1-3

4-Layer Copper Flexible Printed Circuit.
