COMPILATION OF PRESSURE-RELATED INCIDENT SUMMARIES

June 2016 (Rev. 4)

Dejan Ristic
Energy / Pressure Systems Engineer (2-5075)
Facilities and Management Services

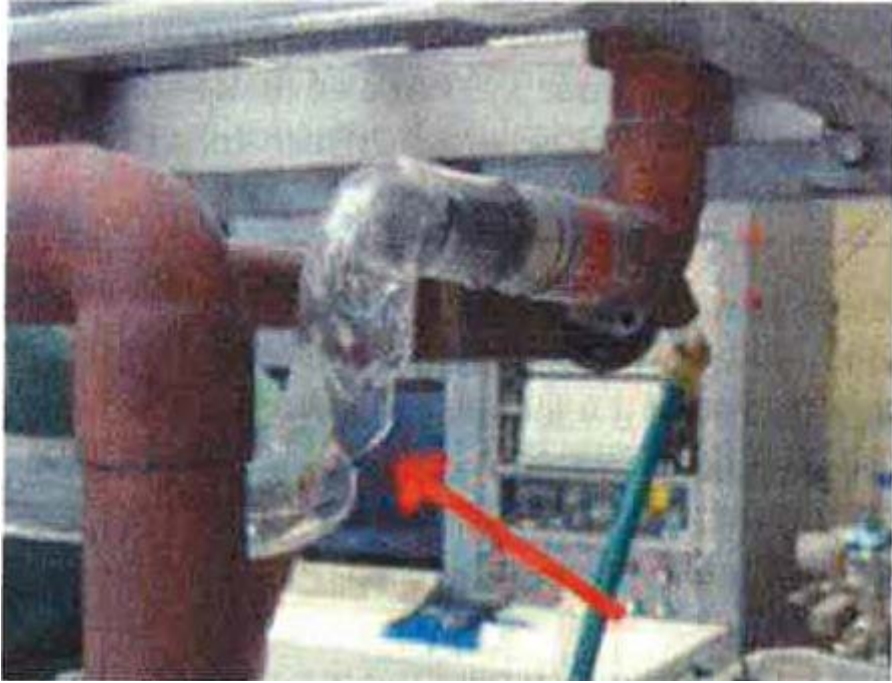
FAILURE OF A GLASS TUBING VACUUM SYSTEM

04/24/2015. At Pacific Northwest National Laboratory a researcher using a system with glass tubing attempted to backfill the system with ~2 psig nitrogen to relieve a vacuum. She was following a procedure, but was unable to open the system because it was still under vacuum. She increased the nitrogen pressure at the regulator to ~5 psig and tried to open the system again. After she opened the supply valves, a section of the glass pipe failed. The suspected cause was a leaking valve or incorrect valve position.

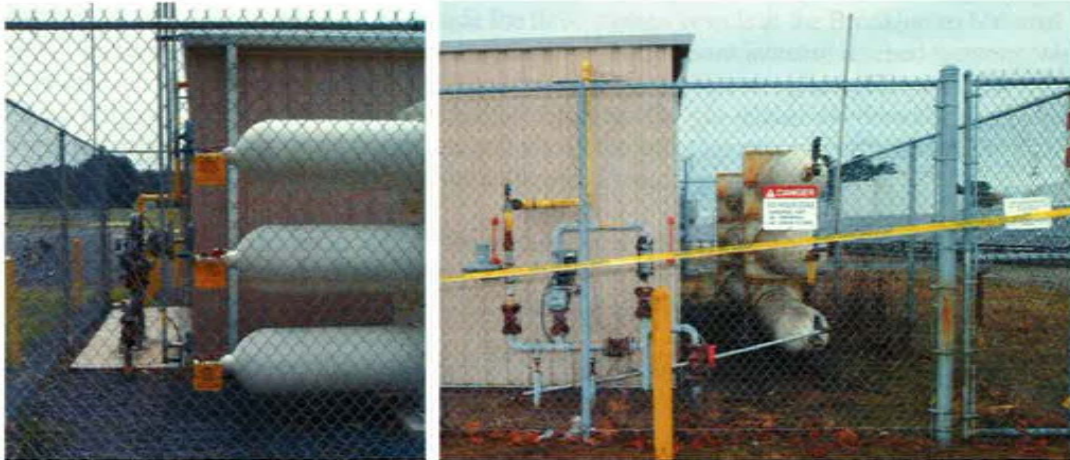
A View of the High Pressure Natural Gas Storage Vessels with the Failed Relief System Before (left) and Aft

On the days leading to January 6, 2014, unusual weather conditions with high temperature variations caused a large pressure rise inside the three storage vessels at the Brookhaven National laboratory (BNL) compressed natural gas (CNG) fueling facility. The pressure increase reached the point where the relief valve on each vessel opened automatically and released gas to the atmosphere. However, the valves experienced valve chatter, were damaged during the event and did not reclose as designed. Furthermore, the discharge piping structure downstream from the relief valves collapsed. Investigation found that the collapsed discharge piping was self-supporting, which is against prevailing code recommendation, and insufficiently braced to resist the reaction forces generated by the high pressure gas discharge.

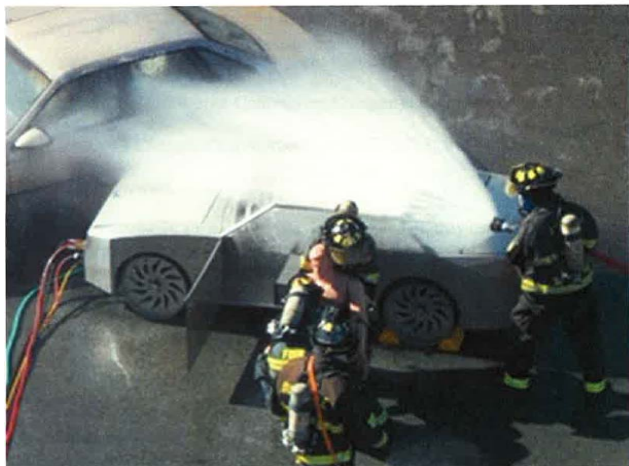
Failed Seal

Poppet

02/10/2014. At Pacific Northwest Laboratory a PNNL-led project team was demonstrating a vehicle hydrogen fire simulator during an off-site class for first responders when the regulator on the hydrogen cylinder failed and gas began flowing out of the pressure relief valve on the regulator. The hydrogen did not ignite and the instructor immediately shut off the valve on the cylinder, stopping the flow of hydrogen.

It was the relief valve, not the regulator that prevented a catastrophic failure. A regulator is not a safety device. Without additional protection, components downstream of a regulator can be exposed to pressures exceeding the set pressure up to the full bottle pressure. Never rely on a regulator as a source of protection.

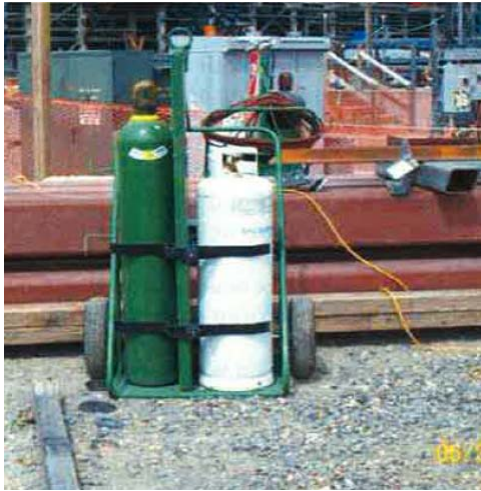
Storage Truck

STARGON GAS CYLINDER KNOCKED OVER SNAPS OFF REGULATOR

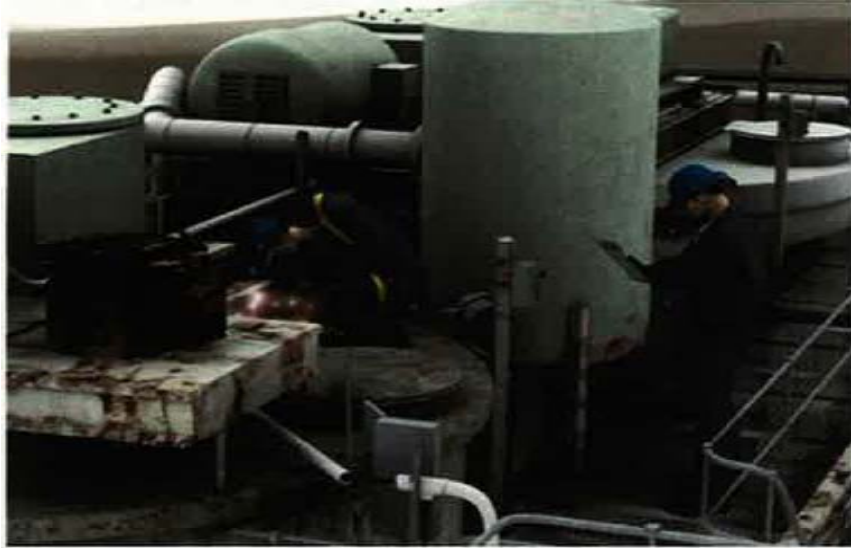
PRESSURE PIPE EXPLODES IN WELDING ACCIDENT

The plant maintenance staff in a power plant was charged with replacing a high-pressure steam piping spool piece that connects the main steam stop valve to the non-return valve. On the day work began, workers noticed that the main steam stop valve on an adjacent boiler was leaking steam. The workers were unfamiliar with the steam piping arrangement and dismissed its importance. The welders did not perform welder procedure inspections required by the American Society of Mechanical Engineers Piping and Boiler and Pressure Vessel Codes. After the first day of work, the new spool piece was being filled with water and steam because a drain pipe was left closed. When the worker returned the next day for a second pass, the vessel exploded.

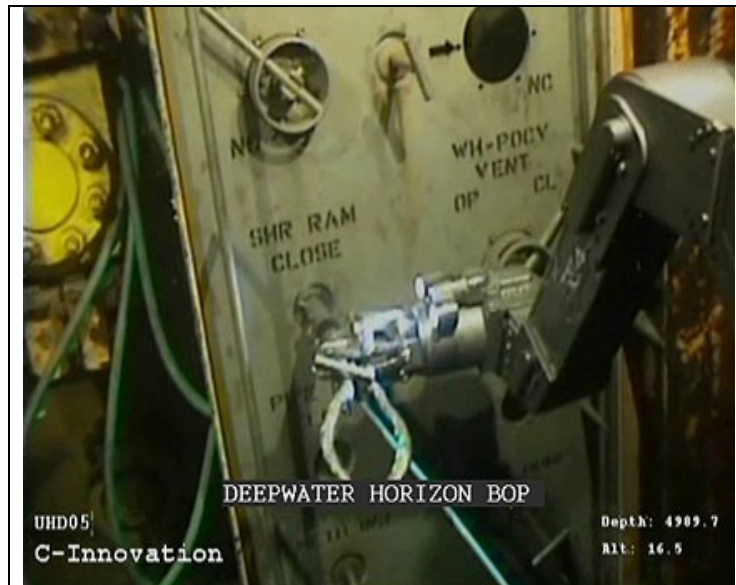
DEEPWATER HORIZON BLOWOUT PREVENTER MALFUNCTION

In April 2010, the infamous incident occurred in the Gulf of Mexico in which an oil rig failed due to a combination of several factors including a hydraulic leak in the blowout preventer and dead batteries. The incident left 11 workers dead, and incredible environmental damage. The Congressional investigation confirmed that the companies involved had documents that showed there was a leak in the hydraulic systems that operated the blowout preventer, as well as the dead batteries before the accident. Also those documents showed that they ignored the tests that had shown a problem.

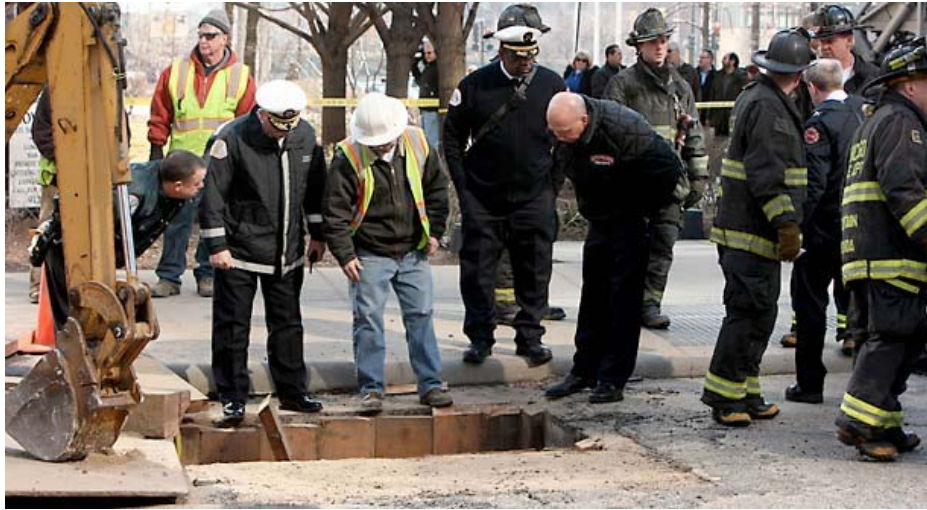
GAS MAIN ACTS AS PROJECTILE DURING PRESSURE-TESTING

On March 3, 2010, a Peoples Gas **worker died and another was seriously injured** after they were struck by a pipe while pressure-testing an underground gas main. The workers were using compressed air for the test when a section of the pipe moved and struck them.

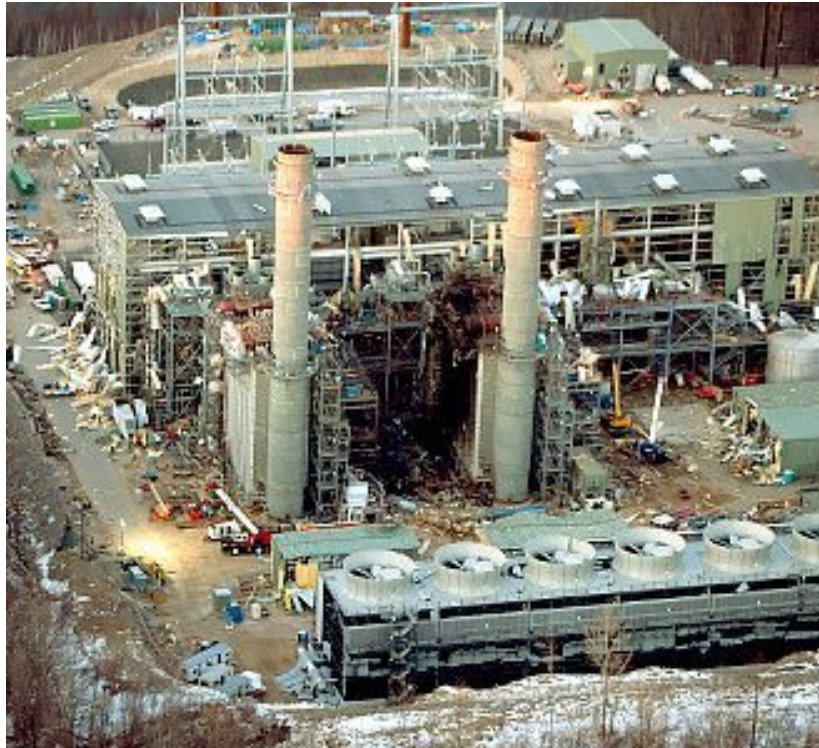
NATURAL GAS BLOW LEADS TO EXPLOSION

On February 7, 2010, an investigator with the U.S. Chemical Safety Board (CSB) said a natural gas blow might have caused an explosion at a Connecticut power plant that **killed six and injured 26**. The blast happened during a planned blow at the 620 MW Kleen Energy Plant during which workers used natural gas at a high velocity to clean debris out of gas pipes. Initial investigations show there was 400,000 standard cubic feet of gas released into an area with two heat recovery steam generators and the wall of the power block building in the ten minutes before the explosion, slowing down the gas' dispersment. With so many construction activities going on at the time, anything could have ignited the gas.

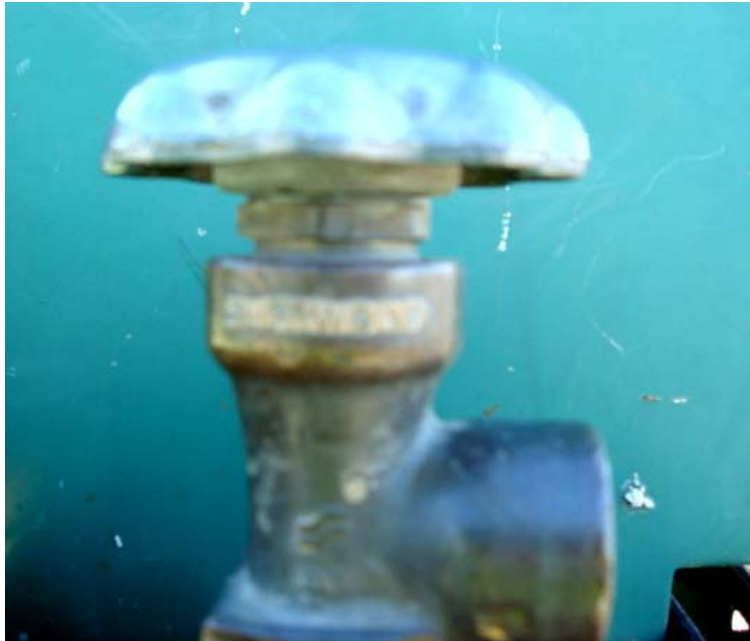
LEAKING ACETYLENE CYLINDER SHUTOFF VALVES

On January 11, 2010, while cutting rebar with an acetylene torch at the Savannah River Salt Waste Processing Facility (SWPF), a small fire (3-inch flame) occurred at a cylinder shutoff valve, which was quickly extinguished. Investigators determined that the cylinder shutoff valve was leaking at the valve stem when the valve was in the open position. An extensive inspection was conducted on acetylene cylinders at the SWPF. Five out of eight cylinders were found to be leaking just below the handwheel of the shutoff valve. The leaks occurred only when the valves were open. The gas vendor removed the leaking cylinders and provided seven new cylinders; however, three of them also leaked at the same location.

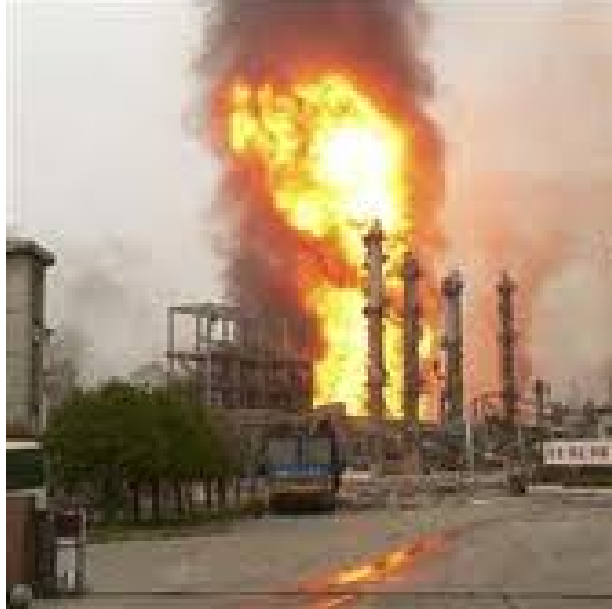
GAS EXPLOSION IN UTAH

On November 4, 2009, an explosion occurred at the Silver Eagle Oil Refinery in Woods Cross, UT when a 10-inch pipe failed catastrophically. Although the failure mechanism has yet to be determined, the pipe showed evidence of significant thinning, which had not been detected by the refinery's mechanical integrity program. The blast damaged nearby homes and was felt over a distance of several miles. A six-member team CSB led by Investigations Supervisor Donald Holmstrom was deployed to the scene of the explosion, which occurred in the diesel hydro-treater unit. Over the past several days, the CSB team has developed a number of serious concerns about the integrity of the piping and equipment at various locations in the plant. These concerns include a lack of required documentation and a lack of needed calculations of the fitness for service of various pieces of equipment. The agency discussed these serious concerns with Utah OSHA, the Utah Labor Commission, federal OSHA and Silver Eagle executives. CSB Chairman John Bresland told the chairman of the board and the president of Silver Eagle that in his view, the best course of action for the refinery would be to stand down as quickly and safely as possible. The refinery units should remain shut down until the integrity and fitness for service of all the equipment can be documented and verified. Silver Eagle's management responded by beginning an orderly process to stand down the refinery until the steps were accomplished.

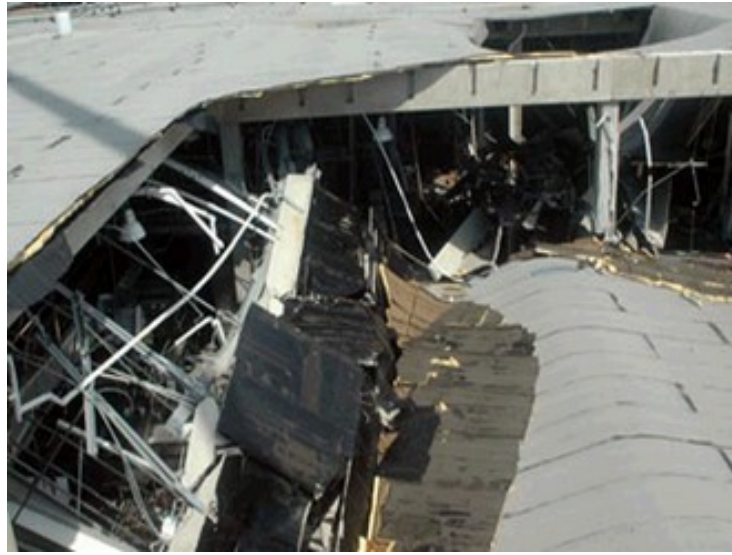
DEADLY CONAGRA EXPLOSION

On June 9, 2009, a natural gas explosion at the ConAgra Slim Jim production facility in Garner, North Carolina, which **caused four deaths, three critical life-threatening burn injuries, and other injuries that sent a total of 67 people to the hospital.** In preliminary findings, CSB investigators determined that the catastrophic explosion resulted from the accumulation of significant amounts of natural gas that had been purged indoors from a new 120-foot length of pipe during the startup of a new water heater in the plant that made Slim Jims, a popular beef-jerky product. During pipe purging, workers feed pressurized gas into a pipe in order to displace air or other gases so that only pure fuel gas remains in the piping when it is connected to an appliance such as a water heater or boiler.

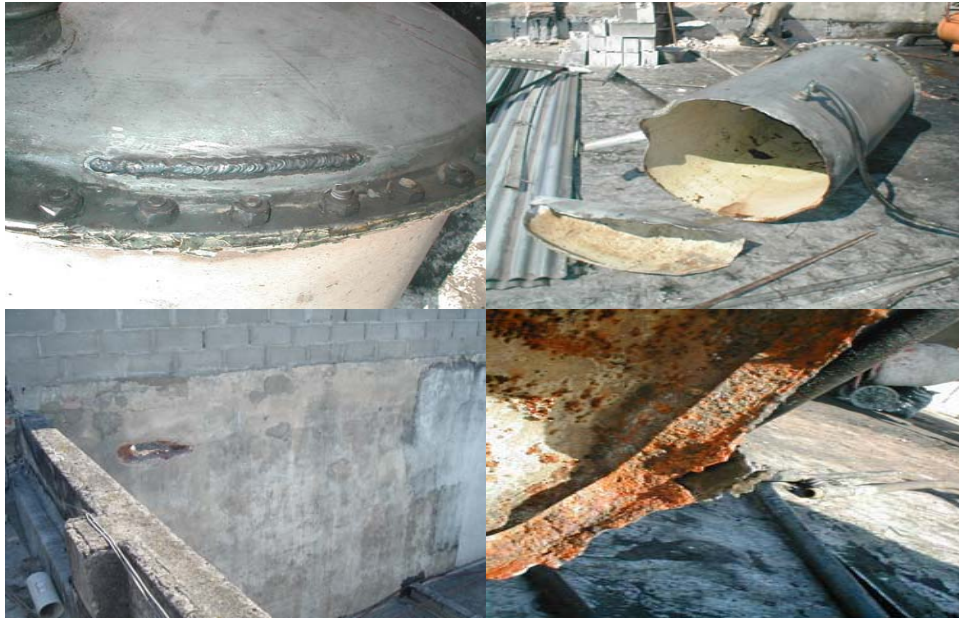
COMPRESSED AIR TANK FAILURE

In May 2009, a compressed air tank failed, blowing the bottom off of the tank and sending fragments flying into a concrete wall, puncturing the wall. Investigation following the incident revealed several serious problems with the condition of the tank, including severe corrosion and rust at the bottom of the tank, where it failed, and an improper weld repair which had been made to the tank at some time in the past. Although the weld repair did not contribute to this incident, it is a symptom of improper maintenance and inspection, and could have caused a tank failure. Fortunately, nobody was in the area when the tank failed, and there were no injuries.

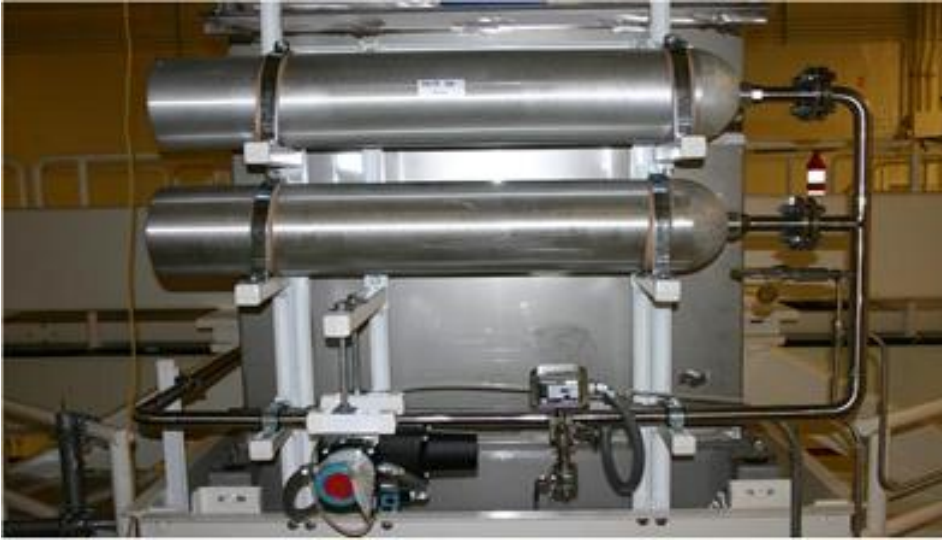
PRESURE VESSEL RUPTURE

On April 6, 2009, an accident at an academic research laboratory seriously injured a worker when a 120-pound laser diagnostic detector assembly broke loose from its overhead mounting and fell onto the worker. This in-house designed and fabricated equipment included a pressurized tube that failed during the accident.

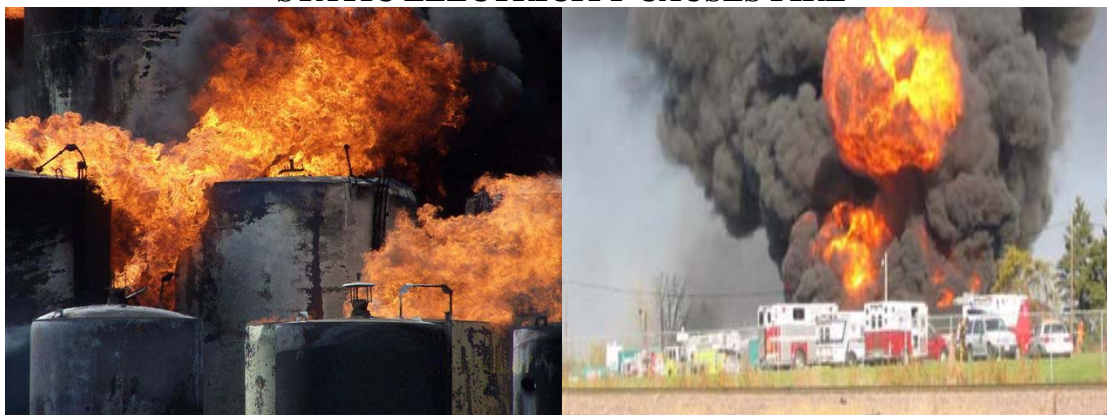
STATIC ELECTRICITY CAUSES FIRE

At the end of 2008, an incident was published which included a fire starting in a packaging area while a 300-gallon portable steel tank (a “tote”) was being filled with ethyl-acetate. Static electricity was discussed as an ignition source, the importance of bonding and grounding, and the use of dip pipes or bottom loading for filling containers with flammable liquids. In this issue we will discuss another important lesson from the same incident. The consequence of this incident became much more severe because the initial fire spread to an adjacent flammable material storage warehouse. The wall separating the two areas was not fire-rated. Large non-fire-rated doors between the warehouse and packaging area were kept open, and were not equipped with self-closing mechanisms. Also there was no fire protection system (sprinklers or other fire suppression system) in the flammable material packaging area. Spill containment is important whenever you are filling containers with any material, whether flammable or not. For flammable materials, containment helps to limit the area potentially impacted by a fire. And, for all materials containment keeps spills from getting into drains, sewers, surface water drainage, or onto uncontaminated soil. While improper spill containment was not identified as a factor in this particular incident, the incident is a reminder of why containment is important.

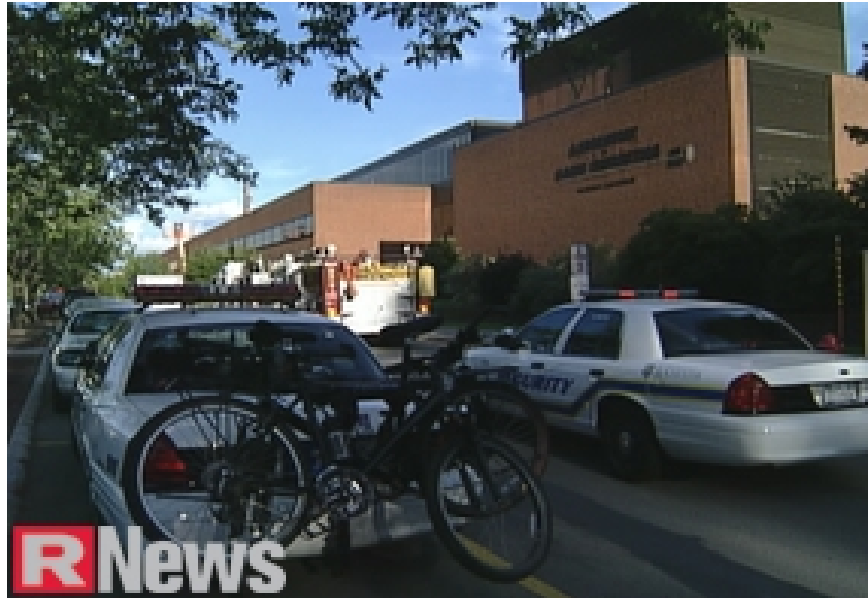
PRESSURE VESSEL EXPLOSION

On August 6, 2008, a pressure vessel exploded in the Omega Laser Facility at the University of Rochester laboratory. A technician from LLE, Sam Roberts, was seriously injured from the explosion when he was pressurizing the LLNL/LLE GCD light pipe in the target bay, the apparatus collapsed on Sam.

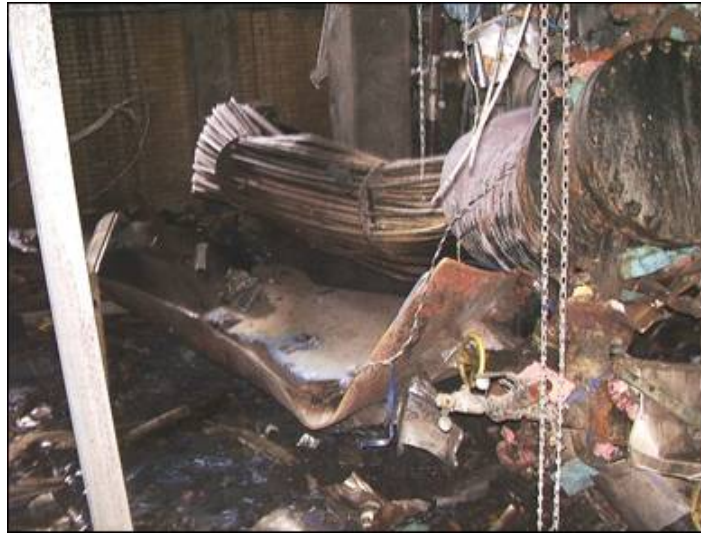
FATAL RUPTURE OF HEAT EXCHANGER

On June 11, 2008 during a maintenance operation on a heat exchanger, pressurized, liquid ammonia was used to cool chemicals that are later processed to make synthetic rubber. The rubber-making chemicals were pumped through steel tubes inside the heat exchanger, while ammonia flowed through a cylindrical steel shell that surrounded the tubes. The day prior to the accident, the process was shut down for cleaning. During the shutdown, an isolation valve was closed between the heat exchanger and a pressure-relief device designed to protect the heat exchanger from possible over-pressure. On the morning of the accident, an operator used steam to clean out process piping; the steam also flowed through the heat exchanger tubes. The steam heated the liquid remaining in the exchanger shell which caused the pressure to build. With the path to the pressure-relief device blocked, the heat exchanger ruptured over. An operations supervisor, who was not involved in the maintenance work but was working in the area, was **killed** by the explosion. Her body, which was covered with explosion debris, was not discovered until several hours after the emergency had been declared over.

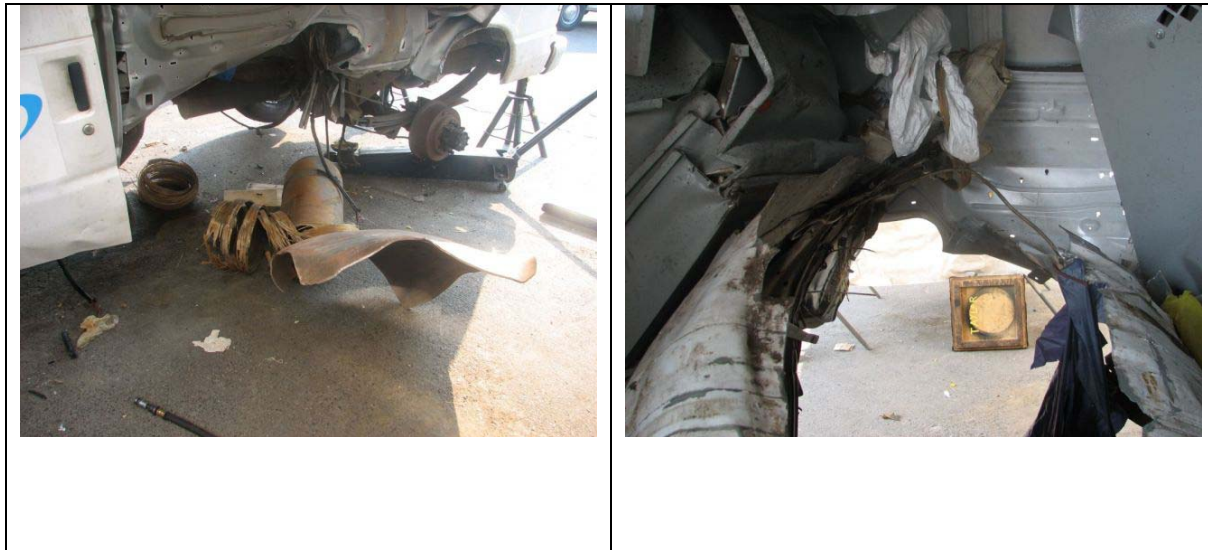
COMPRESSED NATURAL GAS CYLINDER RUPTURE DESTROYS VAN

On June 9, 2008 the cylinders used to store a van's fuel, compressed natural gas (CNG), ruptured and subsequently caused significant damage to a van. No injuries were mentioned in source. Parts of the van were blown clear of the vehicle, and parts of the cylinder in question were located inside the vehicle's cabin. Moderate damage was caused to nearby vehicles. Investigation yielded corrosion in parts of the cylinder's internal liner, as well as rust from chlorine due to road salt exposure. There were also fractures in the composite liner of the cylinder. There was also evidence to indicate that the pressure in the cylinder was too high because of the malfunction of a pressure limiter in the fueling station the van was refueled at earlier.

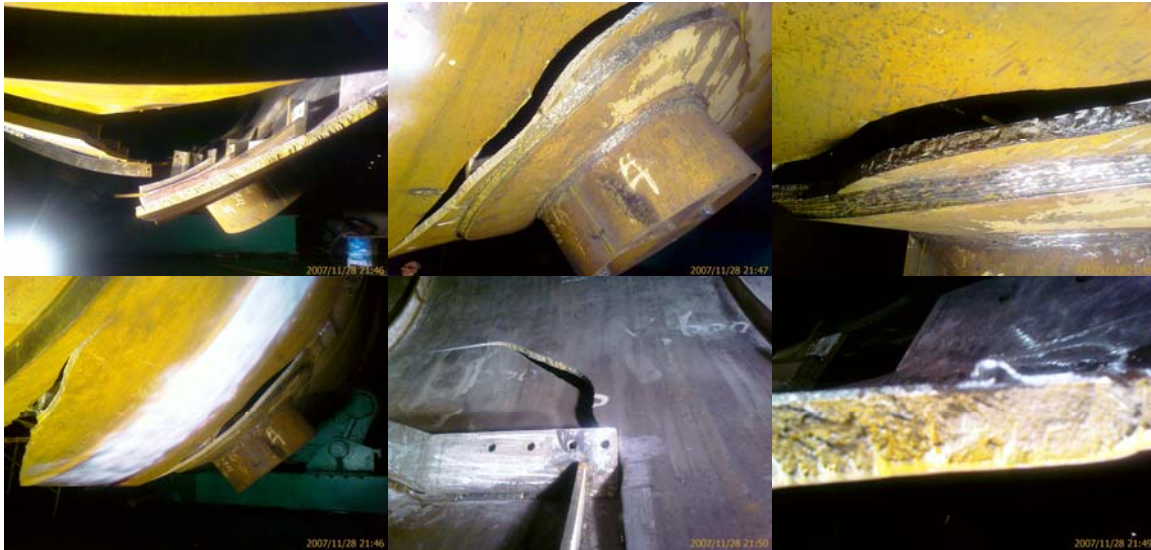
PRESSURE VESSEL FAILURE DURING HYDROTEST

On November 28, 2007, a pressure vessel failed whilst under hydrotest during post fabrication testing. This vessel was manufactured by a vessel vendor in China and the plate was of Chinese mill origin. Unfortunately this is another example of serious equipment/material failures with equipment being sourced out of the rapidly developing economies such as China, Eastern Bloc and others. These examples are becoming almost a weekly occurrence now and are exhibiting failure modes not seen in the mature manufacturing economies since the 1930's. Again we need to ensure vigilance in the acceptance of manufacturers and once more it is important to know where the base materials are sourced from. Apparently this pressure vessel had reached fifty percent of the required test pressure when the shell ruptured. A metallurgical failure report is not available however from the photographs a number of observations could be made regarding the quality of the material and the welding.

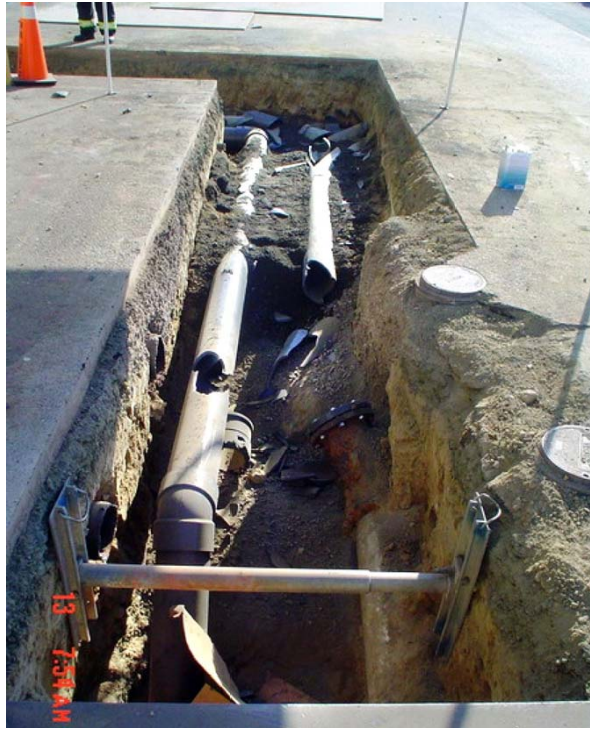
RESIDUAL FLAMMABLE VAPORS IN PVC PIPE CAUSE EXPLOSION

On September 13, 2007, a subcontractor was implementing a hot tap into a carbon steel pipe. The explosion was caused by the heat from the acetylene torch kindled the residual vapor inside attaching to the polyvinylchloride (PVC) piping. Shrapnel pieces were blown up to 100 feet outwards due to the force of the explosion. The two workers who were closest to the explosion were guarded by an alcove wall. However, the explosion resulted in **four** other **workers**, who were standing 25 feet away, suffering temporary hearing loss.

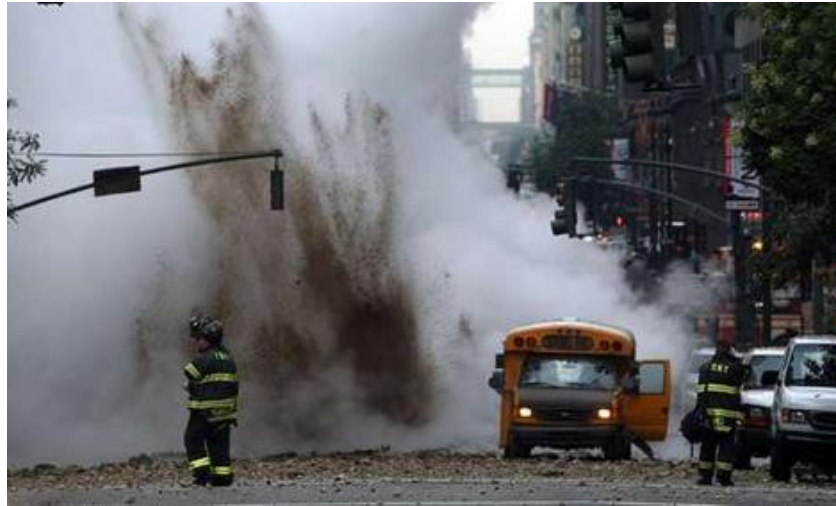
FATAL STEAM PIPE EXPLOSION

On July 19, 2007, a steampipe explosion sparked the fears of an asbestos contamination in Manhattan, NYC, NY. If there was any asbestos, the steam generated by the water would have washed it down. **One person was killed** (the blast gave him a heart attack) and **twenty others with minor and serious injuries**. Smoke and steam filled the air as the cause of the explosion is still unidentified. This incident produced mass chaos as pedestrians believed it to be another terrorists attack. Con Edison agreed to pay \$24 million to make up for damage.

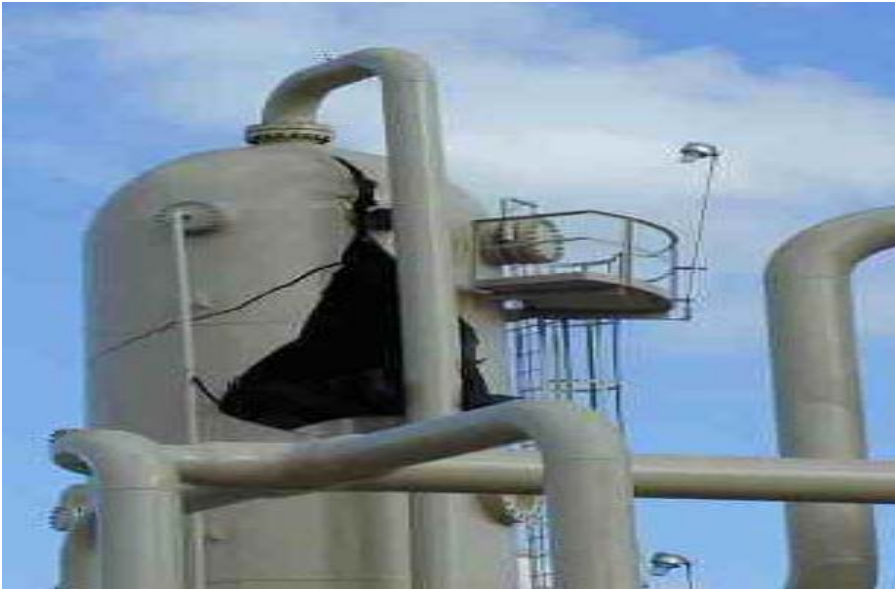
HYDROSTATIC TEST OF NEW VERTICAL VESSEL

An incident occurred in October of 2002. The cause of the incident is still unknown however the use of “cold water” for hydro-testing could have been a factor. No injuries occurred.

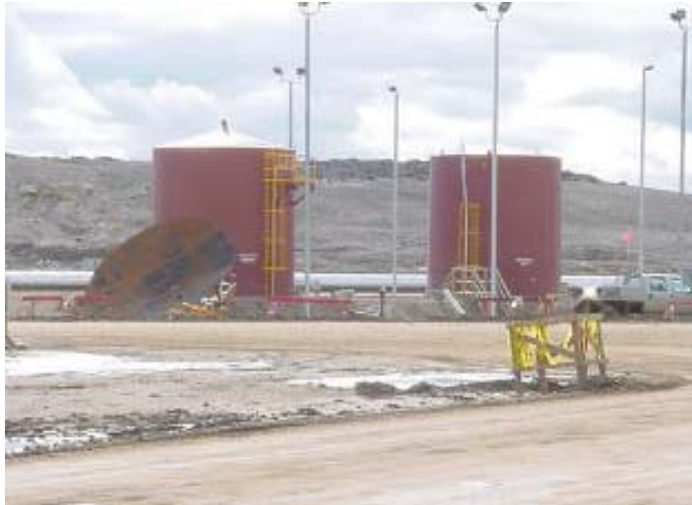
FILLING OF A VERTICAL TANK

In October 2002, the top of the tank was blown off because the relief valve could not displace the air fast enough for the volume of water that was being pumped in (the filling of the tank was made from a fire hydrant).

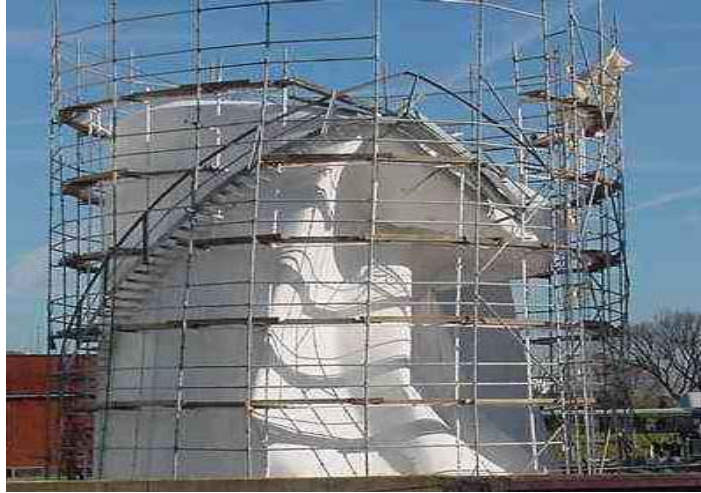
EMPTYING OF A VERTICAL TANK

In October 2002, the vent was a trapped plastic sheet intended to protect the roof, this caused a vacuum. This incident occurred while the tank was being emptied and this type of incident isn't unusual.

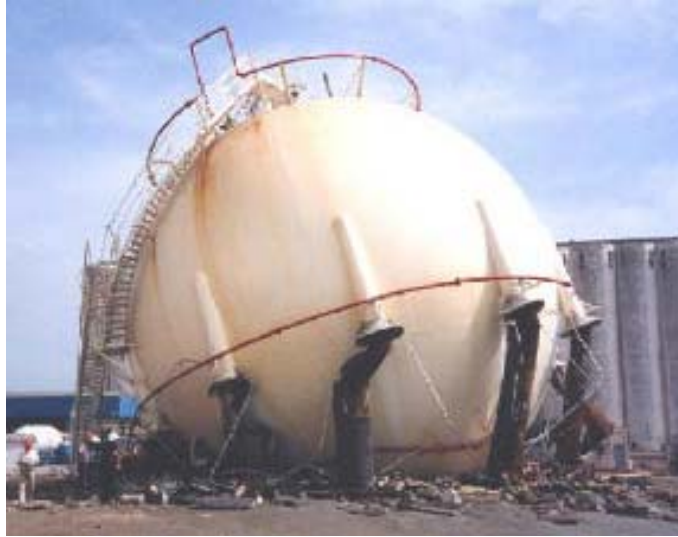
FATAL SPHERICAL TANK COLLAPSE

During the filling of a 2000m³ LPG sphere in October 2002, its legs collapsed. The tank was 80% full, killing one and seriously injuring another. The main cause for collapse was the severe corrosion of the legs under the concrete fire protection. The corrosion originated from water ingress between the steel legs and concrete. The poor design of the water caps over the fire-proofing concrete, vertical cracks, poor repairs, and salt water testing were contributing factors to the cause of the collapse. **One person was killed and one seriously injured.**

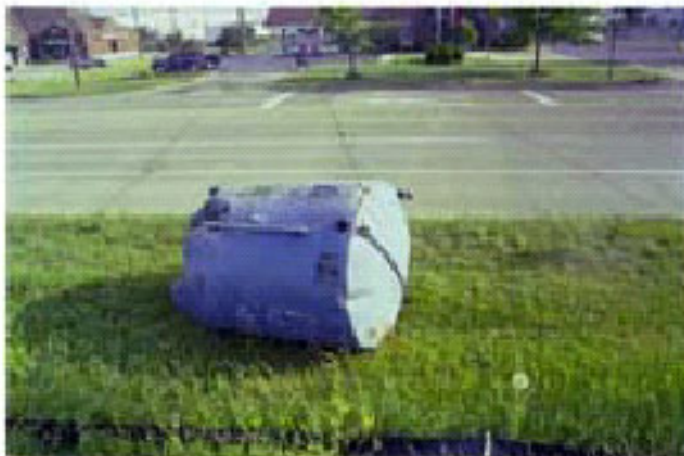
FATAL EXPLOSION OF PRESSURIZED TANK

On June 21, 2001, a 39-year old male **died** when a 500-gallon storage tank he had started to empty of waste oil and water exploded from its base striking him in the head. He had vacuumed the waste oil and water into the tank from a trench on the other side of the plant and transported it with a lift truck to the underground waste storage area for disposal at a later time. He was pressurizing the contents of the tank with air from a compressed airline located just inside the plant to speed the evacuation of the waste oil and water into the waster storage area. The tank was not approved for use as a pressurized vessel. Fittings on the tank had been adapted for the purpose of connecting them to the compressed airline. The force of the explosion propelled the tank 500 feet in the air over the plat fence and a nearby bank parking lot onto a bust east/west road. This was a maintenance task that had been conducted in this manner for over 6 years. No one witnessed the actual event. Statements from nearby workers and maintenance staff were relied upon to reconstruct what was presumed to have occurred. The deceased was found lying near the place where he had been last seen beginning to drain the tank. Emergency personnel confirmed that he was dead when they arrived at the site.

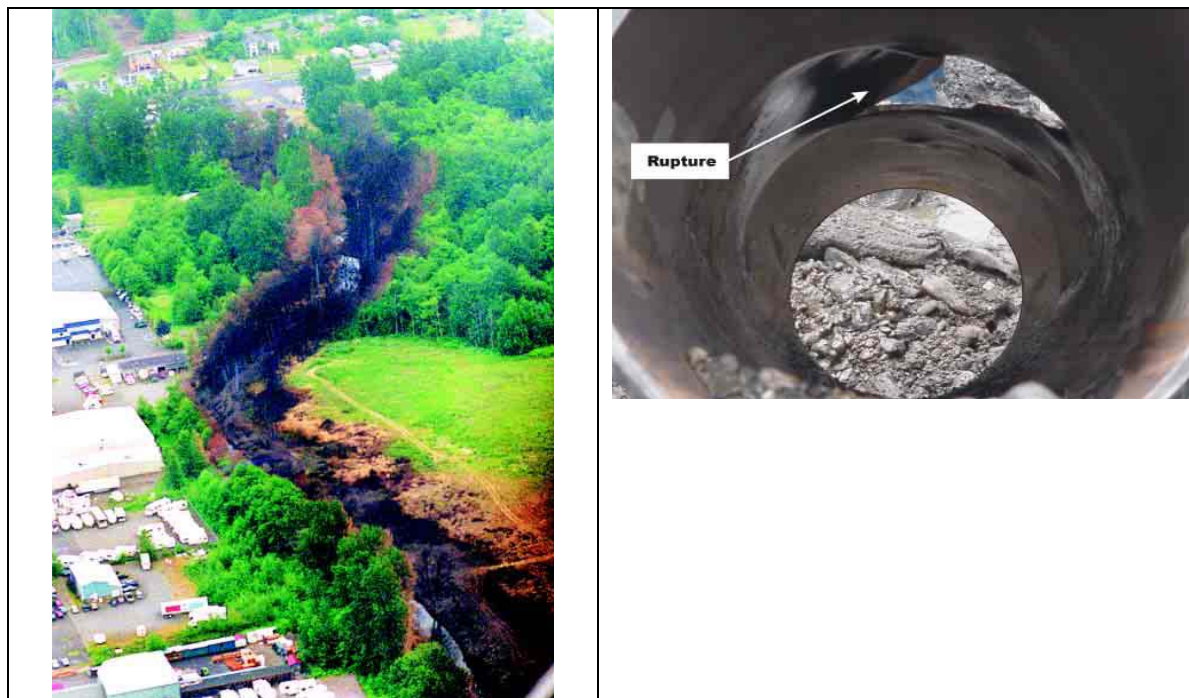
16-INCH PIPE'S LEAK CAUSES 1.5 MILE-LONG FIRE

On June 10, 1999 an oil pipeline ruptured releasing a large amount of gasoline into a creek in Bellingham, Washington. Approximately 90 minutes after the rupture the stream of oil ignited. This caused damage for 1.5 miles along the creek, and killed 3 people. One factor that contributed to this accident was a faulty repair job done in 1994 that weakened the pipe in the first place. A proper inspection of the pipeline could have noticed this damage. Also the control system malfunctioned at the time of the crisis requiring the people running it to switch to a back-up system. Unfortunately not all the information from the primary control system was transferred to the secondary system resulting in confusion among the people in charge.

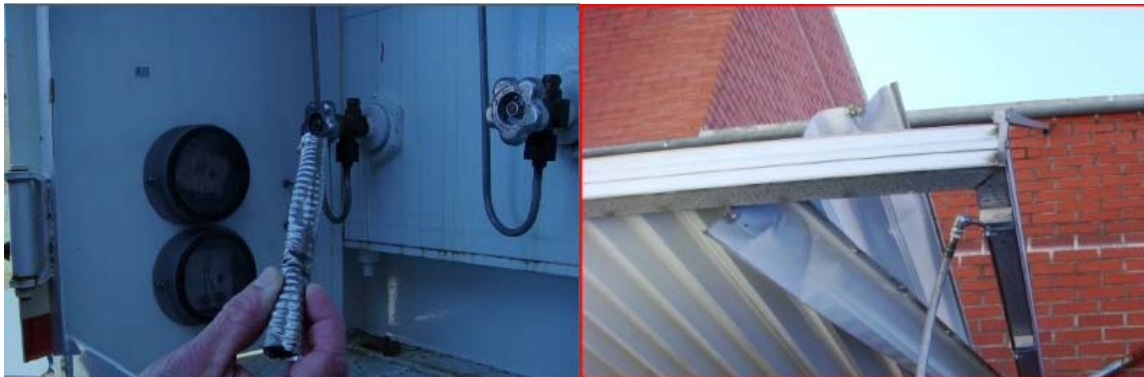
FLEXIBLE METAL HOSE ASSEMBLY FAILURE

An ORNL researcher requested installation of a new argon gas line which would provide a continuous operation of uninterrupted supply of high-purity grade of argon gas for ultra-trace level metal analyses. At the time, an existing copper line had been used for nitrogen gas; the other line was an insulated line used for liquid nitrogen. The researcher suggested that the existing copper line be replaced with stainless steel for argon. The research staff member, task leader, and parts supplier representative participated in a walkthrough of the area and discussed what materials would be needed for the installation of the new argon line. A maintenance work plan was written to replace the copper tubing with stainless steel tubing for the argon supply. Funding delays necessitated that a new plan be written several months later. The new work plan included additional overhead work involving existing plumbing in the laboratory; installation of a pressure regulator on the argon supply manifold, and reconnection of the argon supply piping system (i.e., existing flexible metal hose assembly) to the argon tube trailer outside the building. To complete the work plan, two pipefitters reinstalled a pressure regulator on the building argon supply manifold and reconnected the argon supply piping system (i.e., existing flexible metal hose assembly) to the argon tube trailer outside the building. To leak test the reinstallation of piping, the workers slowly pressurized the system to 2100 PSIG using the needle valve located on the tube trailer. Workers applied 2100 PSIG to the flexible metal hose assembly and maintained it at that pressure for 3 to 5 minutes prior to workers initiating leak testing. Approximately 5 minutes after pressurizing the line and while the workers were performing the leak testing of piping joints, the flexible metal hose assembly failed near a fitting attached to the tube trailer. The flexible metal hose assembly struck one worker on the forehead resulting in a small cut and struck a second worker on his left hand. Medical services sent the **worker with the forehead injury** to a local hospital as precautionary measure. Local medical services evaluated the second worker on-site. Off-site and local medical services evaluated, treated, and released both employees.

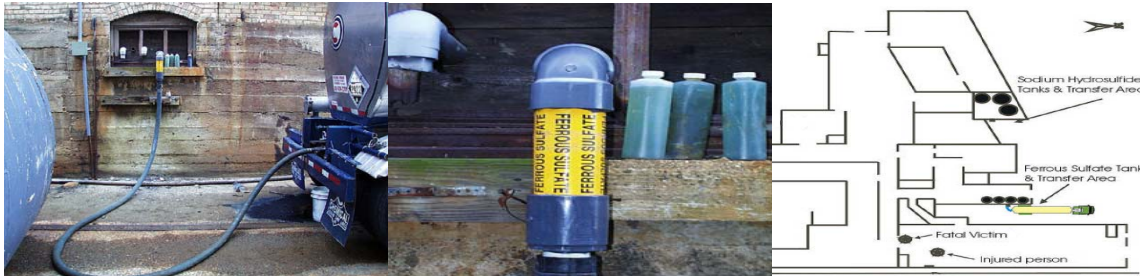
FATALITY CAUSED BY UNLOADING THE WRONG CHEMICAL

A truck of sodium hydrosulfide-solution arrived at a factory at about 3:30 AM, and was to be unloaded to a storage tank in the area near the top center of the diagram (right picture above). The truck driver had never been to the plant before, and asked the plant shift supervisor for assistance. The shift supervisor had been told to expect a chemical shipment, and assumed that the chemical would be ferrous sulfate, which is the only chemical that he had ever received on his shift. He directed the truck driver to the unloading station for ferrous sulfate, where the truck is shown in the diagram. The shift supervisor did not verify the identity of the chemical in the truck, although the shipping papers did properly identify the contents as sodium hydrosulfide. The supervisor signed the shipping papers without reading them and left the area. No plant employees remained in the unloading area. The truck driver connected his truck to a hose which was connected to the ferrous sulfate storage tank as shown in the photographs. He began to unload the sodium hydrosulfide solution into the ferrous sulfate tank. Unfortunately, sodium hydrosulfide and ferrous sulfate react to form hydrogen sulfide, a highly toxic gas. Shortly after the unloading began, a plant employee in the basement of the building noticed a pungent odor and lost consciousness. He regained consciousness and made his way outside where he got help from other employees, who called emergency response personnel. They found the truck driver unconscious inside the building, and he was **pronounced dead at the scene**. He was determined to have been overcome by hydrogen sulfide gas.

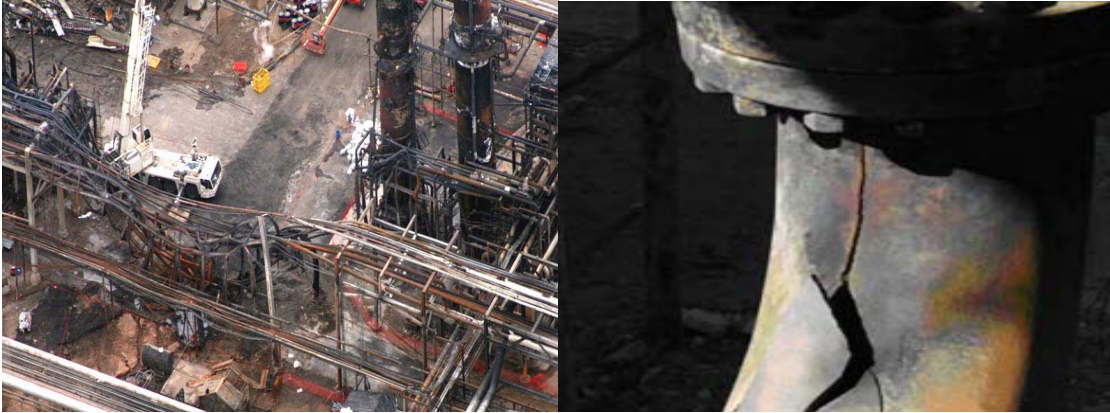
ICE RUPTURES UNUSED PIPE AND CAUSES FIRE

A section of piping in a refinery unit was taken out of service during a process modification. The unused piping was not physically removed, nor was it isolated from the active piping with slip blinds. Instead, it was isolated from the connected piping by closed isolation valves. The active piping contained liquid propane under high pressure, and the propane contained a small amount of liquid water entrained as a separate water phase. Debris jammed in the seat prevented one of the isolation valves from closing fully. This allowed wet liquid propane to leak from the active piping into the unused piping. The water, which is heavier than propane, accumulated at a low point in the unused piping. During the winter, the water which had accumulated in the unused piping froze. When water freezes it expands, and this expansion caused a crack in the unused pipe. When the weather warmed, the ice melted and propane leaked from the active piping through the leaking isolation valve, and then out through the cracked pipe. A large flammable vapor cloud formed and ignited. The resulting fire caused **four injuries**, the refinery had to be evacuated, and it was shut down for nearly two months. The fire caused major damage to other equipment and piping, resulting in additional release of flammable materials and escalation of the fire. More than two tons of chlorine was also released from containers impacted by the fire.

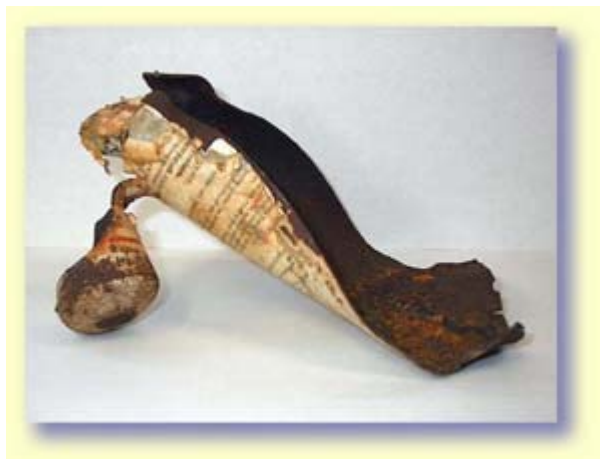
GAS CYLINDER EXPLODES AT UNIVERSITY

At an unknown date a gas cylinder that contained hydrogen fluoride exploded in a University of California laboratory. The speculated cause of the explosion was that the hydrogen fluoride reacted with the metal container it was in, slowly forming iron fluoride. This weakened the inside of the cylinder until it finally gave way. The shelf life for cylinders storing HF is one to two years. The cylinder in question was at least seven years old.

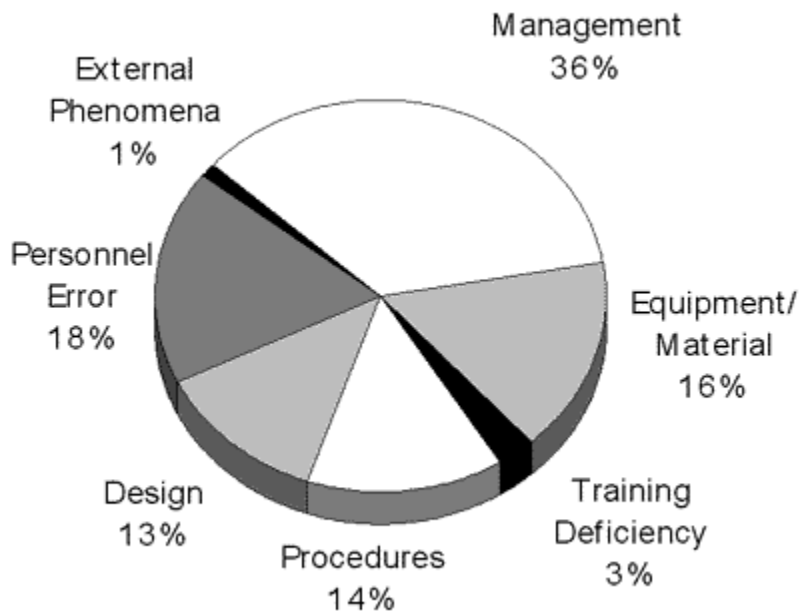
Root causes of gas cylinder events:
