Beam Scan (RHC mode) : May 1, 2024

Athula Wickremasinghe
NOvA Tuesday Meeting
05/14/2024

In this talk, we present a comparison of 2024-MAY (RHC) mode scan data with 2019-DEC (FHC) data.

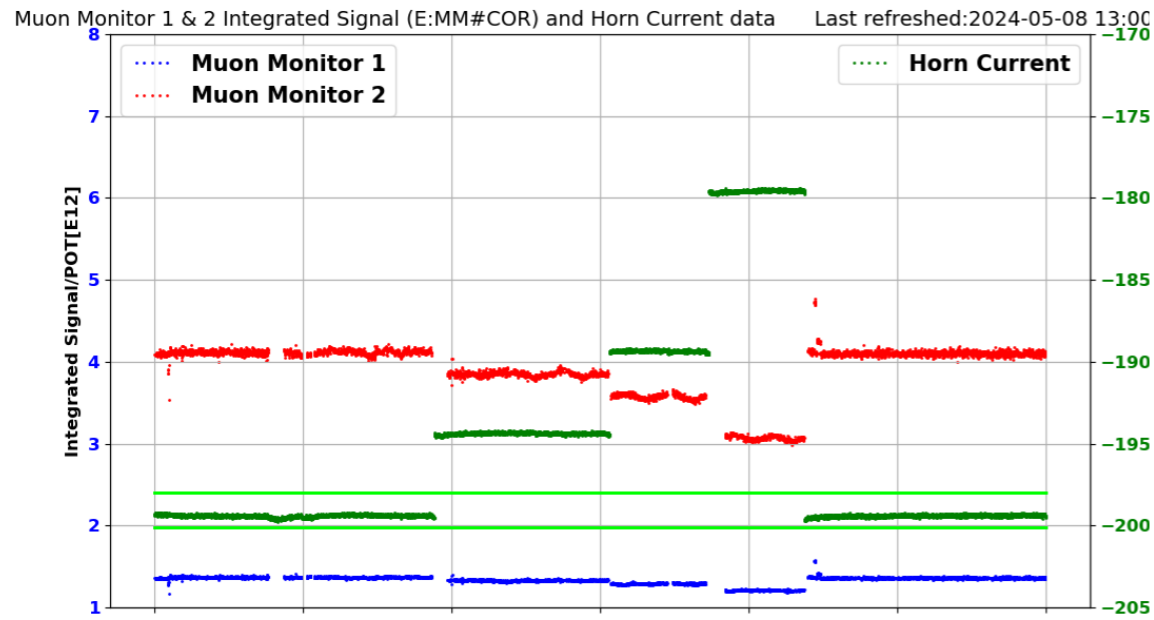
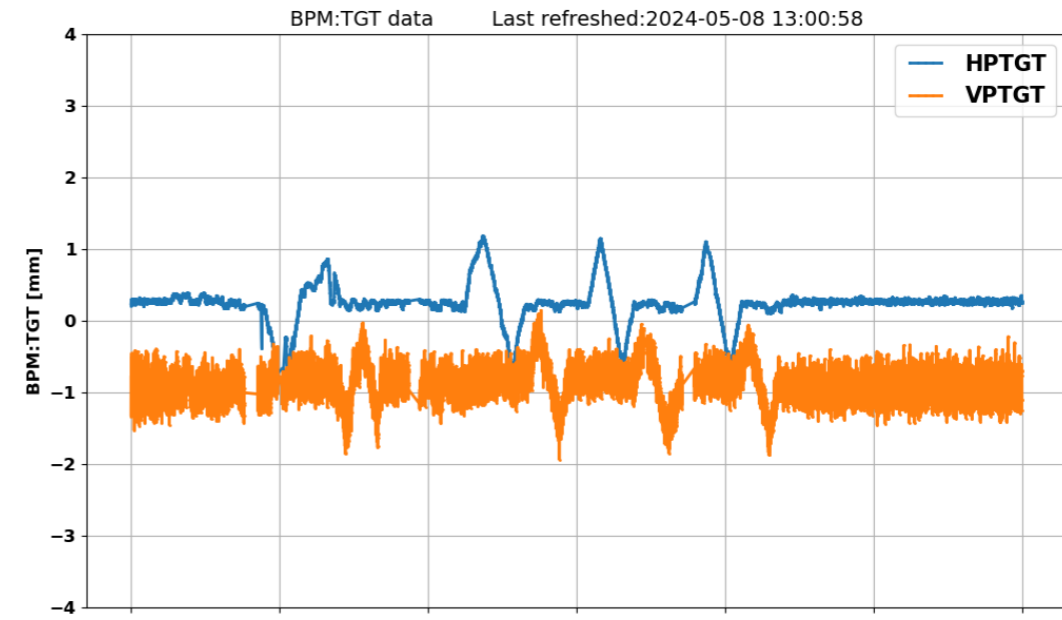
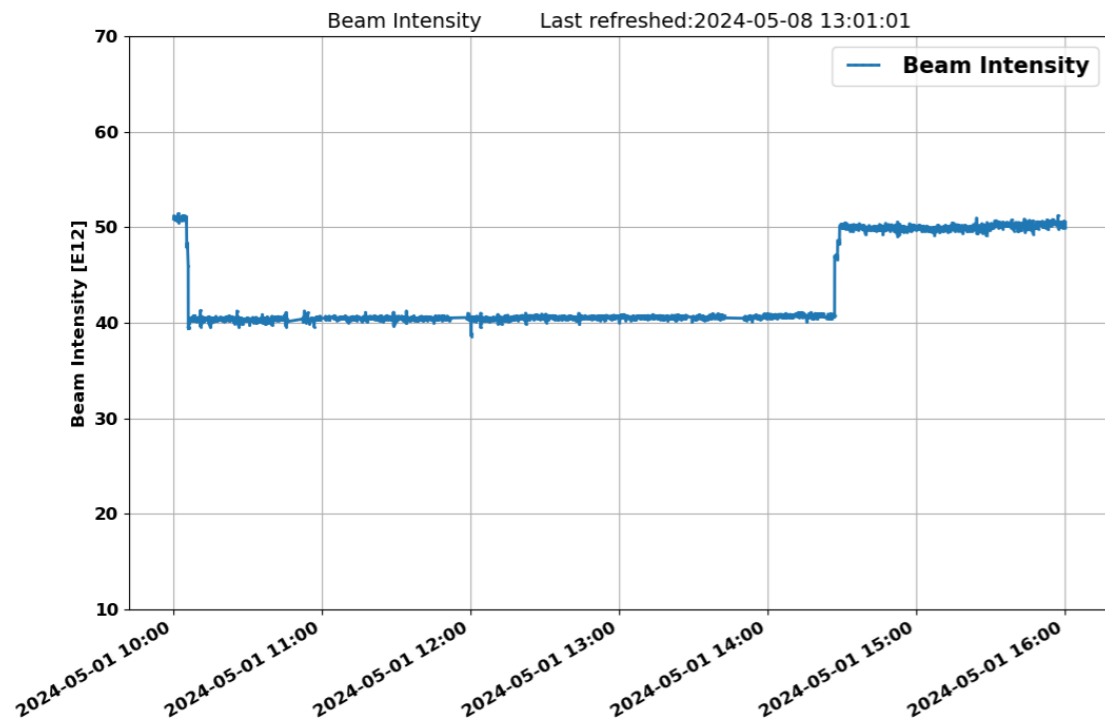
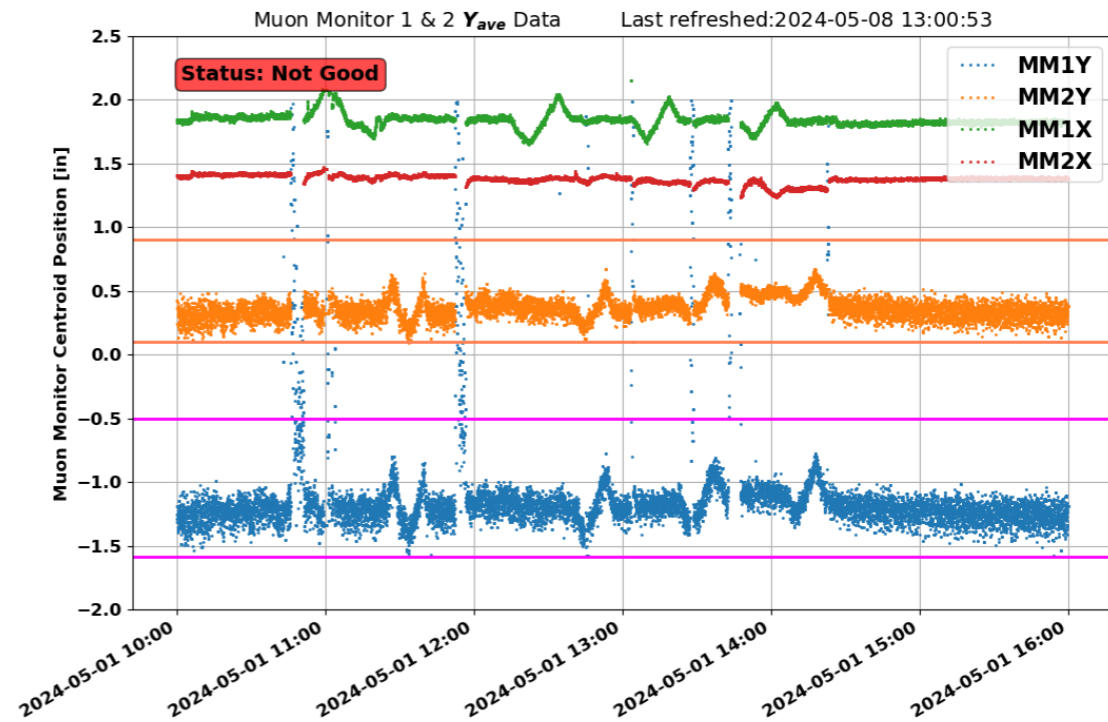
Beam Scan (RHC)

Note: The actual horn current is 1% higher than the ACNET recorded horn current.

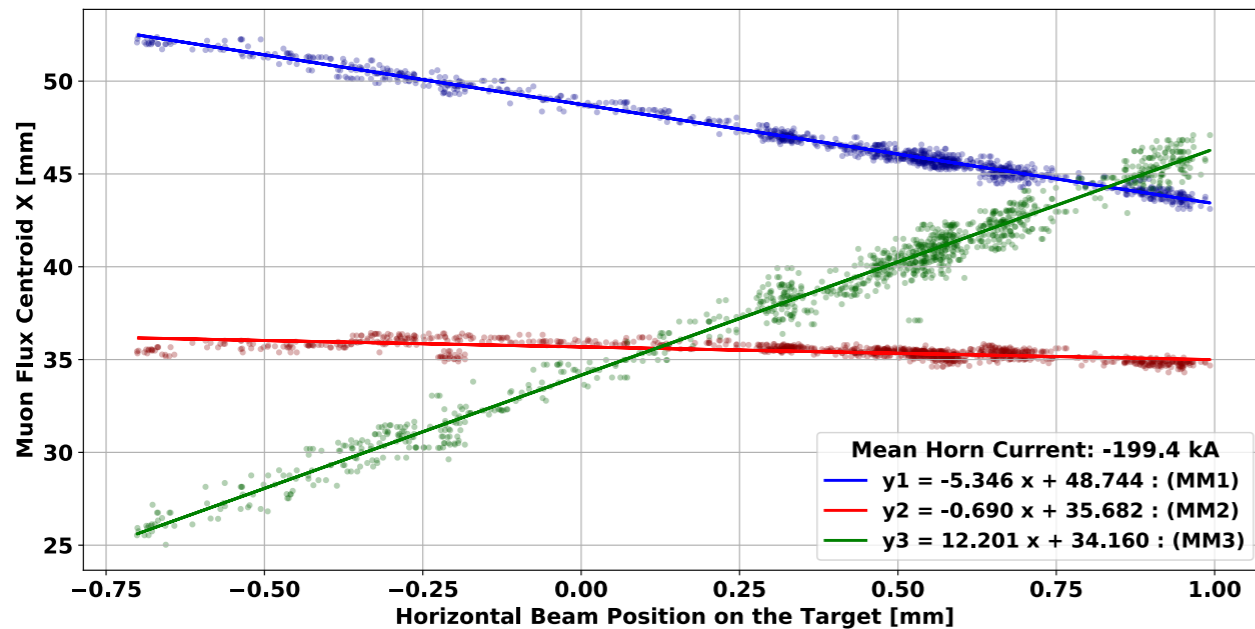
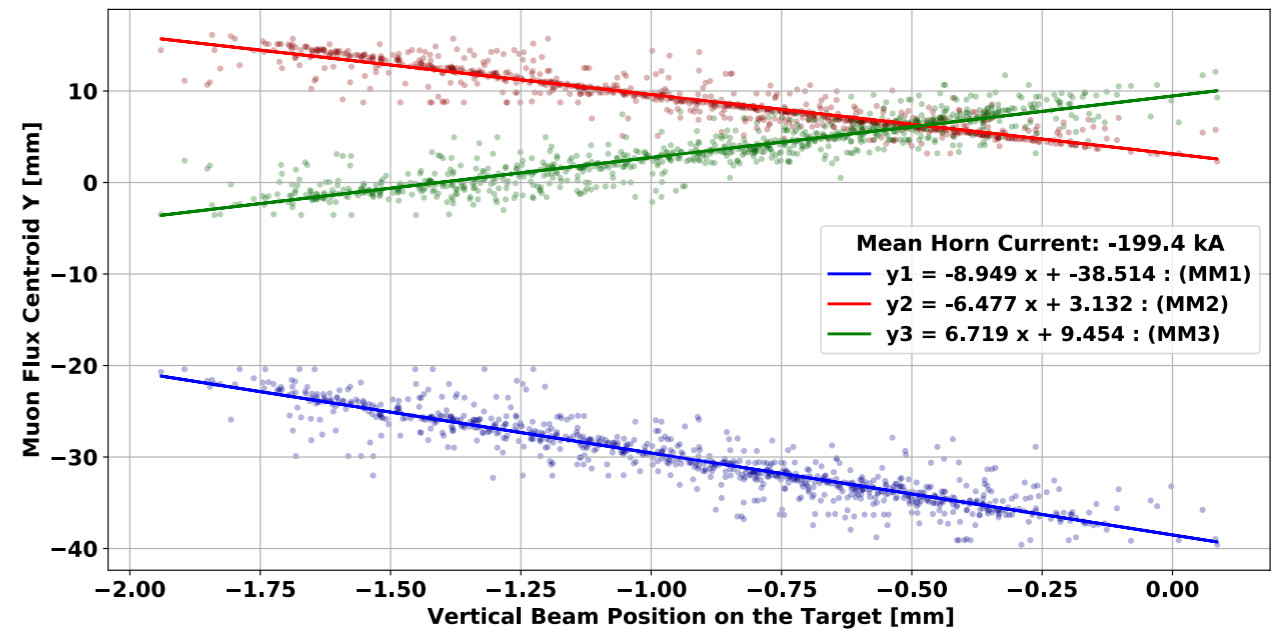
Mean Horn Current : -199.4 kA

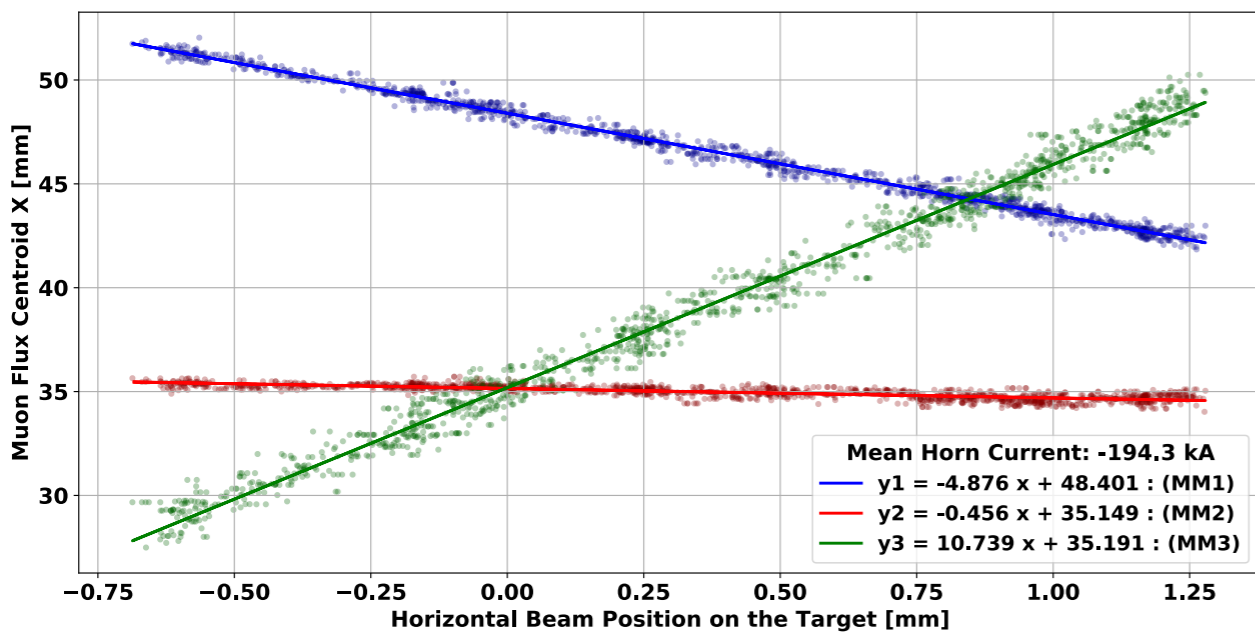
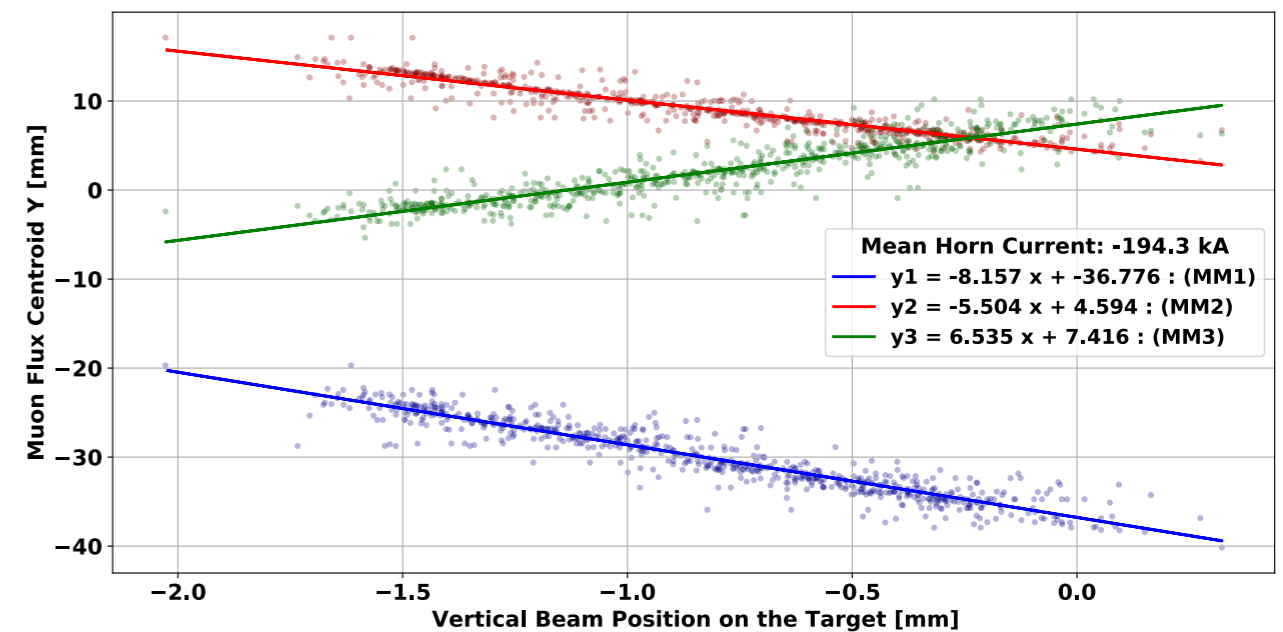
Mean Horn Current : -194.3 kA

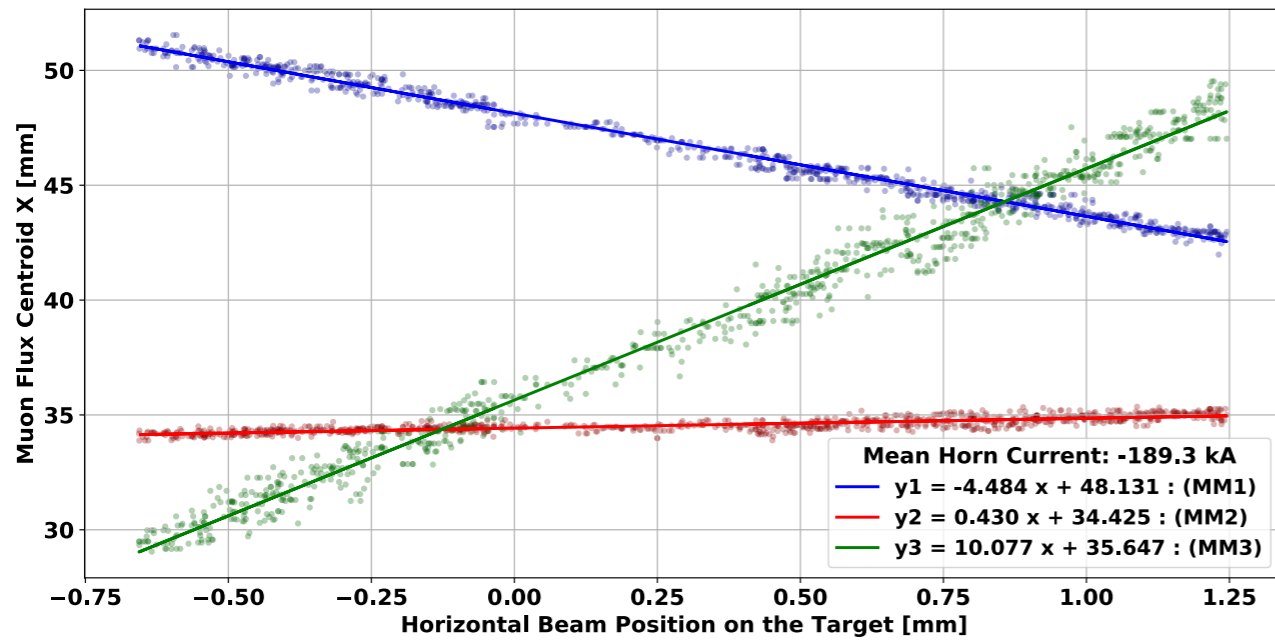
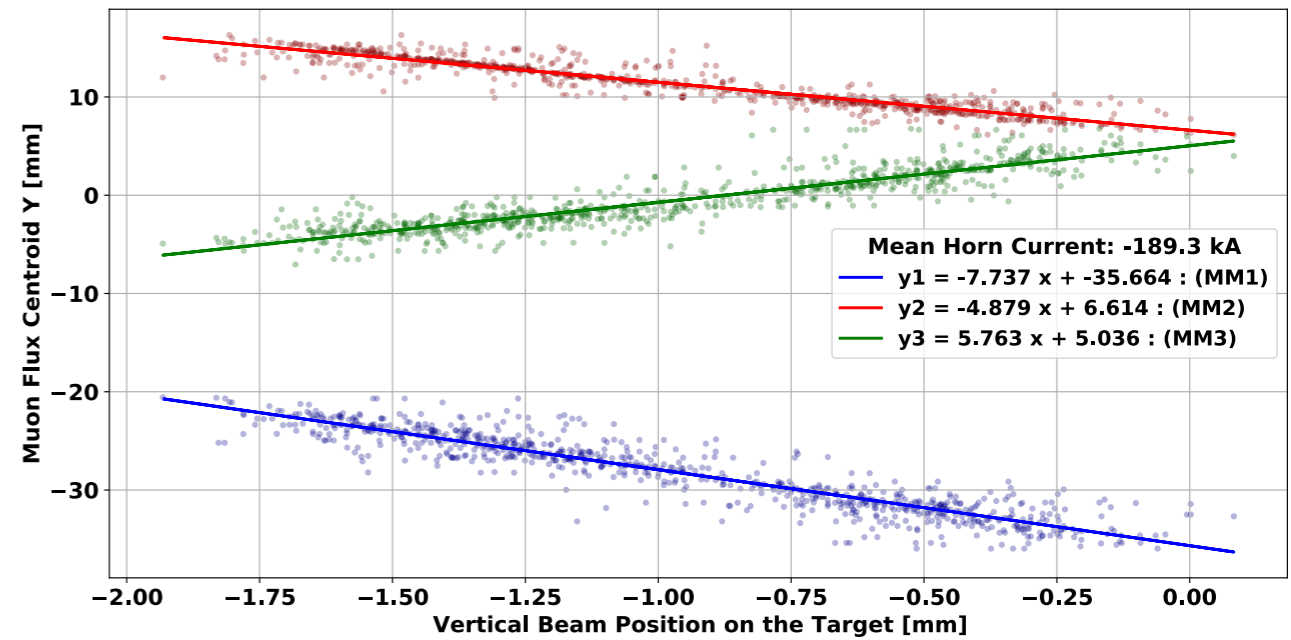
Mean Horn Current : -189.3 kA

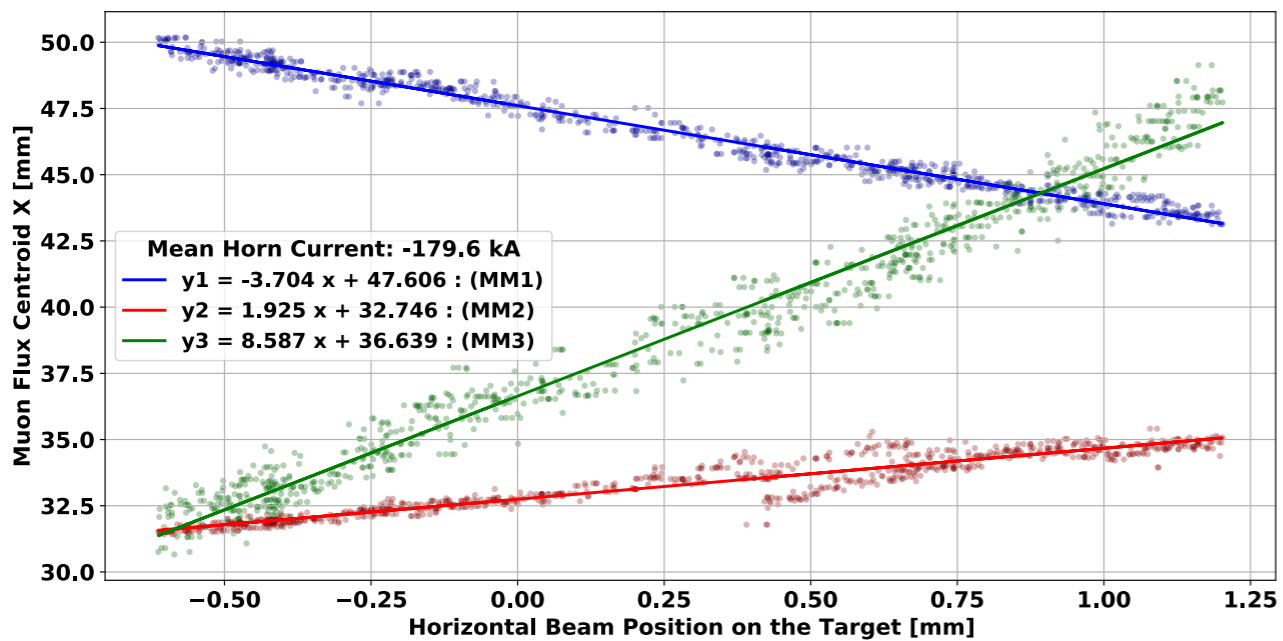
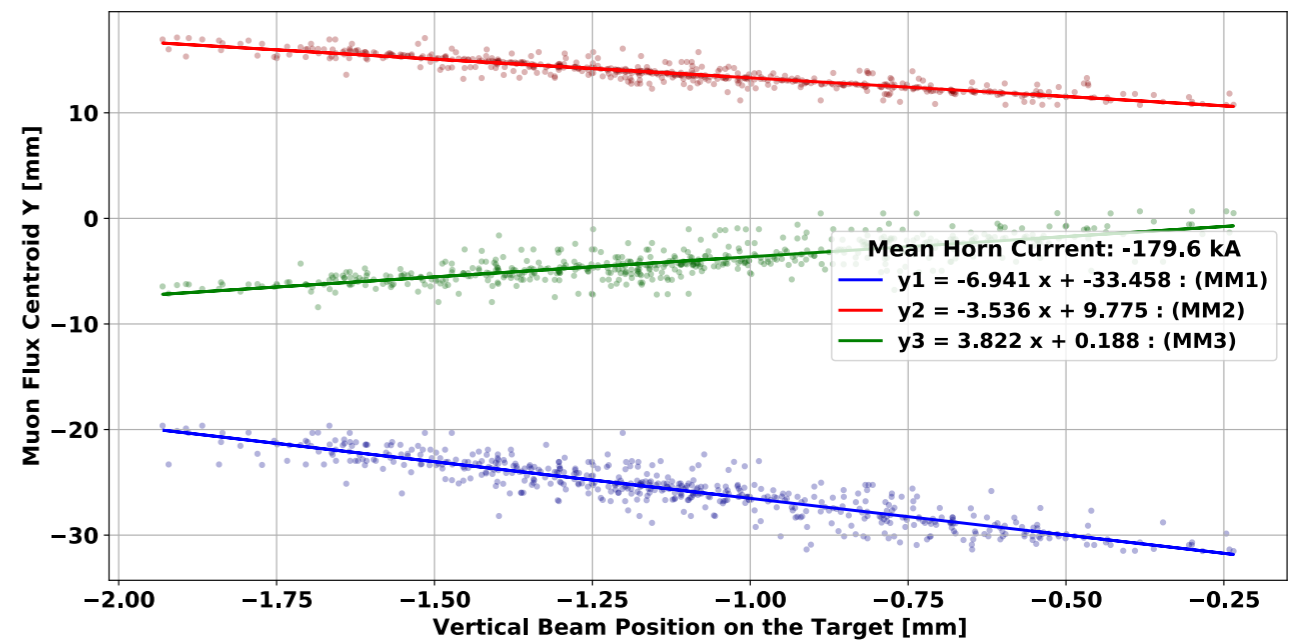
Mean Horn Current : -179.6 kA

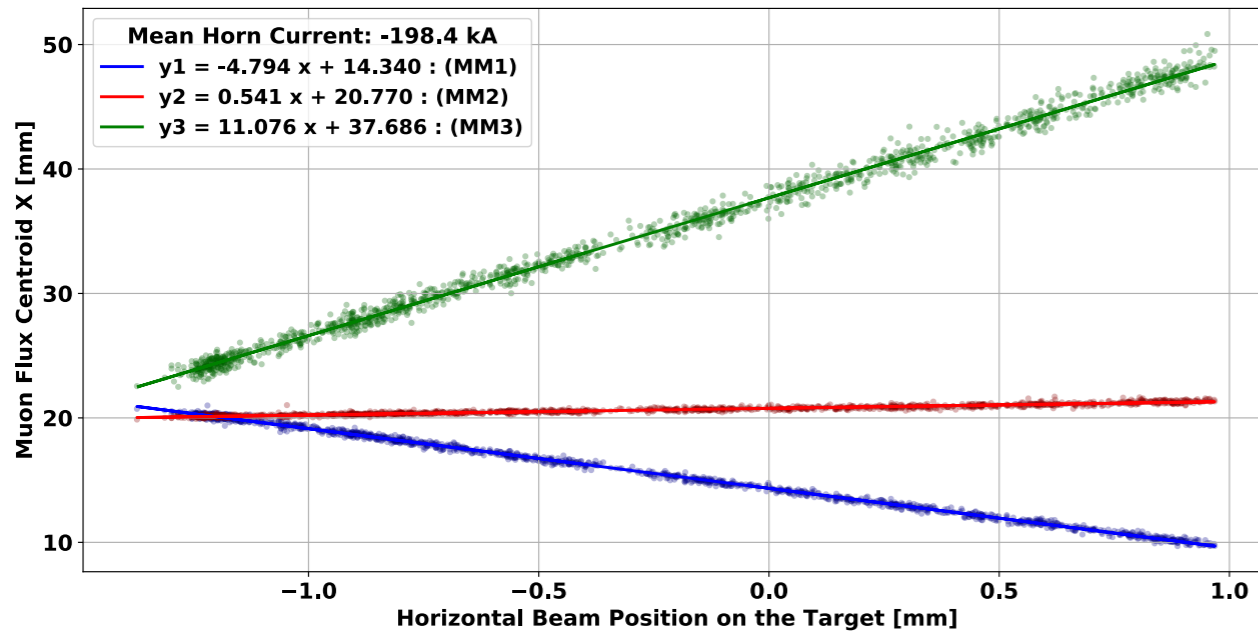
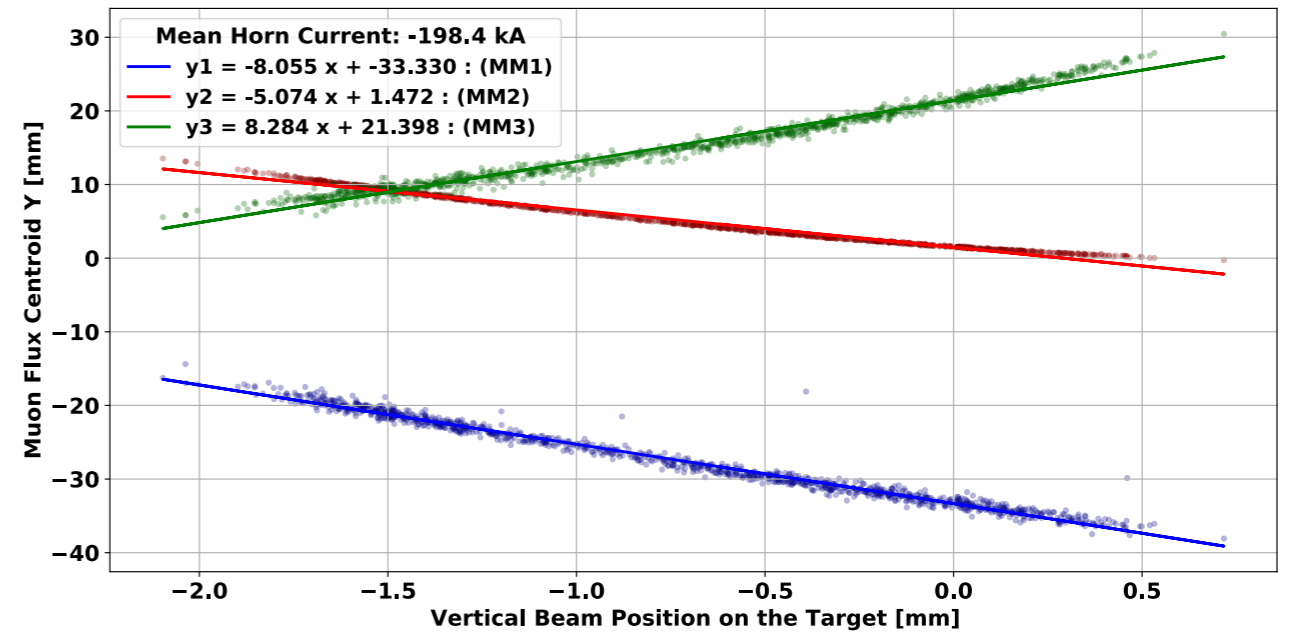
Mean Horn Current : -198.4 kA

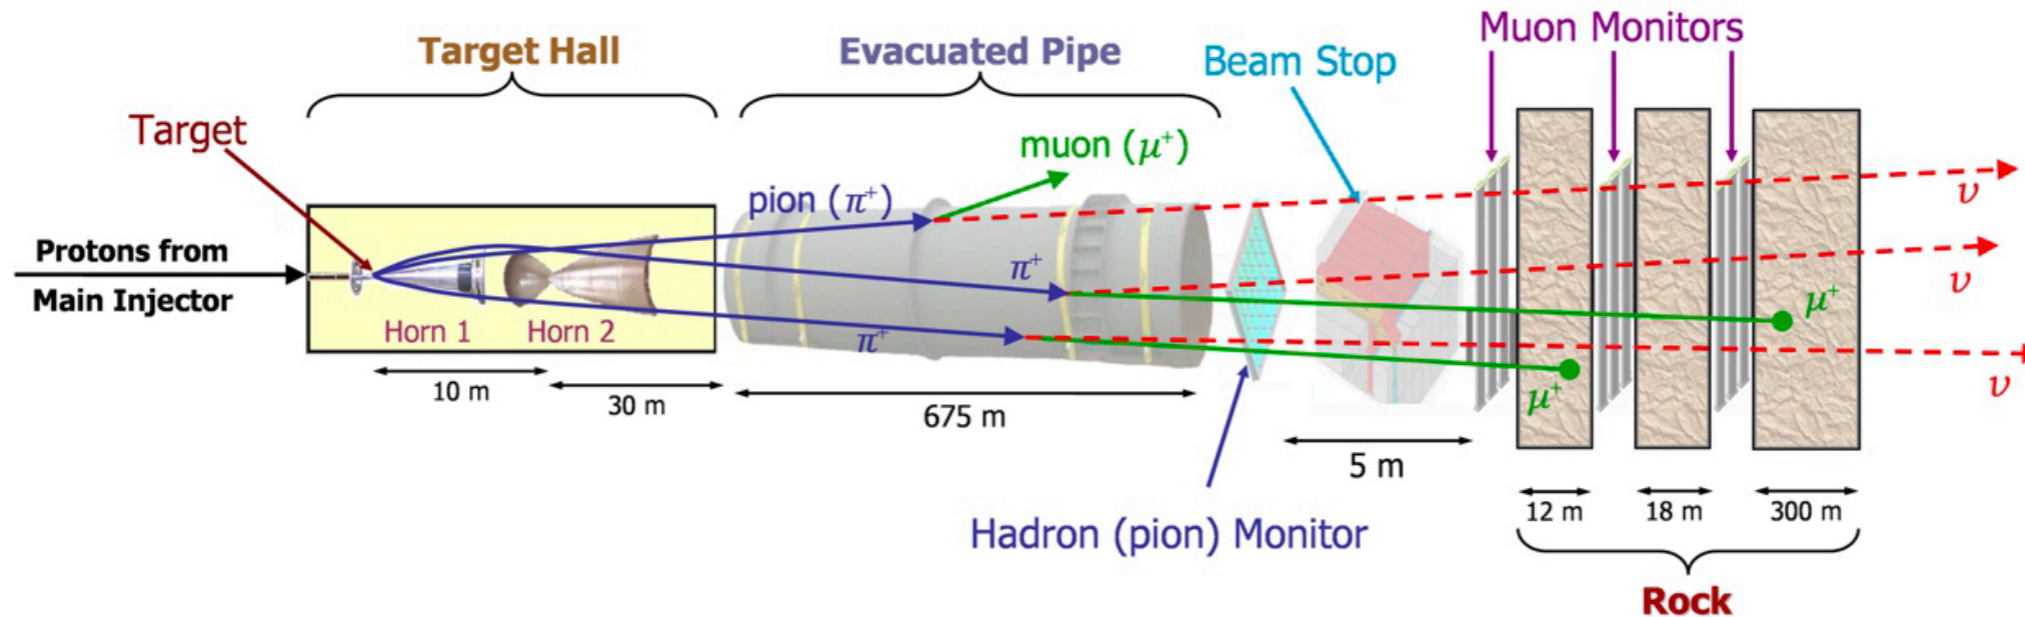
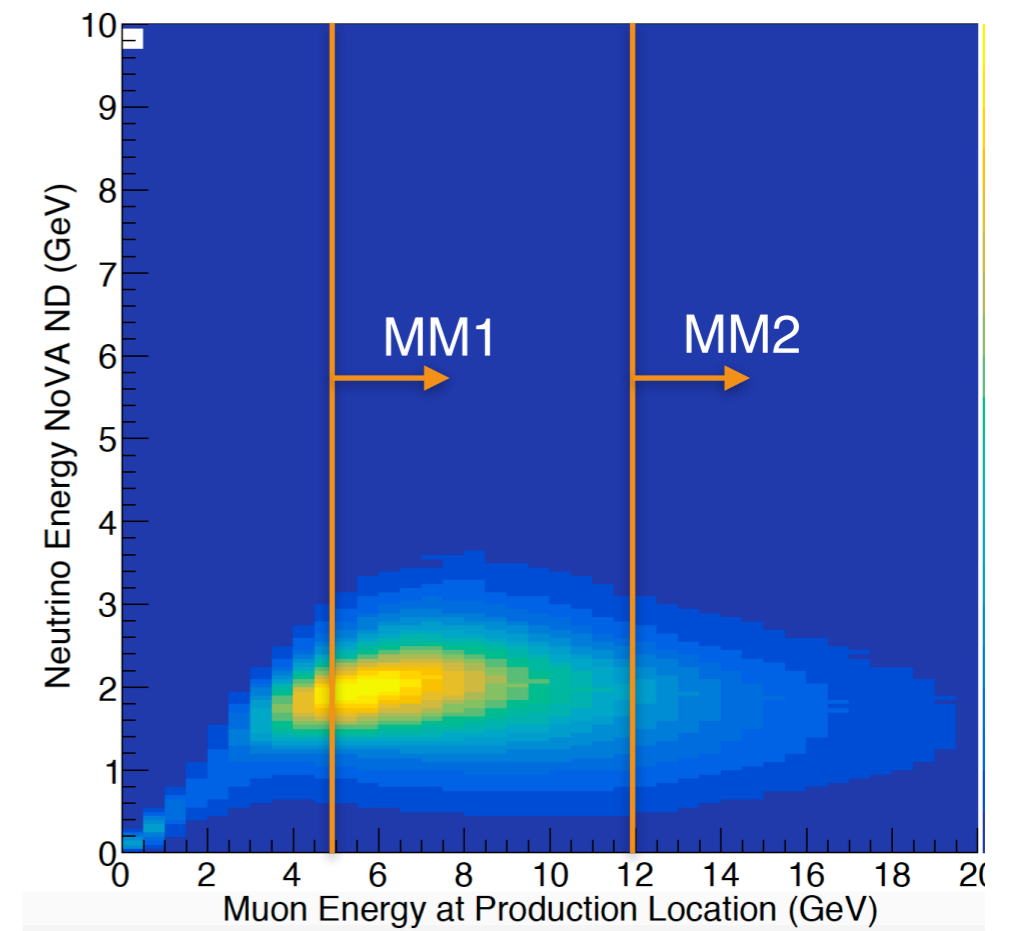
Introduction to Muon Monitors

- Three muon monitors are located in the downstream of the hadron absorber
- Each muon monitor consist of 9x9 arrays of ionization chambers
- Each ionization chamber consists of two ceramic parallel plates with the separation of 3 mm gap
- The chambers are filled with He gas

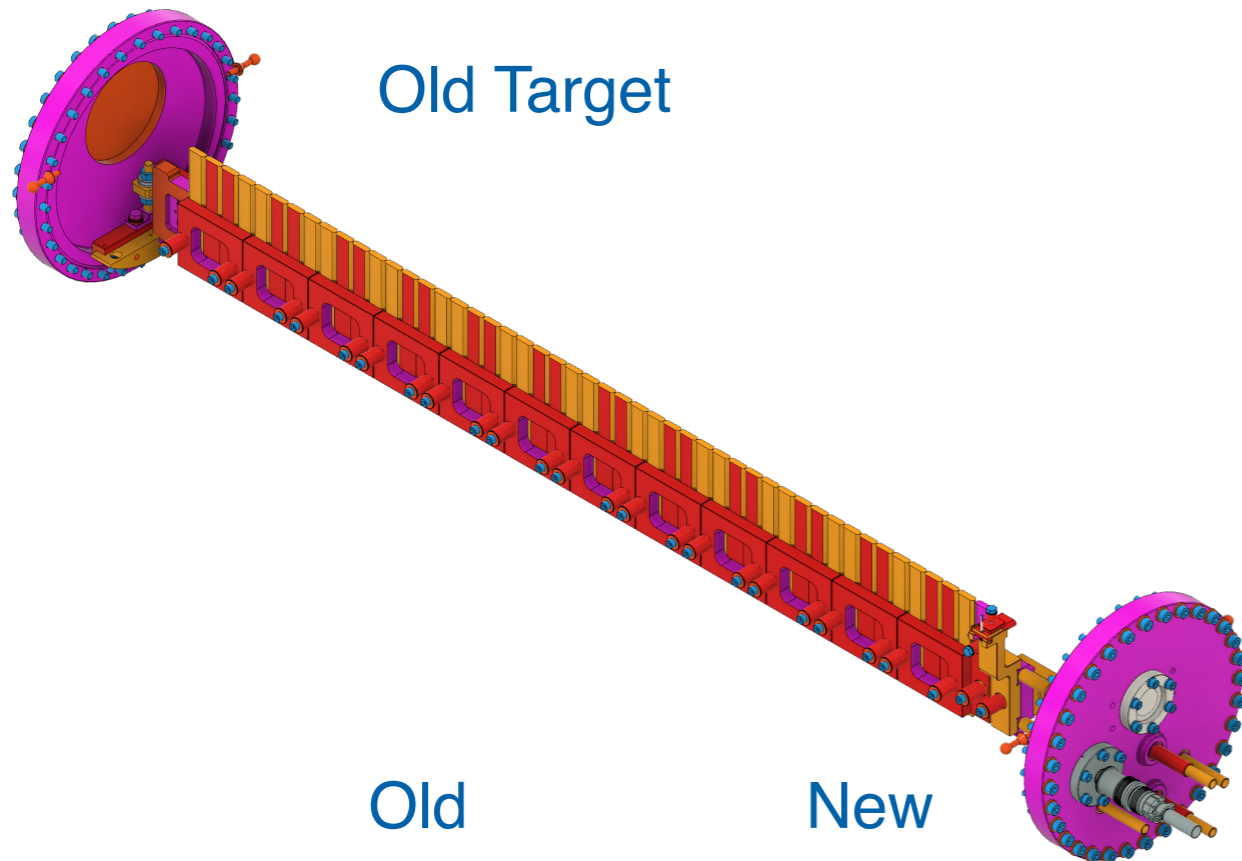
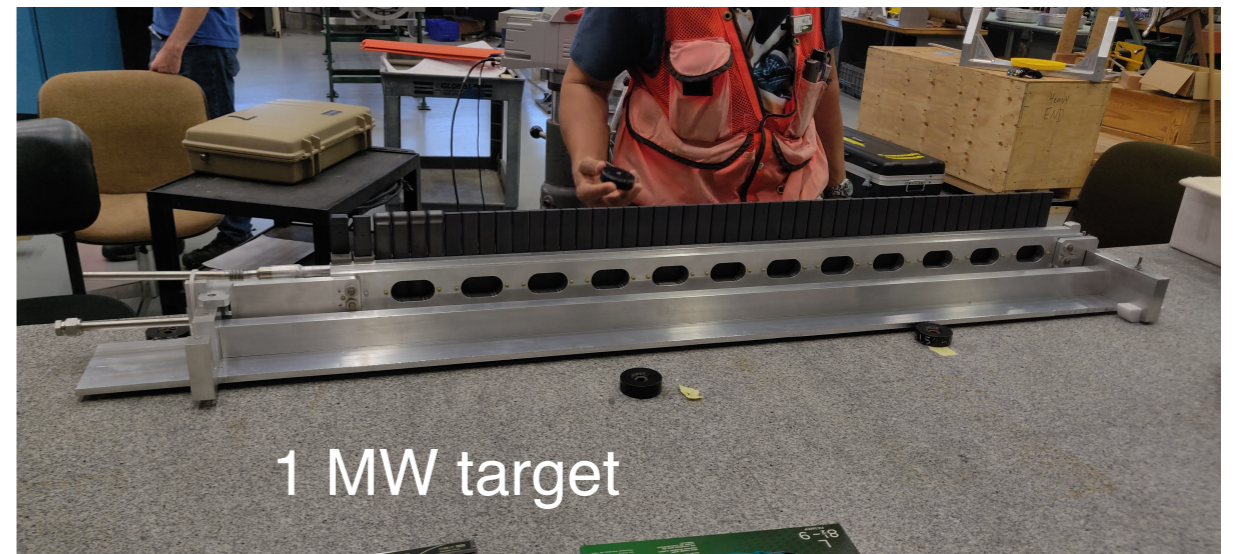
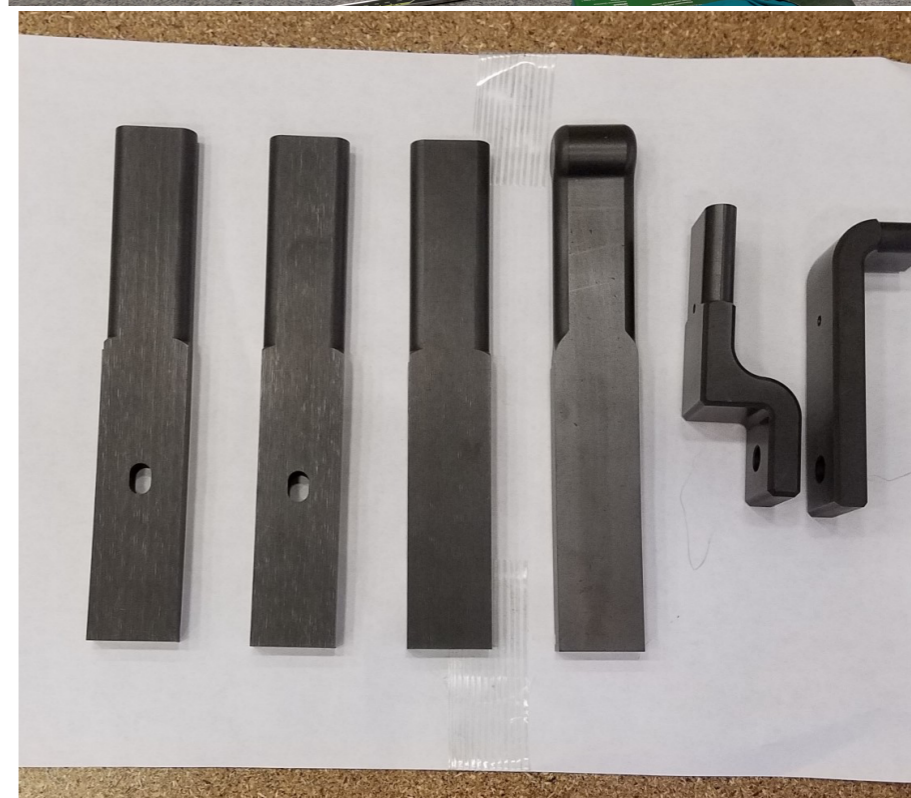
New vs Old Targets

1-MW NuMI target has been installed during the summer shutdown in 2019

Old	New
Width :	7.4 mm	9.0 mm
Height:	14.30 cm	15.53 cm
Segment length:	2.5 cm	2.5 cm

- Four target segments have cylindrical shapes tops in the new target system
- Densities are same
