Coupling Coil Testing

Ruben Carcagno
Fermilab
June 17, 2013

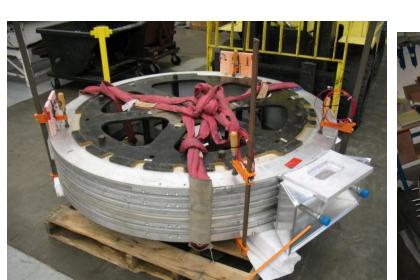
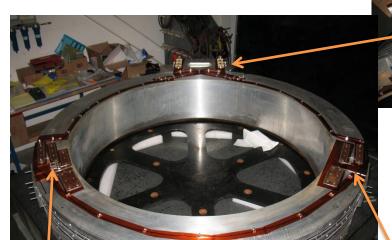
Fermilab Cold Mass Preparations (LBNL)

Included cooling tubes welding, installation of leads stabilization, passive QP (cold diodes), instrumentation, etc.

Stabilization

Cooling **Tubes Connections**

Cold QP Diodes Leads Stabilization

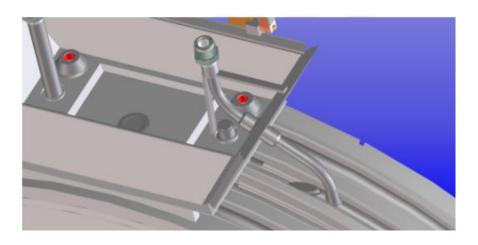
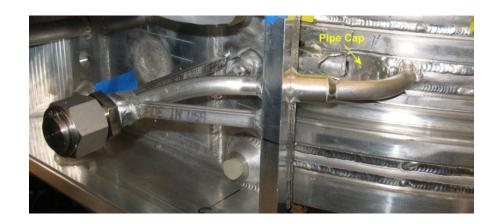
Cooling Tube Leak (LBNL)

- Cooling Tube Vacuum Leak found during checkout
- Solution: a bypass pipe branch

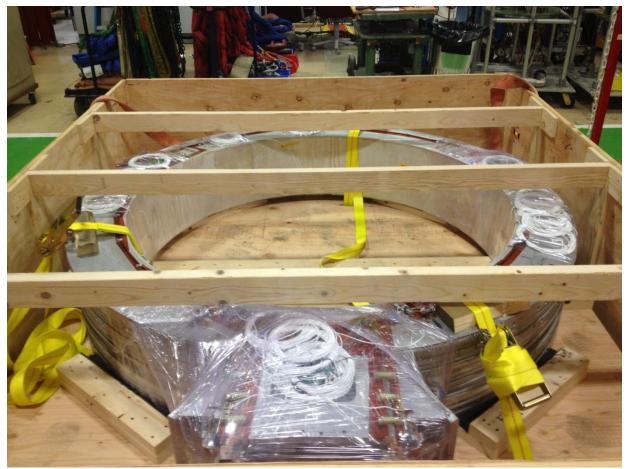
Fermilab First MICE CC Arrived at Fermilab

- First Coupling Coil arrived at Fermilab on 1/31/13
- Coil passed hipot, leak check, and instrumentation check

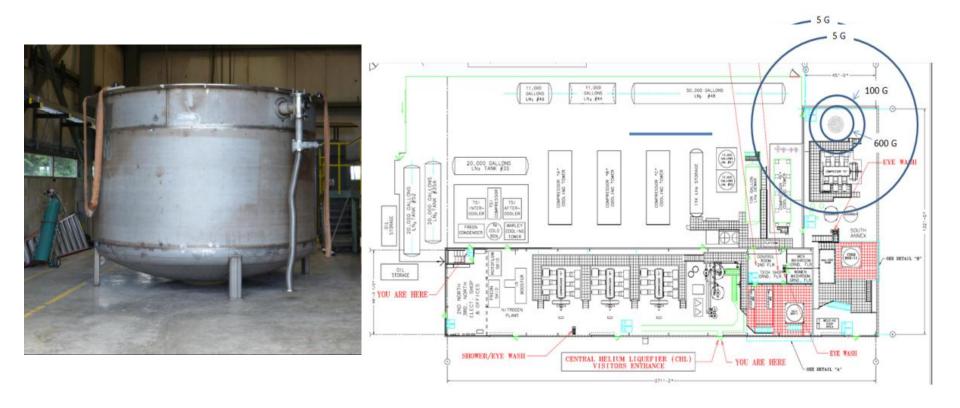
- The Test Cryostat was brought to Fermilab from the NHMFL in Florida and installed in the CHL building, South Annex
- Unnecessary internals were removed, and both the vacuum vessel and the top plate were leak checked and passed

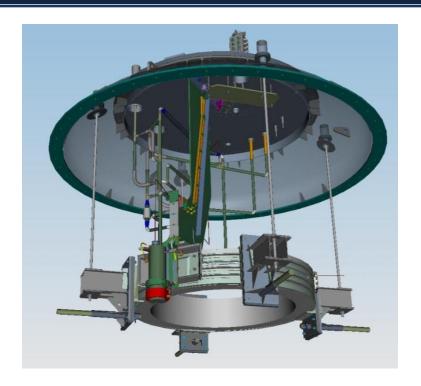
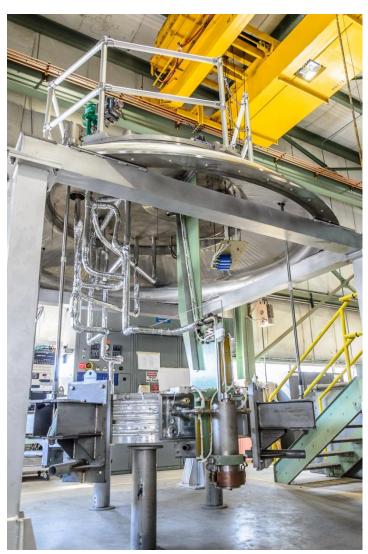
Top Plate Insert

- New Dished Head
- Mechanical Supports
- Cryo Piping
- Current Leads
- Valves, Instrumentation
- Pressure Test
- Leak Check
- Hipot

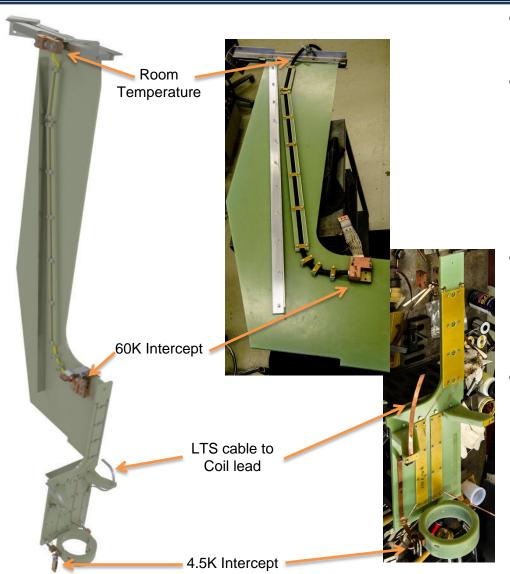
Current Leads

- Conduction-cooled, optimized for 220A
- Two thermal intercepts: 60K (thermal strap to 4.5K GHe return pipe) and 4.5K (Wang NMR intercept to 4.5K boiling He reservoir)
- Low Temperature Superconductor (LTS) section between 4.5K intercept and coil leads
- G-10 mechanical support for magnetic forces

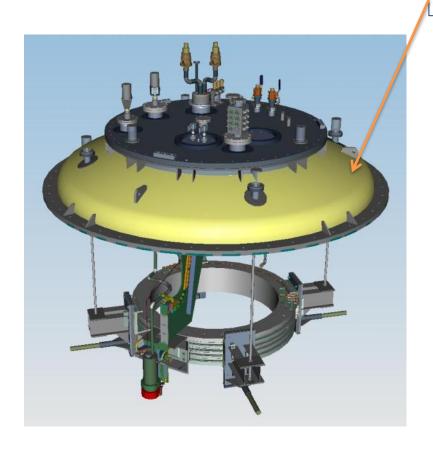
Top Plate

Valves and Instruments, Instrumentation Tree, U-Tubes Connections, Power Connections, etc.

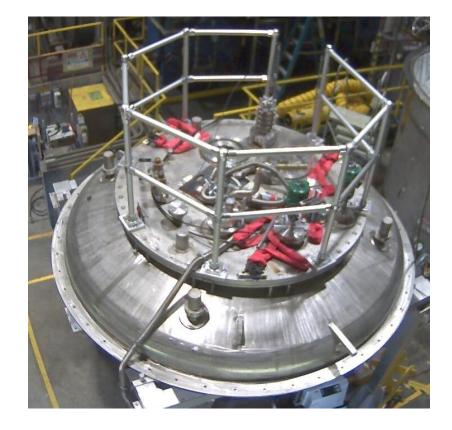
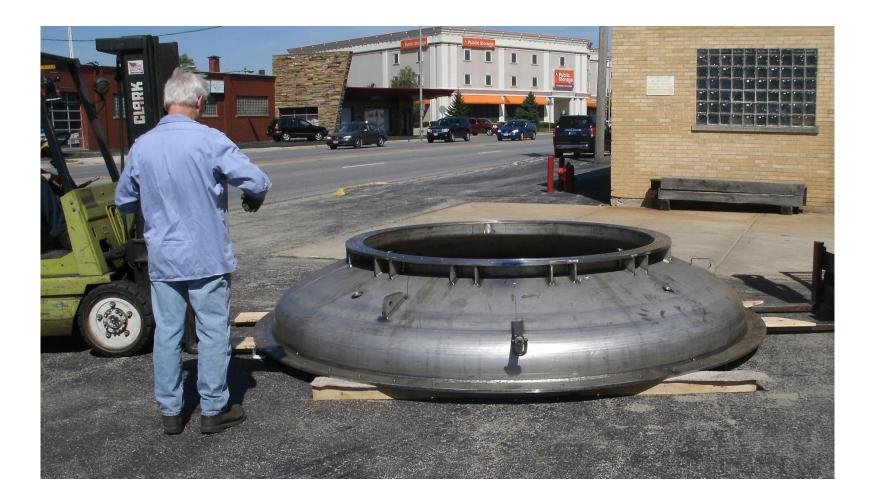
Dished Head Fabrication

New Dished Head

Designed by Fermilab, fabricated by Meyer Tool

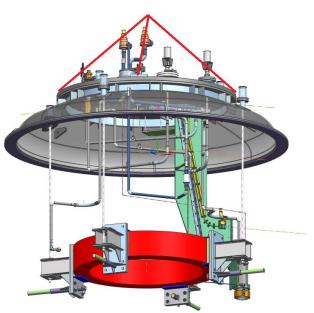
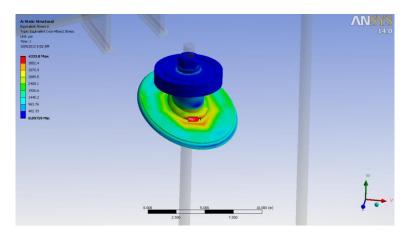
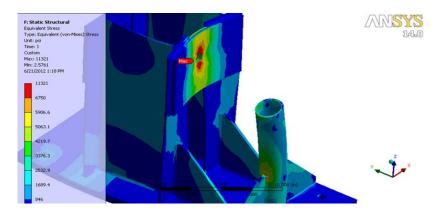
Coil Support System

Design takes into account cold mass weight and magnetic forces with building ferromagnetic structures

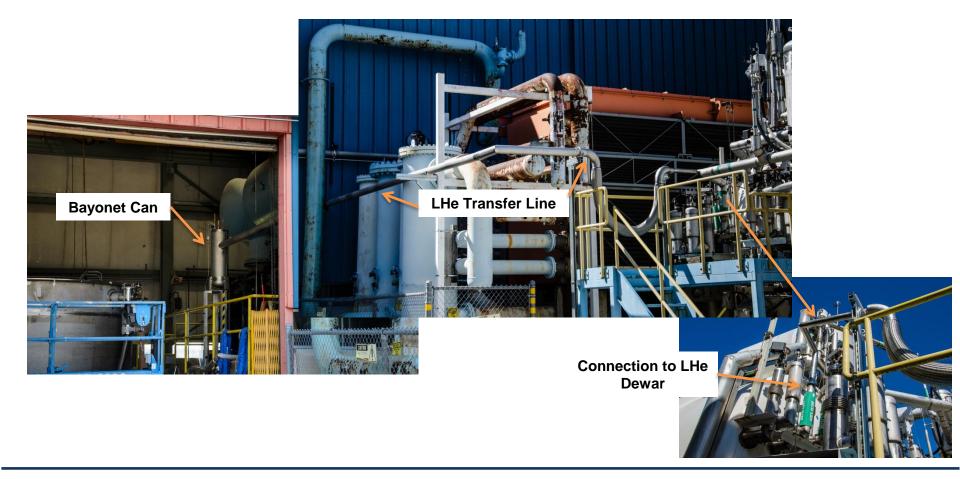
CHL Distribution System

Liquid Helium (LHe)Transfer Line from 10,000 Gallon LHe dewar to Bayonet Can

- Liquid Helium and Helium gas recovery provided by the Central Helium Liquefier (unused after the Tevatron shutdown in September 2011)
- Up to 10 g/s of liquid helium at 4.5K supply to the Coupling Coil cooling tube from a nearby CHL 10,000 Gallon liquid helium Dewar
- Helium inlet temperature during cooldown/warmup controlled to maintain a maximum cold mass gradient of 50K
- The return helium warmed up to room temperature before sending back to the CHL facility for recovery
- No venting to atmosphere expected during a quench (small LHe inventory in the cooling tube)

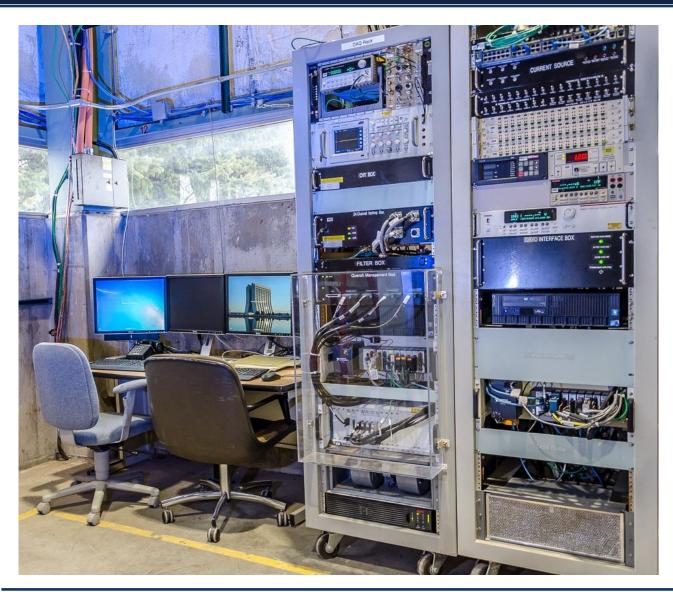
Controls, DAQ

DAQ and Control System Racks with Local Control Station near Test Cryostat

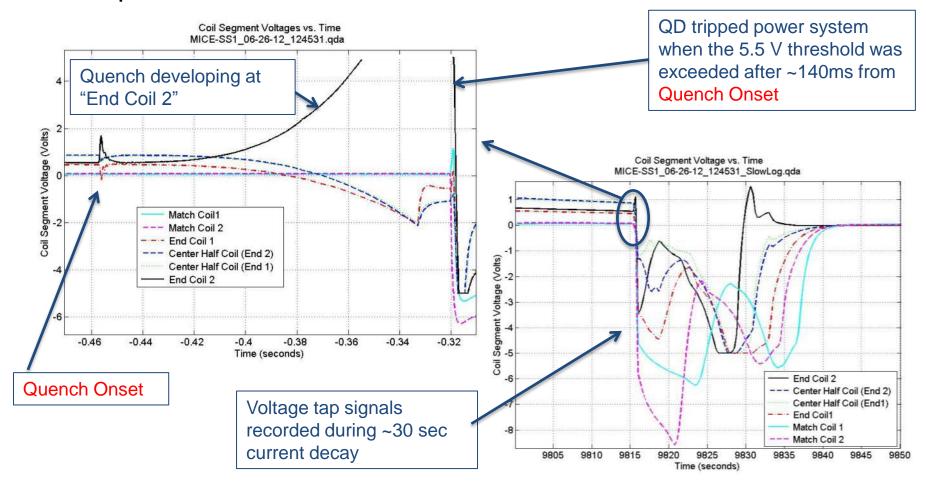
Voltage Taps DAQ and Quench Detection System

- Similar Fermilab system being used successfully for the MICE Spectrometer Solenoid Test at Wang NMR
- Example: Quench on 6/26/12, I = 215 A

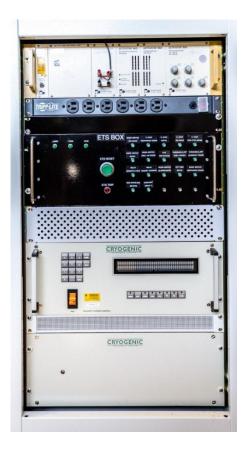
- The Test Facility Power System Rack delivered by LBNL
- Fermilab added personnel Emergency Trip System Box and current readout hardware to the rack

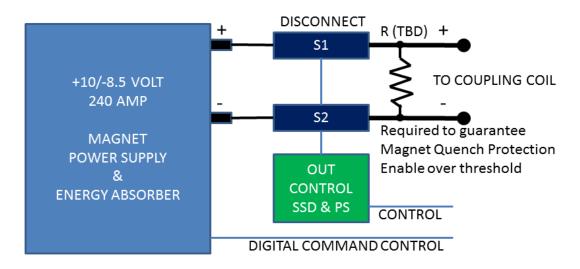
MICE COUPLING COIL POWER SUPPLY SYSTEM

AC power and system grounding details not included

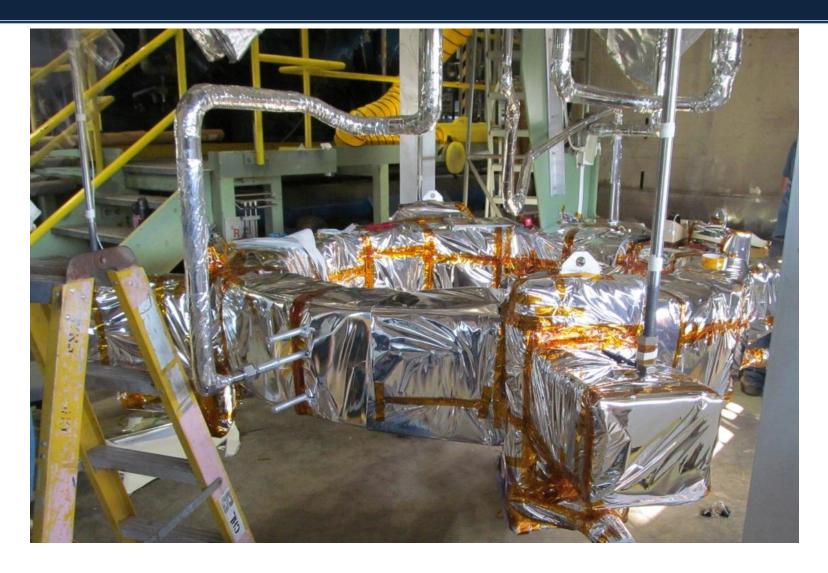
Coil Wrapped in MLI and Inserted in Vacuum Vessel

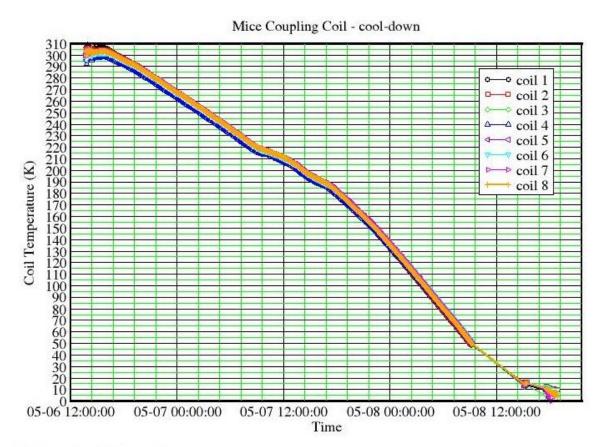
First Controlled Cooldown

- Started Monday
 5/6/13 at noon
- Automatic cooldown with < 50 K Delta T proceeded very well
- Coil < 10 K by Wednesday 5/8/13 afternoon
- Shlomo Caspi from LBNL followed the cool down closely and analyzed strain gauge measurements

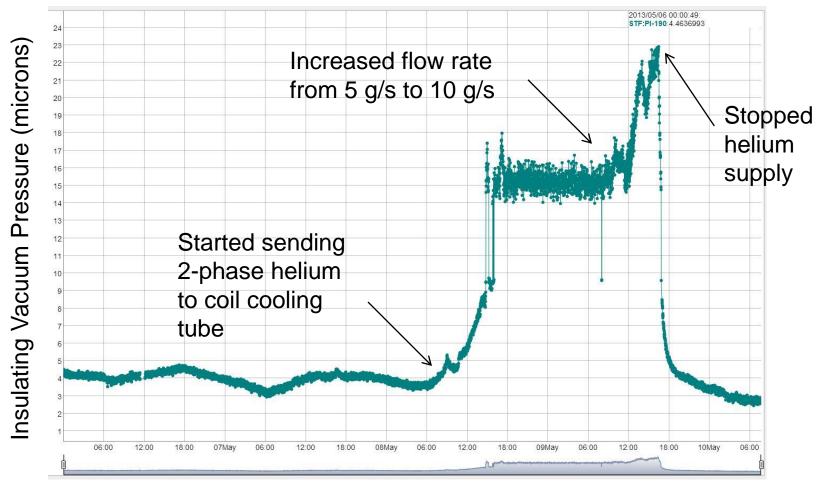
A Cold Leak!

Insulating vacuum quickly degraded when we started sending two-phase helium to the coil cooling tube on Wednesday evening!

- According to the data, the leak location was never exposed to two-phase flow during cooldown:
 - A leak at this location does not explain the sharp dependence on two-phase flow conditions!
 - It does however explain a relatively poor insulating vacuum (~ 4 microns) during cooldown
- Is there another leak we could not find at room temperature?

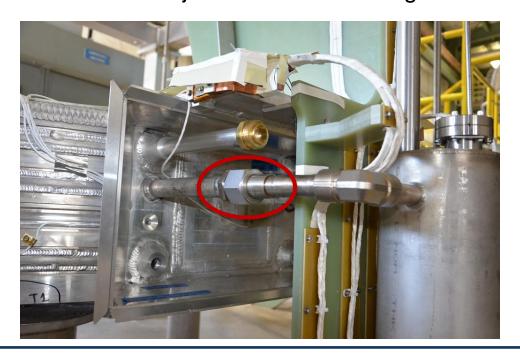
Leak Hunting

- After several attempts to overcome the cold leak, the best cooling conditions we could achieve were a cooling tube helium gas outlet temperature of 5.5 K at the maximum cooling flow rate of 10 g/s. Outer cold mass temperatures were between 8K and 11K. This was not sufficient to proceed with the test.
- A decision was made on 5/13/2013 to warmup the coil, and attempt to find and repair the leak at room temperature.
- After pressurizing the piping to 80 psig, a leak was found at one of the outlet VCR connections. All other joints did not show signs of a leak.

- We have decided to first conduct an acceptance test of the test cryostat <u>without</u> the coil in the loop:
 - Install a coil bypass pipe between inlet and outlet
 - Short the power bus at the cold end
 - Cooldown and power the shorted bus to full current
- Once the cryo and power pass the acceptance test, then we connect the coil and proceed. If a leak is detected at that point, we can be fairly confident that it is in somewhere in the cold mass.
 - As a contingency, we are also considering having provisions for quickly switching to another cooling tube in the cold mass in case of problems
