SNS Target Systems Operational Experience and Upgrade Plans

T. J. McManamy
October 2009

**Workshop on Applications of High
Intensity Proton Accelerators
October 19-21, 2009
Fermi National Accelerator
Laboratory, Batavia, IL, USA**

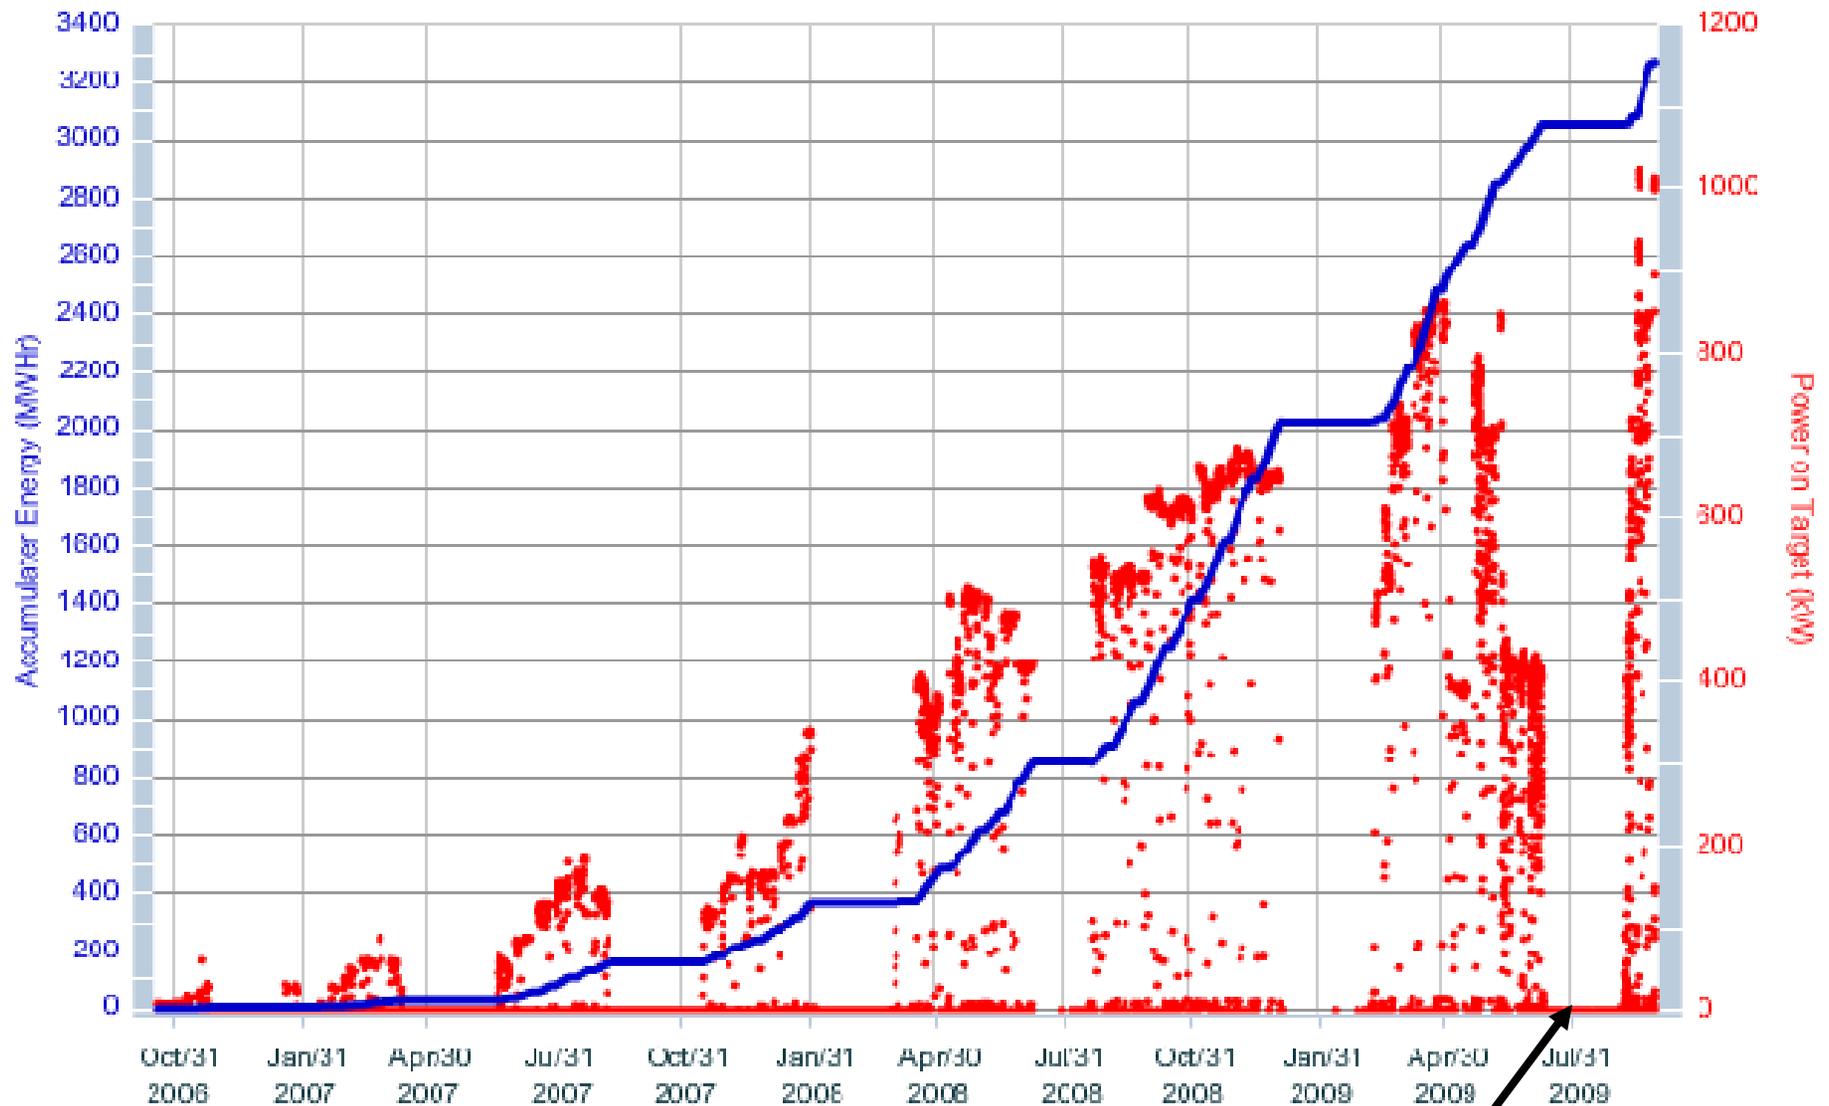
Power on Target

Energy and power on target from October 2006

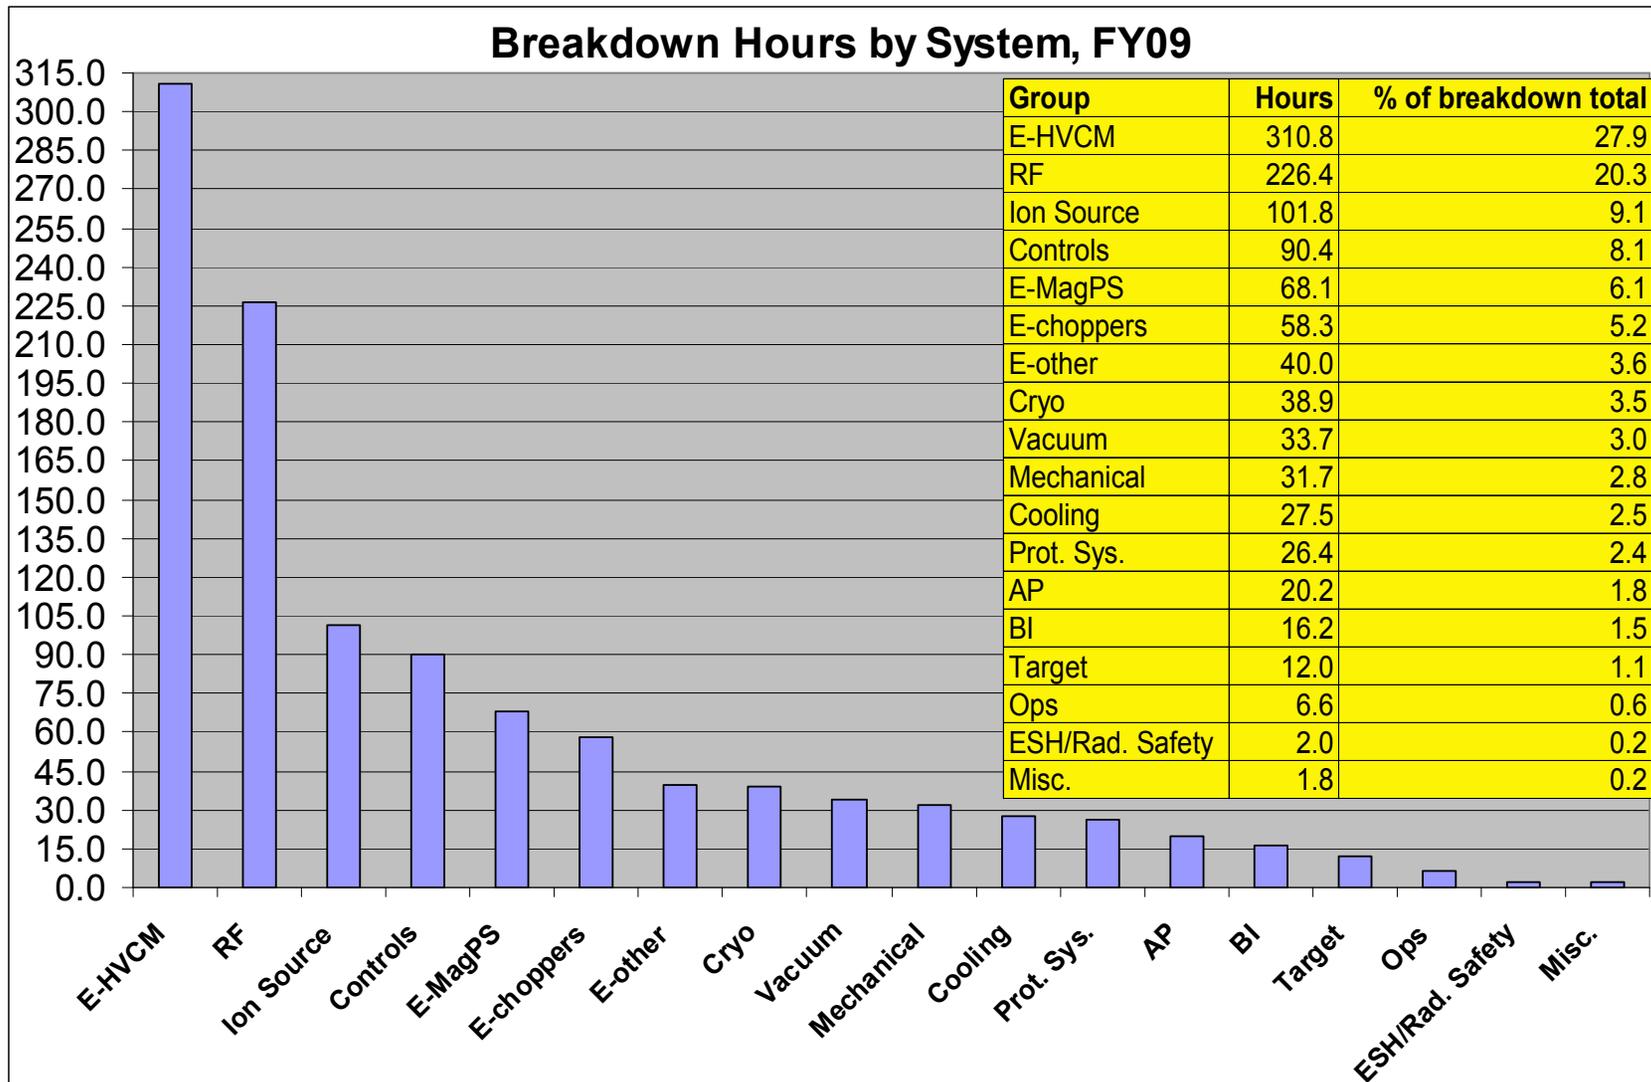
Overall Unscheduled Downtime - FY09

Good availability has been achieved for the Target Systems

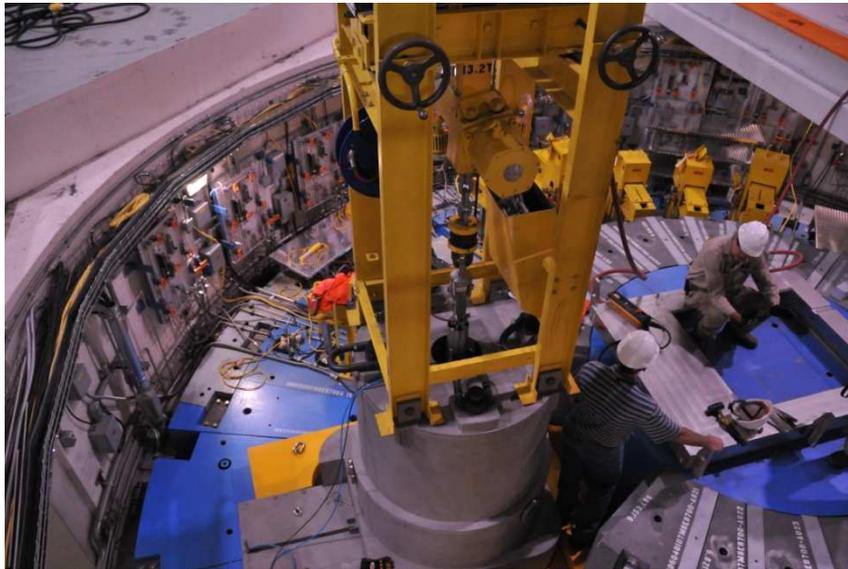
Shielded Cask and Hoist

Proton Beam Window Replacement

- **The first target accumulated 3055 MW hours with an estimated peak damage of 7.5 dpa in the 316L material**
- **While up to ~ 10 dpa was considered acceptable, it was replaced early during the July shutdown to avoid unscheduled loss of neutron production during the next run cycle**
- **The Inconel 718 Proton Beam Window (PBW) was also replaced during this shutdown with an estimated peak damage of 6.5 dpa.**
- **The PBW replacement was done early to avoid scheduling conflict with other remote handling work planned for the next shutdown.**
- **The target and PBW replacement also allowed deployment of a new Target Imaging System (TIS) which could improve estimates of the peak beam intensity on the target**

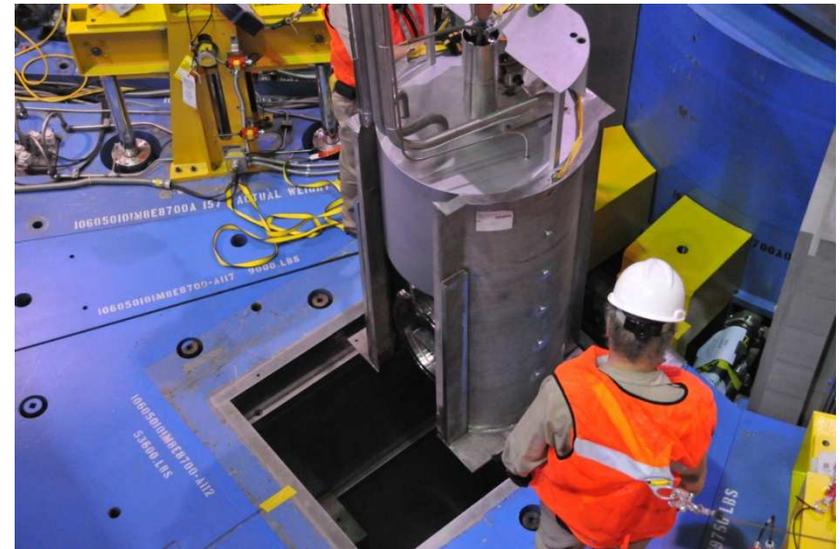
New PBW with guide can and counterweight being installed

Old PBW during retraction into cask →

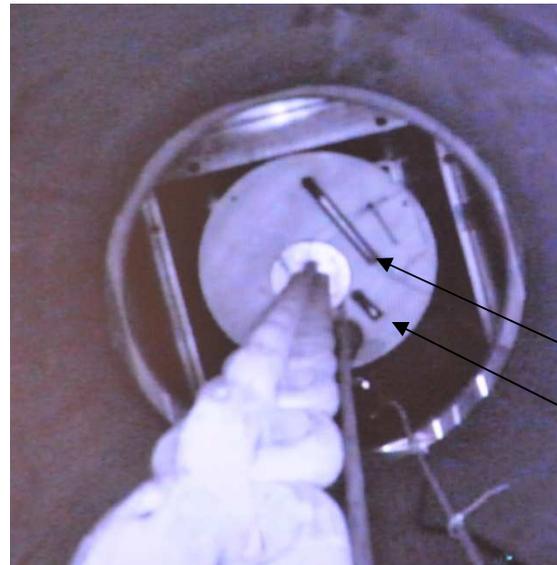
Cooling lines cut prior to removal with long handle tools

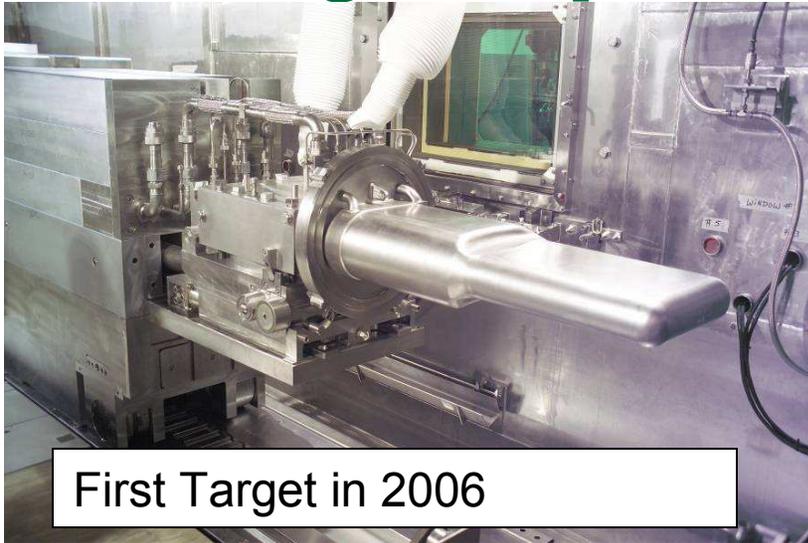
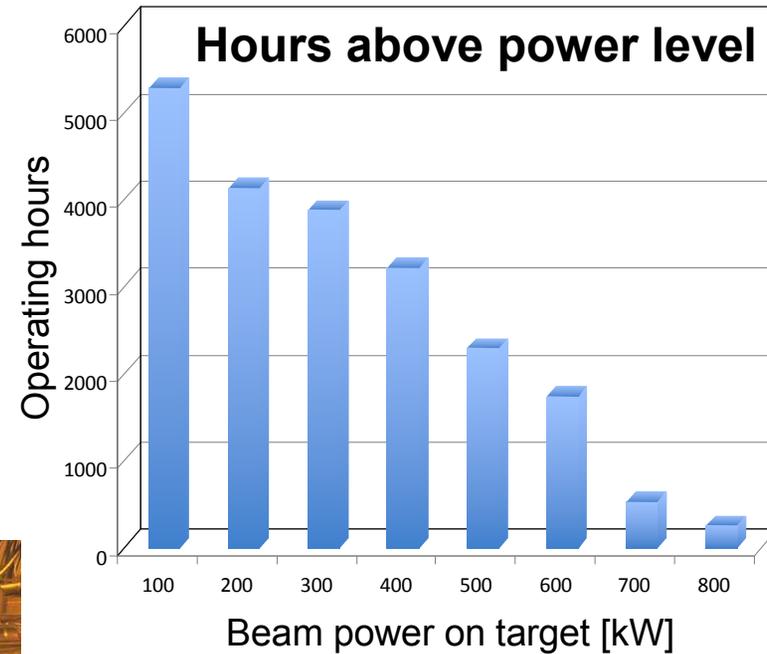
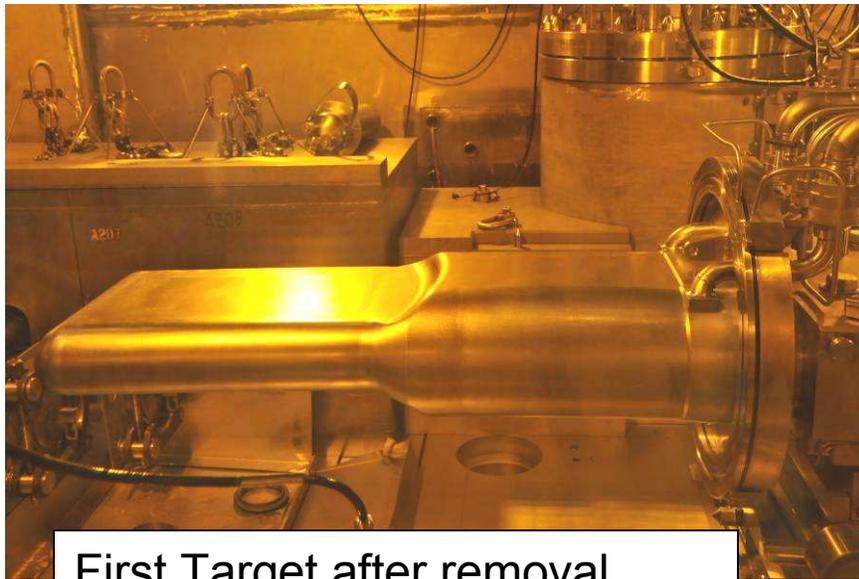
First target replacement

- No observed corrosion
- Internal Boroscope examination in progress
- ~ 50 mm diameter samples to be cut from target nose around the end of October

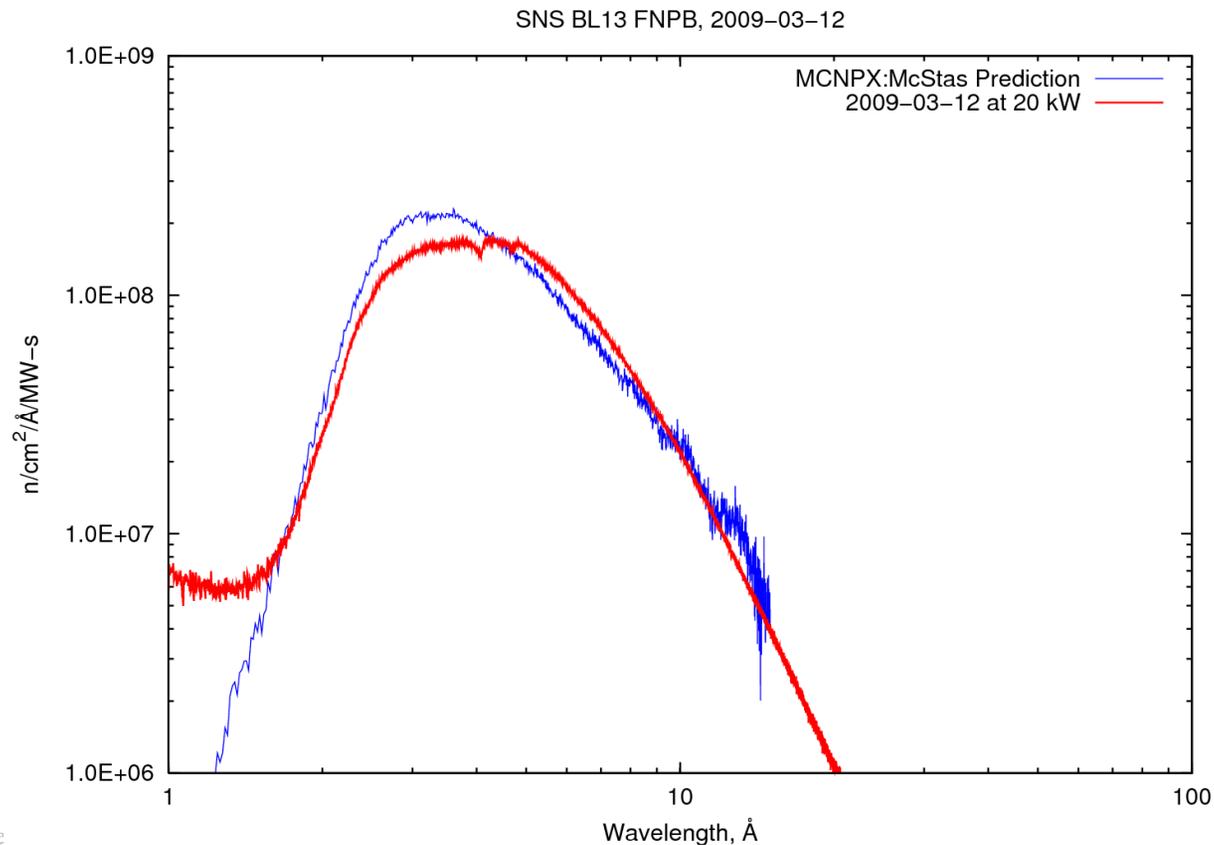
Source seems to be performing as predicted

- Neutron flux at sample location
- Bottom downstream coupled hydrogen moderator (post Jan09 repair)
- Includes guide modeling in McStas and MCNPX

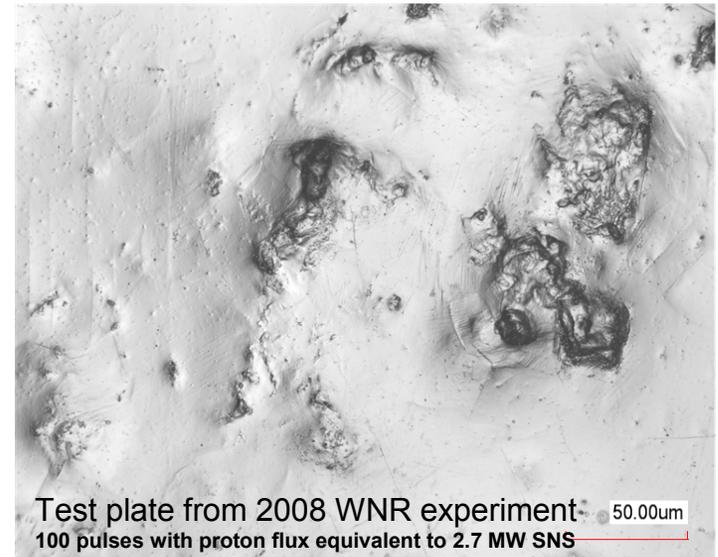
- The first target operated for >1700 hours at or above 600 kW and up to 800 kW without a failure
- R&D by the SNS and J-PARC teams has shown that the target wall is likely to experience pitting damage by the collapse of cavitation bubbles
 - This has been shown for short pulse (< 1 μ second) operation
 - The rate of damage is sensitive to beam power (P⁴?)
- A target imaging system (TIS) is being developed to give improved measurement of the beam profile which could improved beam control and target lifetime
- Mitigation methods using small distributed bubbles or bubble walls near the surface are being developed by the R&D programs

- **Experience with targets at or above 1 MW is needed to determine if gas mitigation methods are needed**
 - **Post Irradiation Examination (PIE) will be done on samples from the nose region of the first target (which did not fail)**
 - **Subsequent Targets will be run until mercury is detected in the interstitial region (or to 10 dpa) and PIE performed to locate the leaking region and remove samples**
 - **At 1 MW with the nominal beam profile, 10 dpa would be reached after 5000 hours of operation**
- **If cavitation damage does not limit lifetimes unacceptably, structural analysis of the current target design indicates it can operate at 1.4 MW**

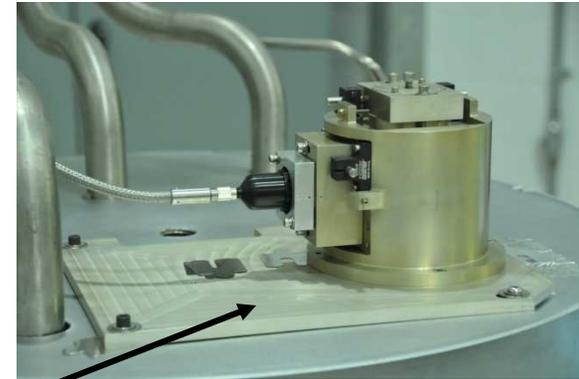
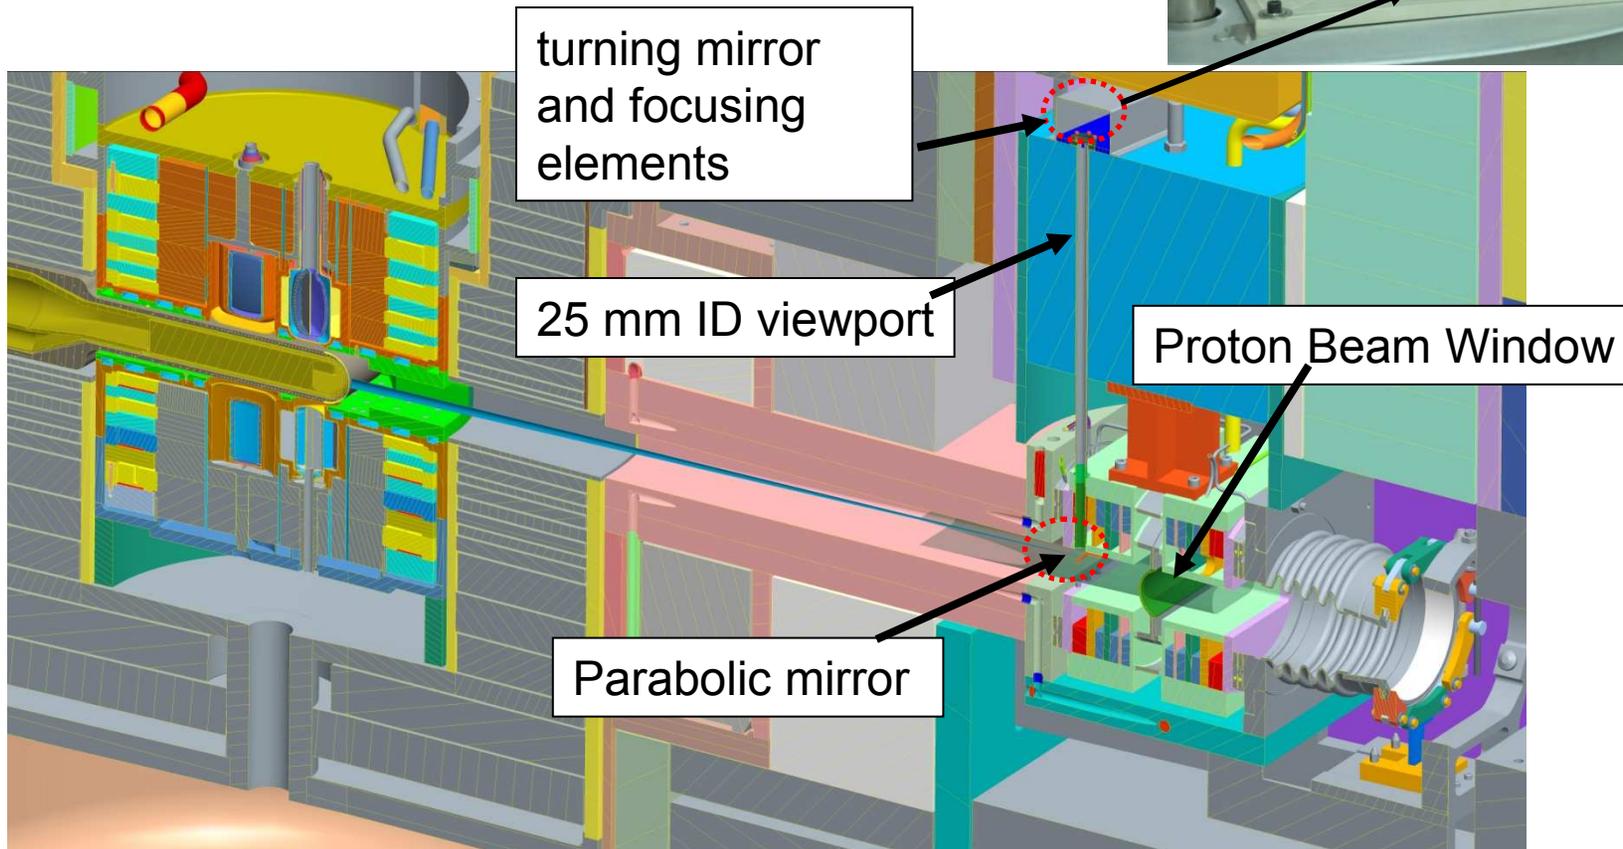
Target Imaging System

System Deployed during July 2009 Shutdown

Second PBW view from downstream side

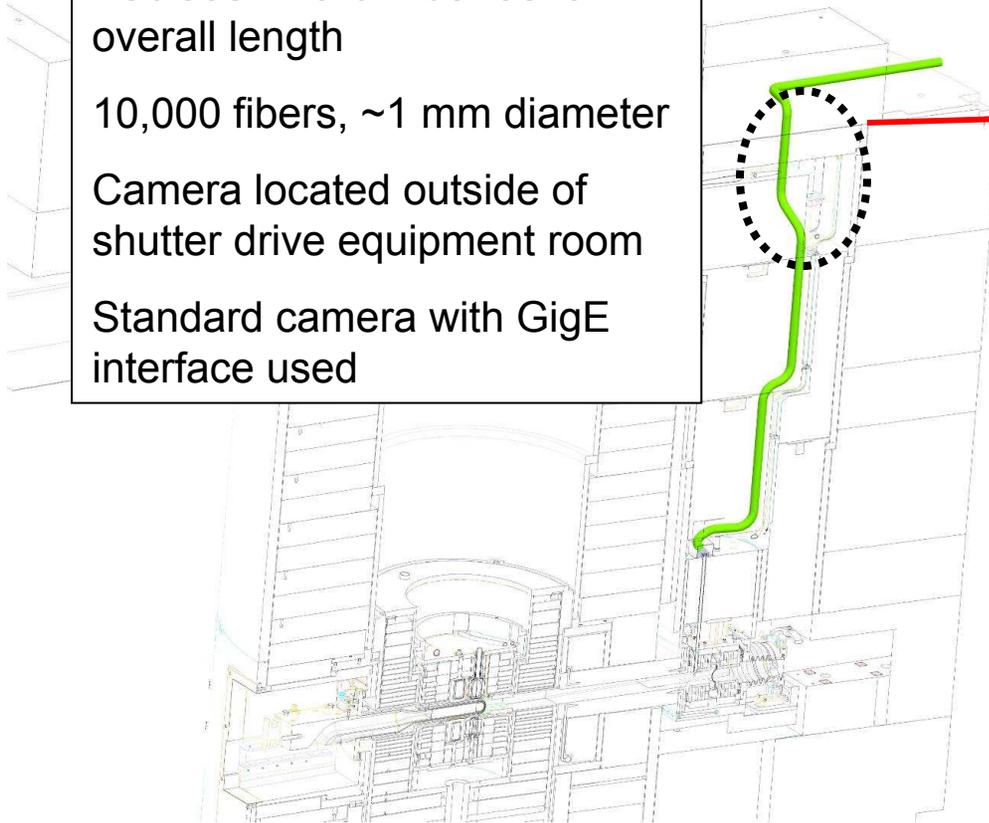
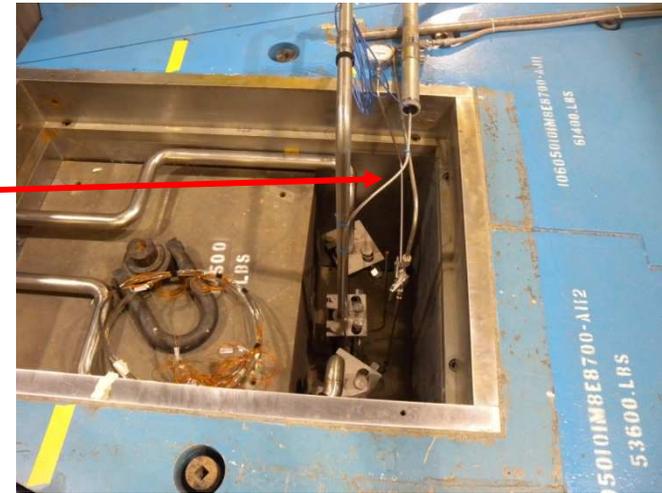
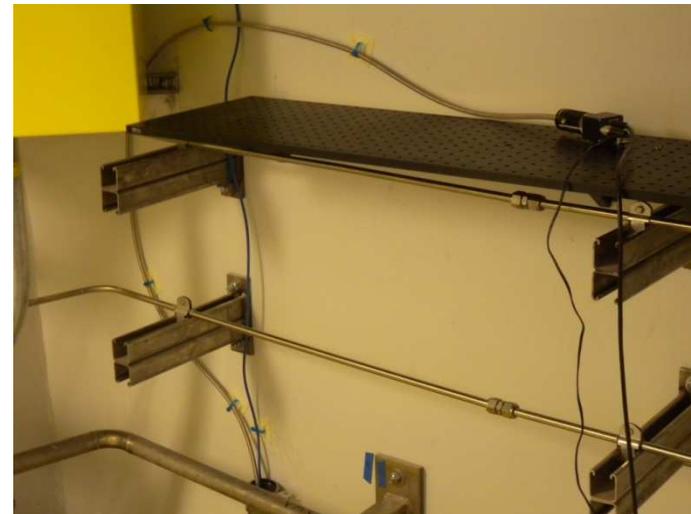
Camera mounted outside shielding

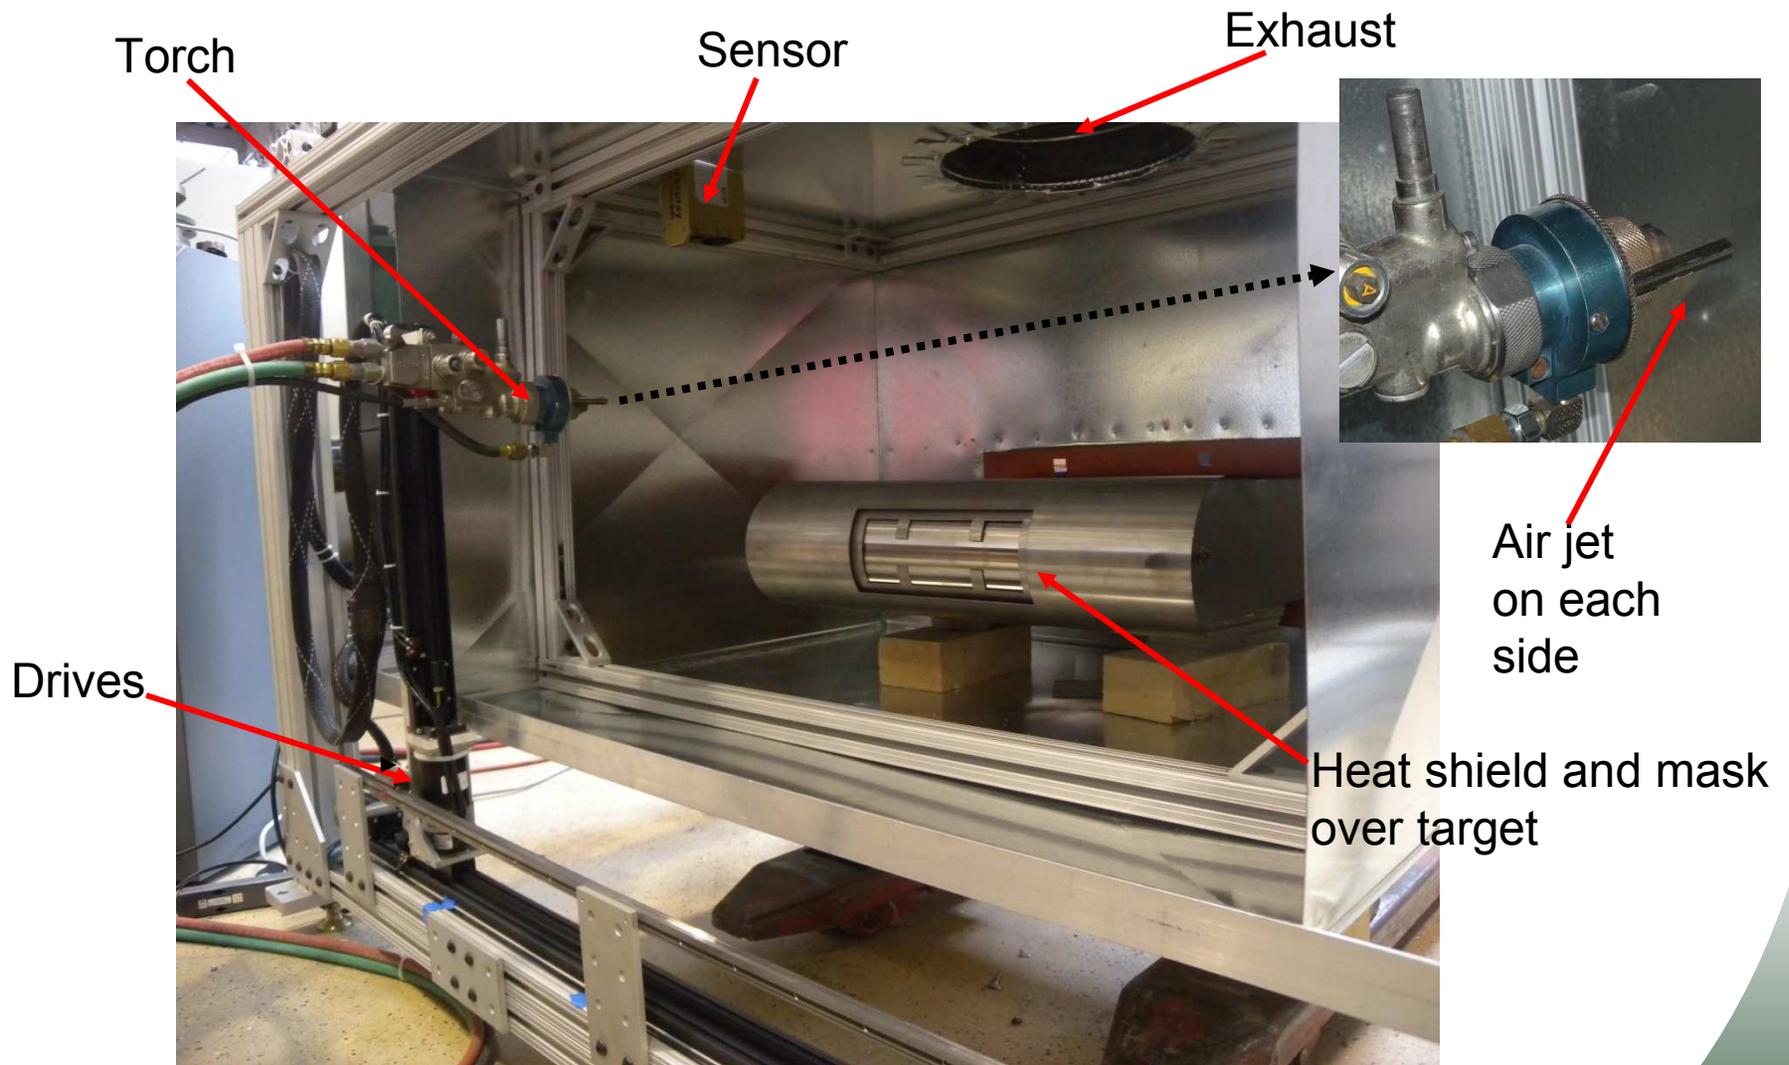
Flame Spray ($Al_2O_3 + 1.5\% CrO$) development

Portable Flame Spray Coating and Ventilation System Developed by the Center for Thermal Spray Research (SUNY at Stony Brook)

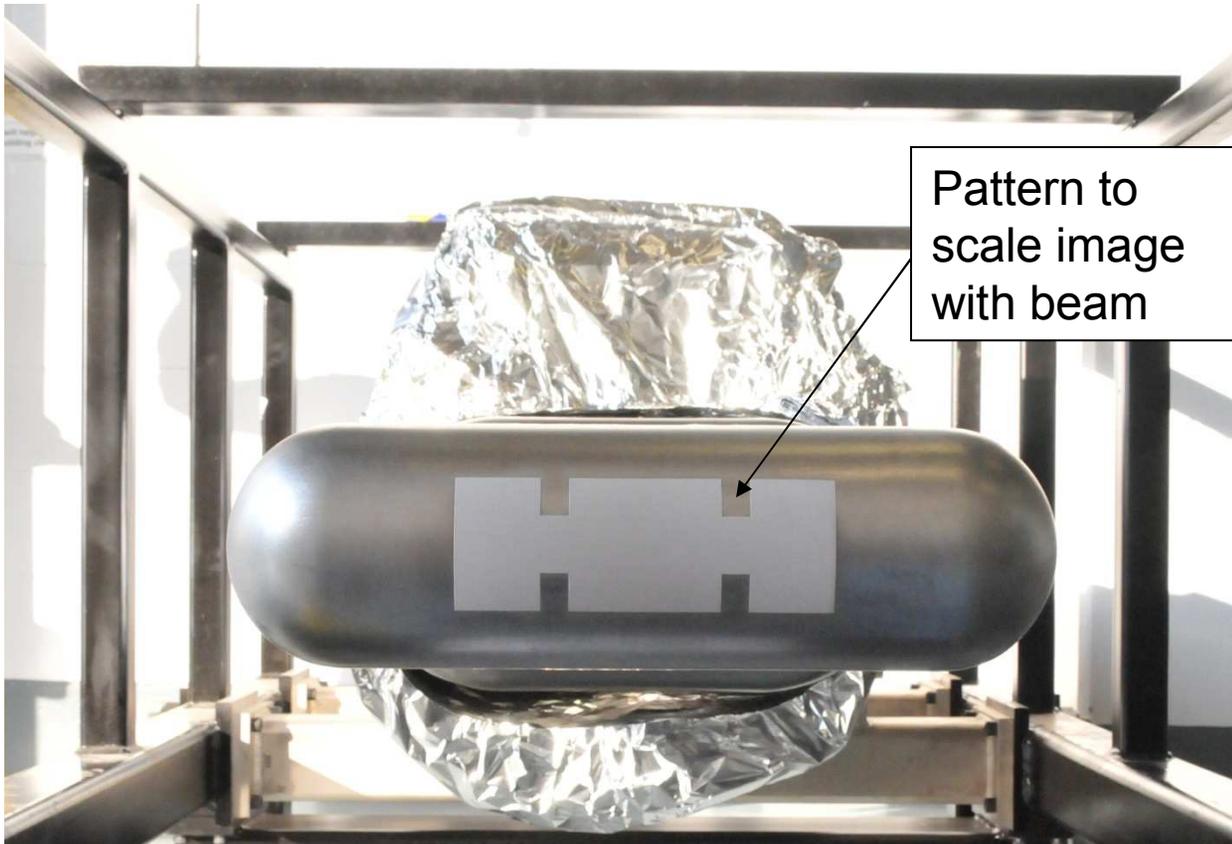
Completed Target Coating

Nominal Thickness 0.25 mm, 200mm x 70 mm pattern

Mockup testing established parameters and showed substrate temperatures were < 120 C with air cooling

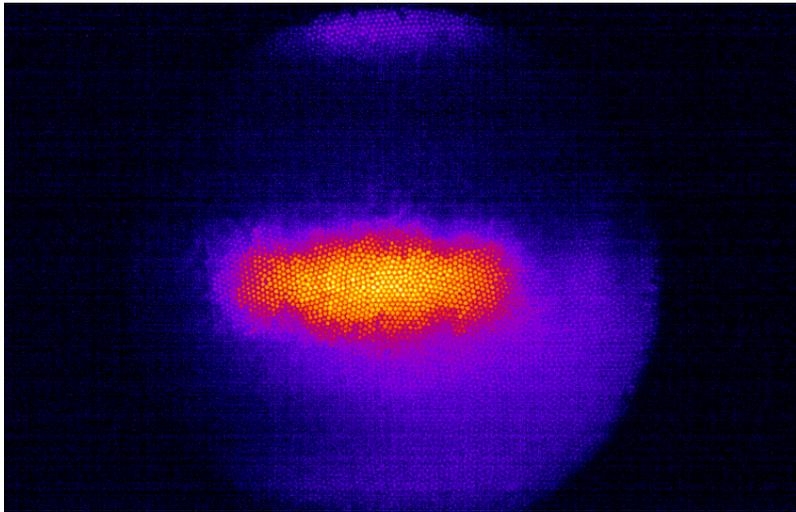
False color target images at 800 kW

Case 1: image with potential gas scintillation

- Data analysis of profiles in progress
 - Initial results similar to previous projections
 - No beam tilt
 - ~10% higher peaking than previous estimates

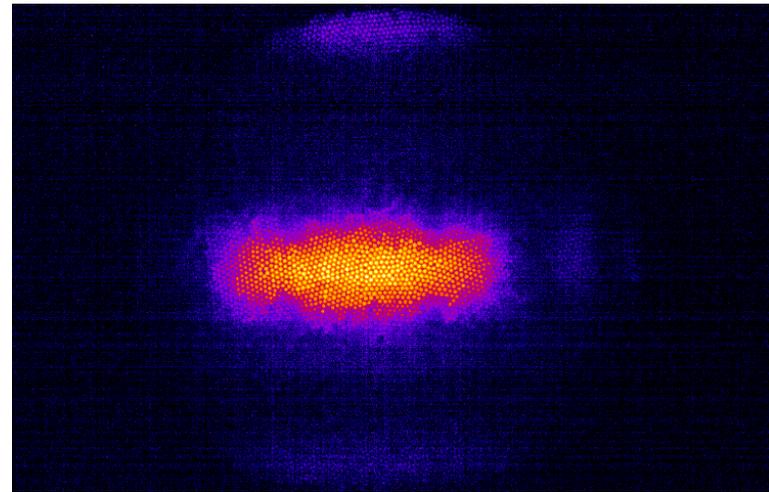
Case 2: image with shutter delayed by 4 microseconds to gate out suspected gas

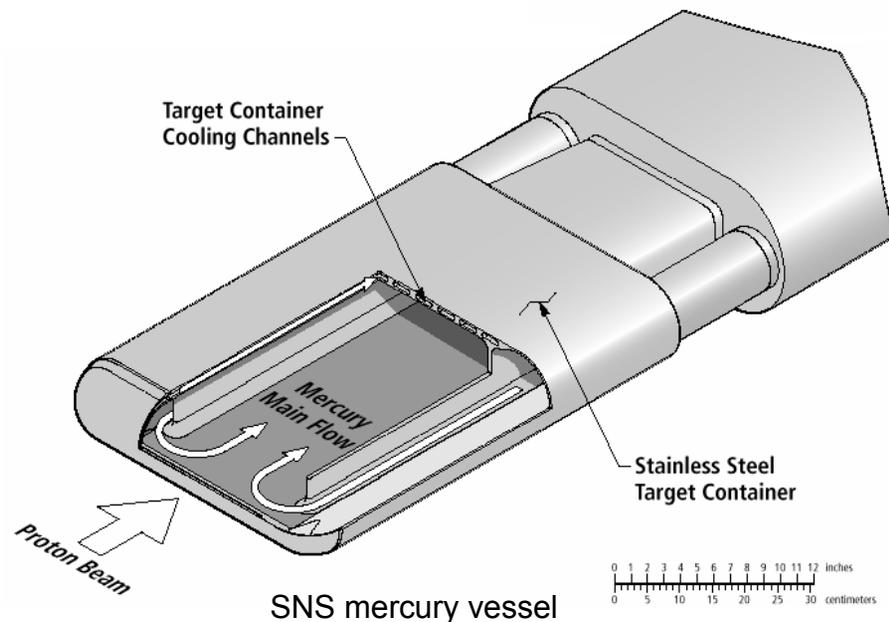
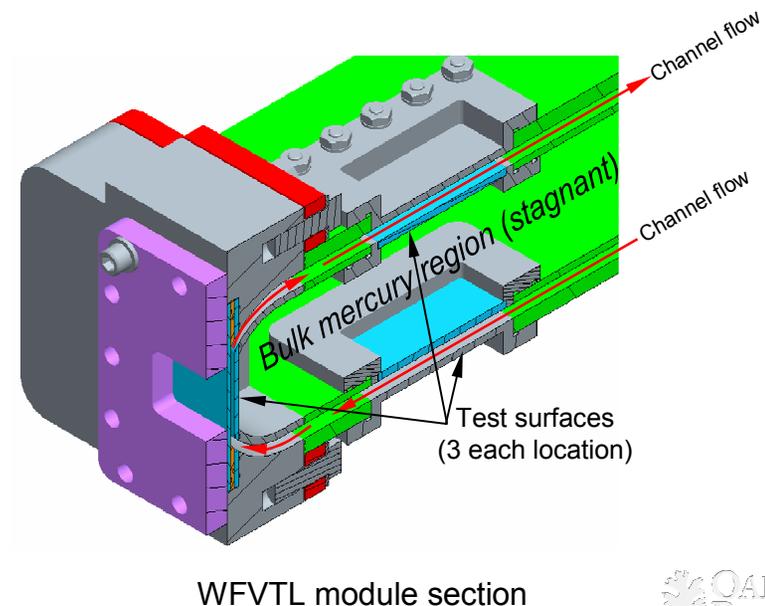
WFVTL target module and mercury loop

- In-beam experiment examined narrow mercury channel damage under conditions more prototypic to SNS
 - Previous in-beam test results for channel damage indicated this region is especially vulnerable
- Investigated damage reduction vs. flow velocity
 - Previous in-beam test indicated damage *reduced by flow*
- Sought confirmation that water in channel is benign

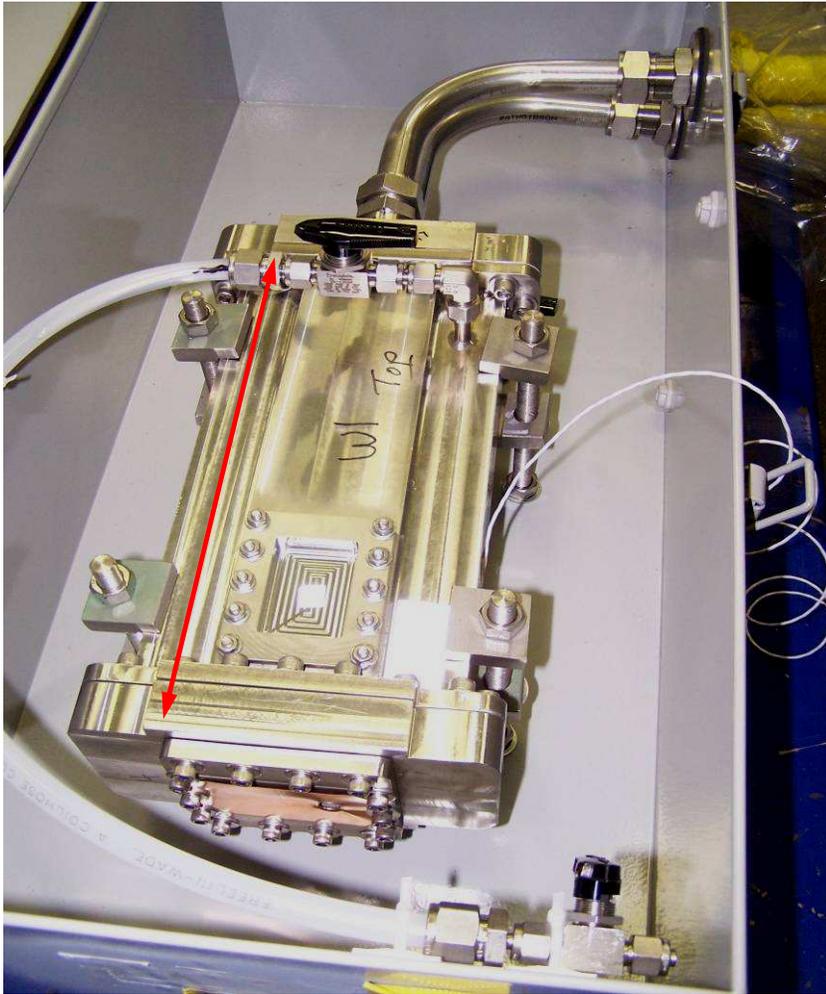
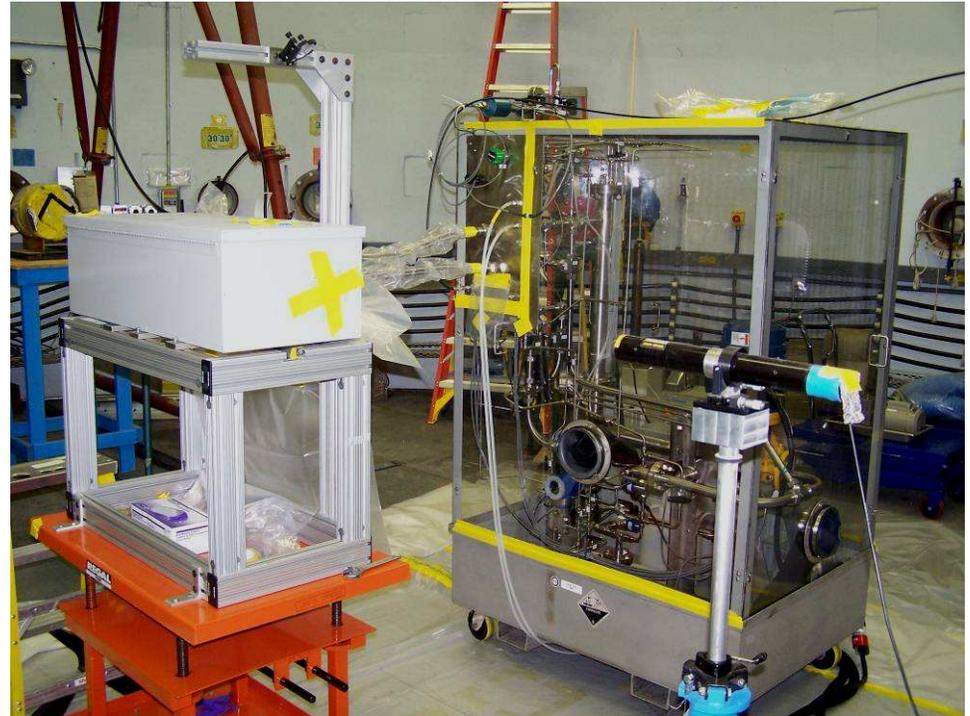
Hg length: 325 mm

- Variable speed centrifugal pump employed for channel flow speeds for up to 7 m/s
 - Only ca. 4.3 m/s achieved
- Test targets connected to loop via flexible hoses

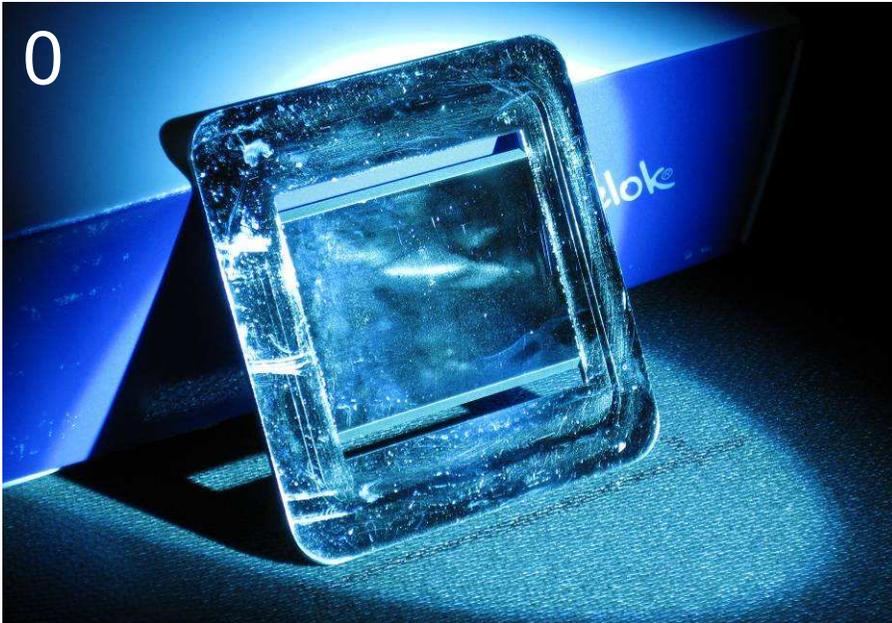
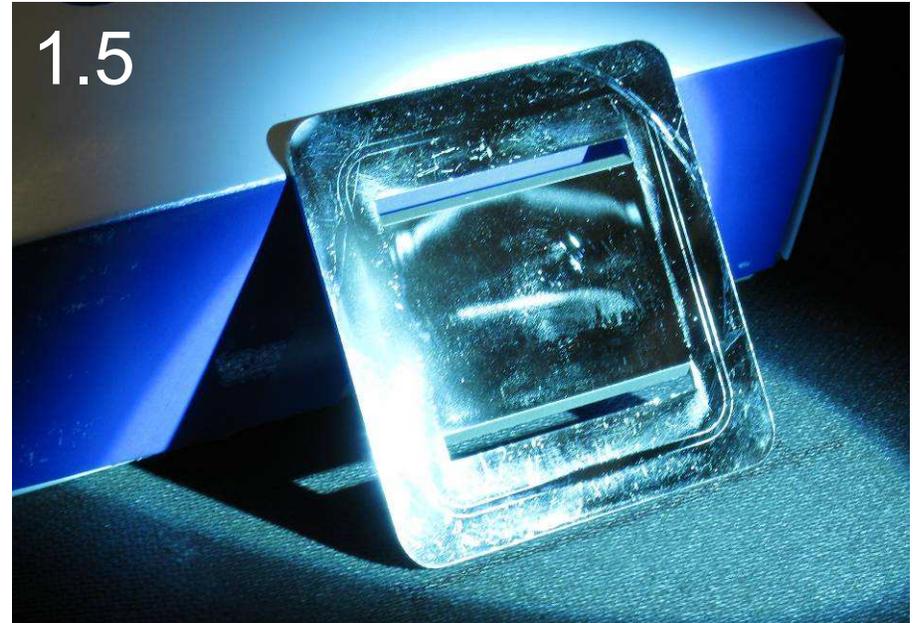
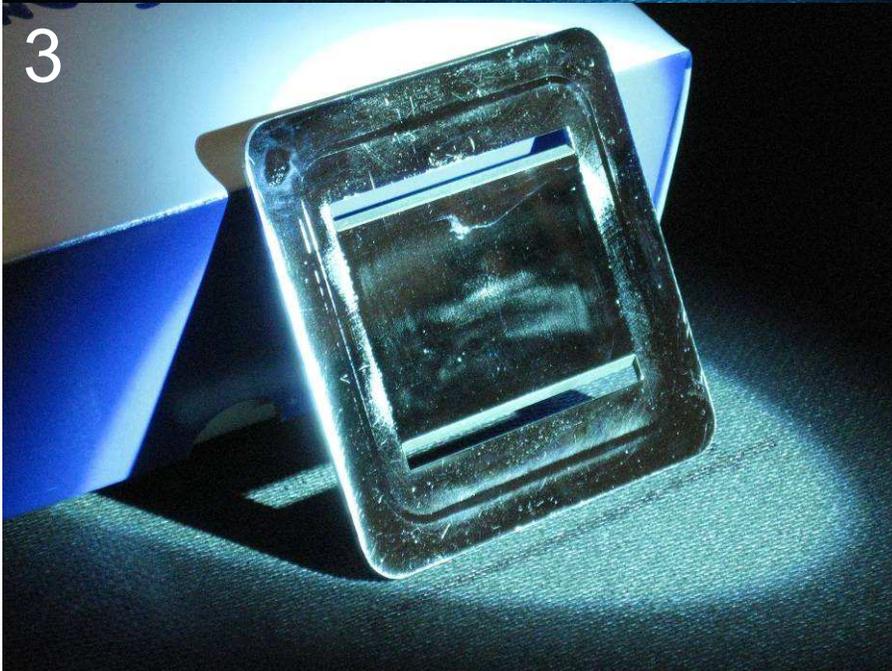
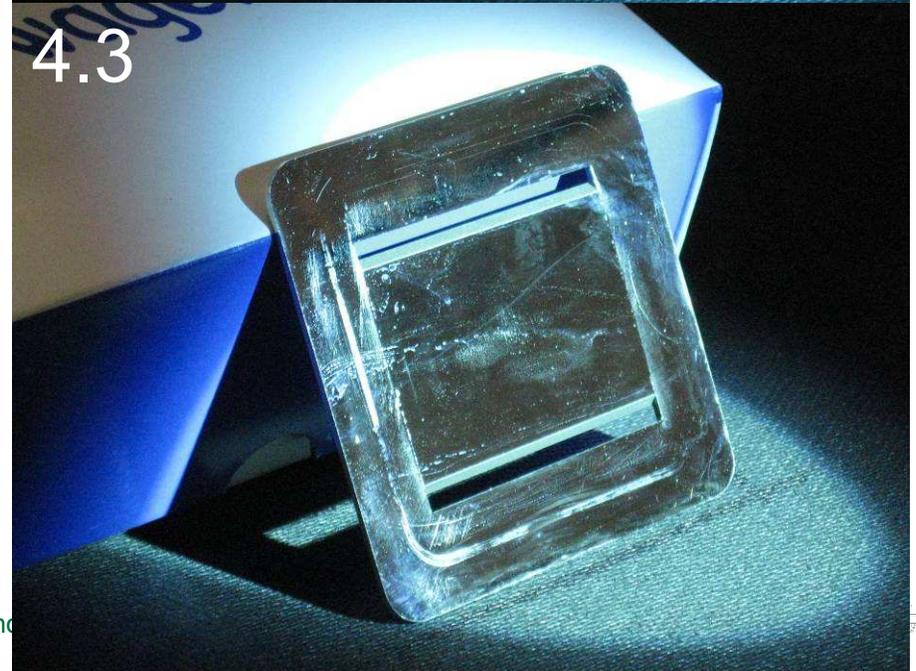
Damage patterns - Front inside plate - Channel side

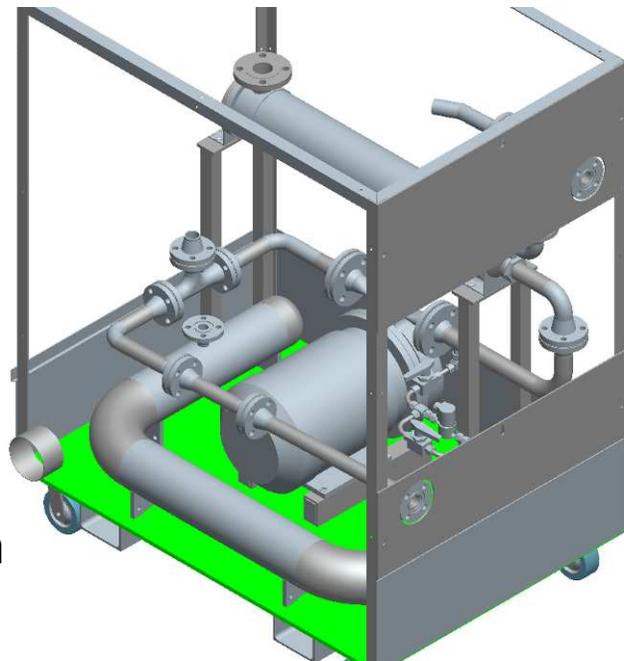
Pump system

- This will investigate small gas bubble mitigation with improved bubblers
- Flowing mercury system required
- Will be done in close collaboration with JPARC team

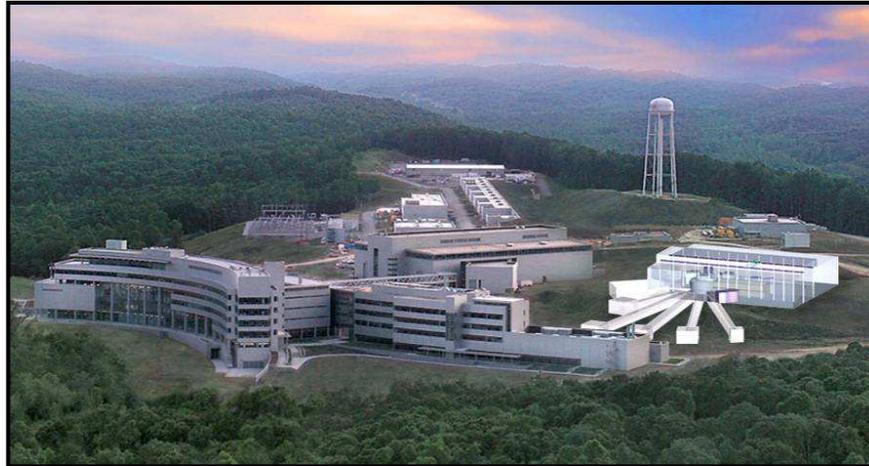
SNS Second Target Station (STS)

- **Scope of STS includes design, build, install, test, and commission a second target station at SNS consisting of:**
 - New spallation target and supporting systems
 - Extended SNS accelerator systems
 - Conventional support buildings
 - Initial neutron beam instruments
- **Mission Need Critical Decision-0 approved in January 2009!**
 - Current plan: Start construction project in 2012; complete in 2019
