SNS Target Systems Operational Experience and Upgrade Plans

T. J. McManamy
October 2009

**Workshop on Applications of High
Intensity Proton Accelerators
October 19-21, 2009
Fermi National Accelerator
Laboratory, Batavia, IL, USA**

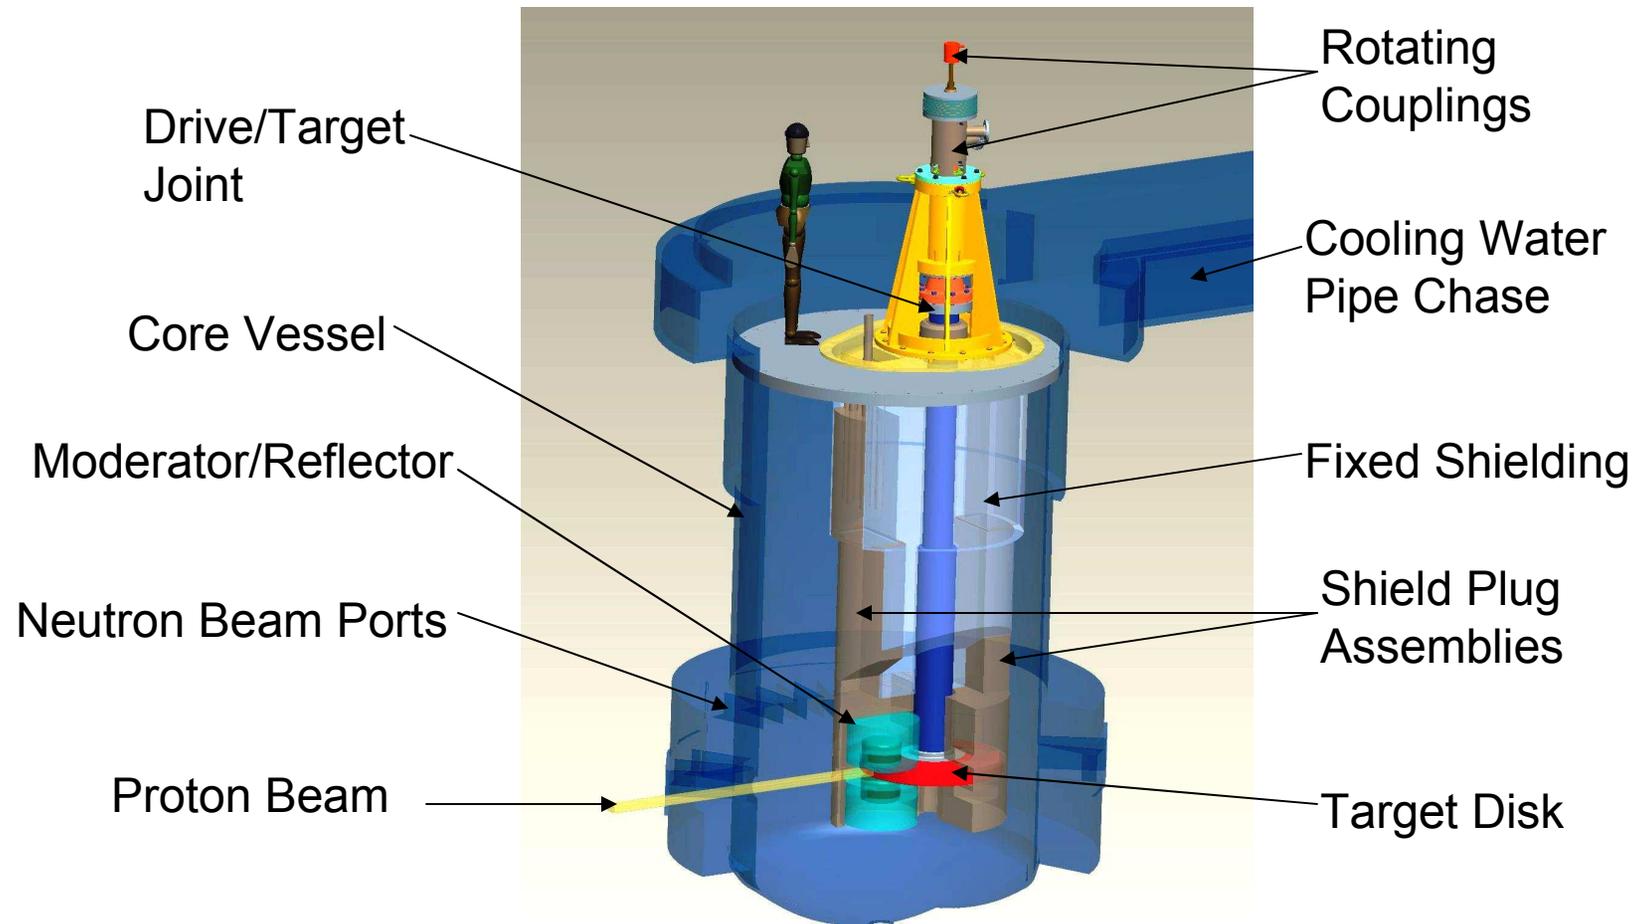
Target Plug Configuration

- **Target, moderators and reflectors mounted in a single large vertical plug**
- **Target driven with assembly mounted 3.5 meters above the disk.**

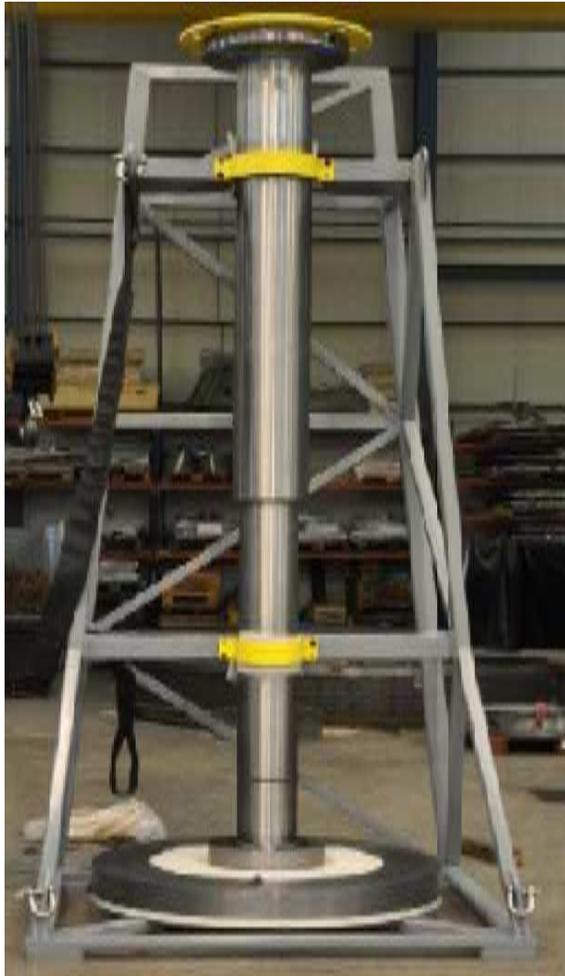
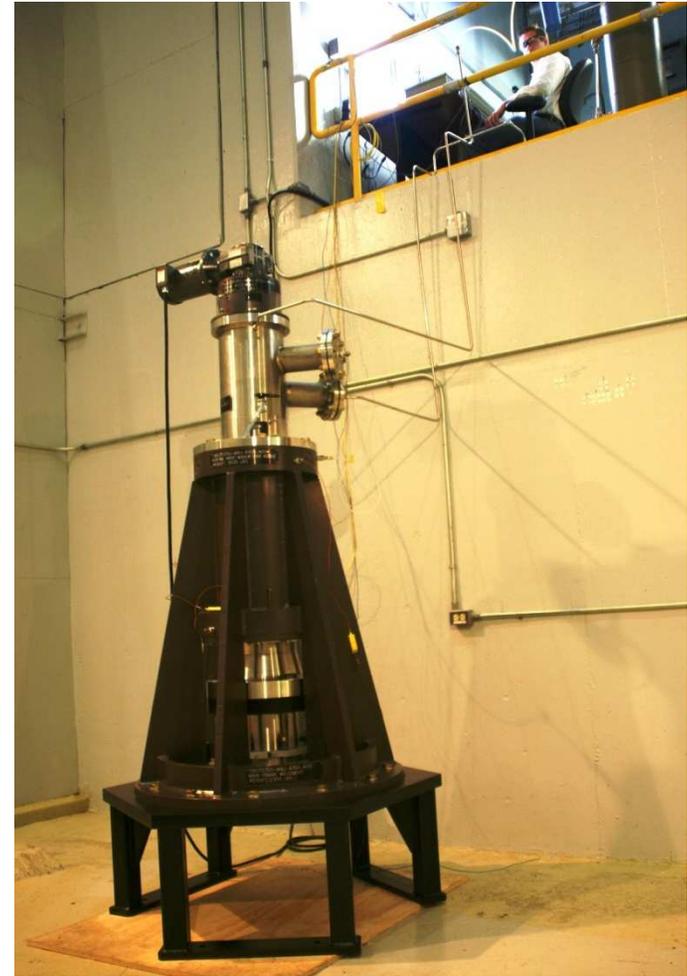
Rotating Target Drive Configuration

- A Prototype drive module has been built and successfully tested for > 1000 h.
- Drive designed to be removed independently of the target module
- Testing with shaft and target disk planned for FY10

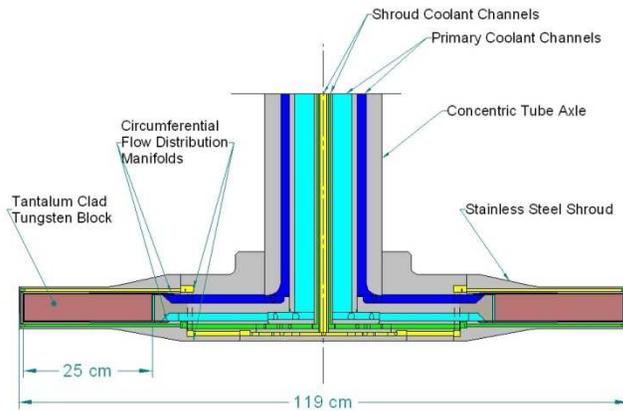
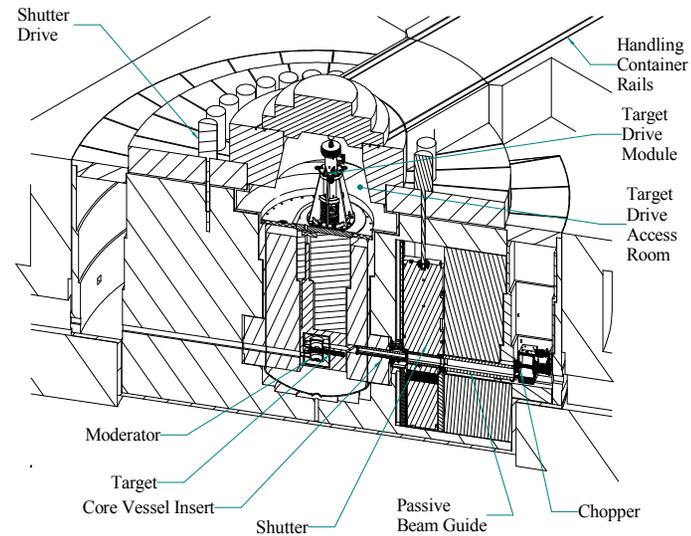
Configuration Studies

- **Recent power upgrade accelerator studies have indicated that 1.5 MW is a likely upper bound for power on the second target station for reasonable costs with ~2 MW on the first target station**
- **Rotating Target design studies have started based on this power level with long pulse operation at 20 Hz and 1.3 GeV, consistent with the Power Upgrade Planning and Accelerator Improvement Projects**
- **Design Studies**
 - **Optimize target neutronic & thermal hydraulic design for 1.5 MW**
 - **Develop safety basis for passive decay heat removal**
 - **Develop integrated monolith and hot cell structures**

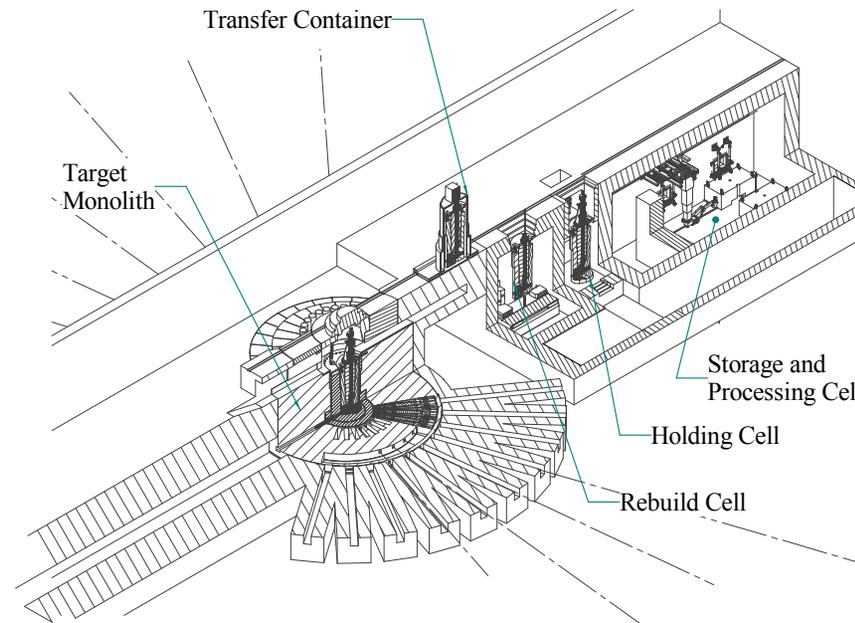
Target Parameters

- 1.2 m diameter
- ~60 mm W height
- ~ 12 mm steel shell
- ~ 1.5 mm flow channel
- 1mm Ta clad Tungsten
- ~30 RPM
- Gaussian or flat beam profile

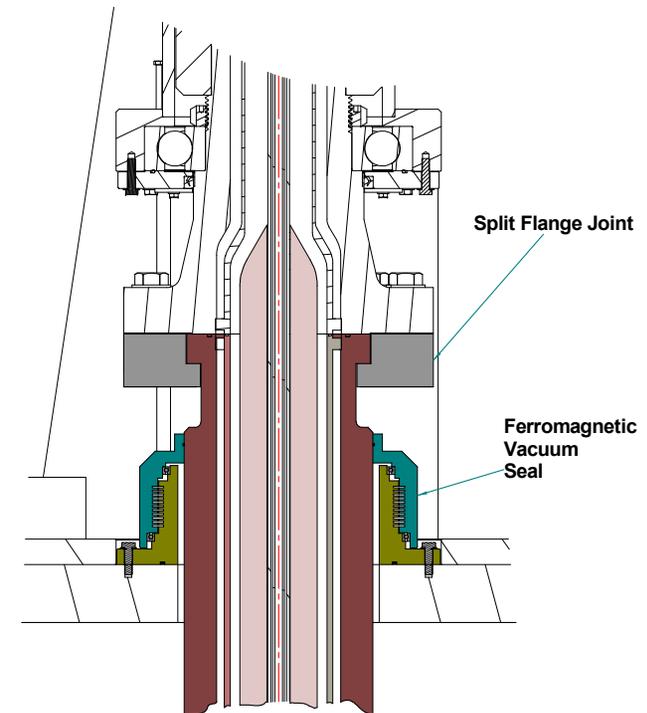
Rotating target vacuum operation

- The proton beam window (PBW) is a credited engineering boundary for containing mercury in case of target failure
- For a rotating target with water cooling an option under evaluation is eliminating the PBW and operating the target in vacuum
- Ferrofluidic seals on the shaft are under consideration
 - 10^4 Gray/year estimated dose should be acceptable based on testing at Riken to 1.8×10^5 Gy
- Improved neutronic performance and reduced remote handling maintenance are expected from this change
