# LCLS-II Cryomodule Assembly and Design Changes/Issues at Fermilab

Tug Arkan

LCLS 2-HE CRYOMODULE PERFORMANCE WORKSHOP

April 25-26, 2019

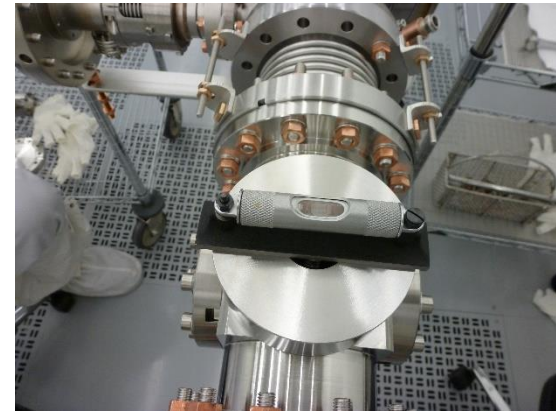
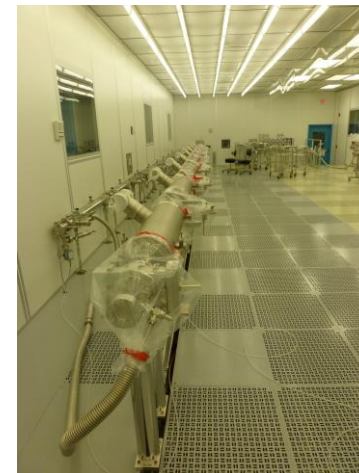
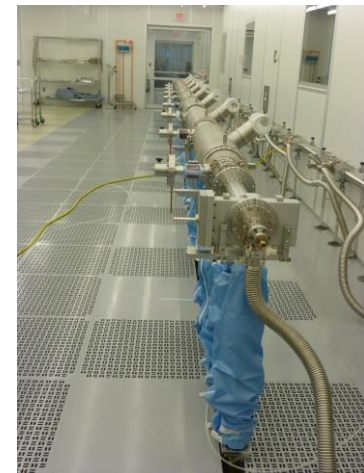
# String Assembly-III (WS1)

- BPM sub-assemblies with feedthroughs (*titanium-grade 2 SHCS; increased torque from 12 N-m to 16 N-m starting from F1.3-8, after F1.3-6 beamline loss incident during transport to SLAC and post mortem, fasteners were replaced with titanium grade-5 studs and torquing sequence is updated*)
- BPM + Magnet Spool Tube + GV2 assembly and leak check
- BPM/Magnet package subassembly to the 8 cavities string
- Pump down the fully assembled cavity string
- Bag and conduct final leak check
- Backfill to atmosphere-vent

# Post F1.3-6 beamline loss incident, corrective actions are implemented

- Replaced grade 2 Titanium socket head cap screws with grade 5 Titanium studs, 316L nuts and washers
  - Materials specifications and certifications are confirmed and verified

- Demonstrated reproducible gasket crush of at least 0.2 mm on BPM subassemblies using torque of 12~14 N\*m with the new hardware.
- Thermal cycled new BPM subassemblies to ensure gasket compression does not change after thermal cycles and leaks do not appear.

- Measured new fastener yield and tensile strength and ensured studs are being used in their design range.
- Modified BPM assembly procedure to reflect new hardware and torque sequence and pattern that is consistent with XFEL and what was used to demonstrate leak tight BPM assemblies during bench testing.

- Updated all assembly travelers with the new procedures
- F1.3-1, F1-3-4, F1.3-7, F1.3-9 were partially disassembled. BPM hardware were replaced. Additional procedures are added that every fastener in the CM is tightened and secured against unintentional loosening by at least 2 means of locking (torque, Loctite, Belleville/lock washers etc.)

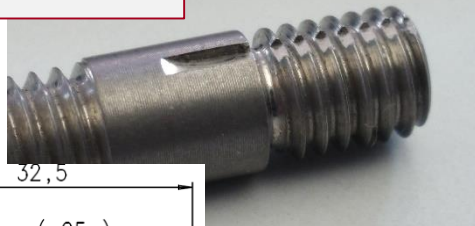
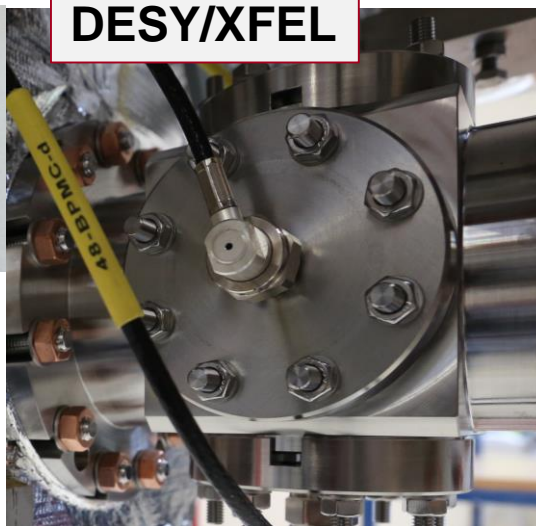
# DESY/FNAL/JLab comparison: BPM feedthrough fasteners

Titanium grade 5 SHCS fasteners intended, not spec'd

Titanium grade 2 SHCS fasteners ordered/received

Hardware is UHV cleaned, not electropolished

F1.3-06 assembly was missing the SS washers – all others checked and ok

Titanium grade 5 studs – specialized design

316L (A4-70) hex nuts

316L (A4-70) washers

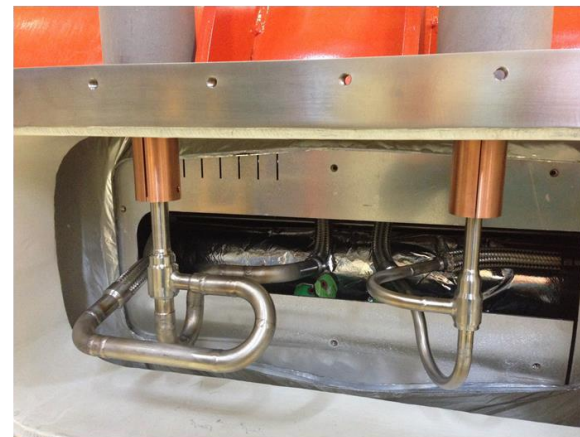
Reverse Direction

JT and CD valves are welded with reverse configuration

Gas guarded DN10 size JT and CD valves with reverse configuration is installed on some tested CMs and will be installed on all CMs before shipping to SLAC.

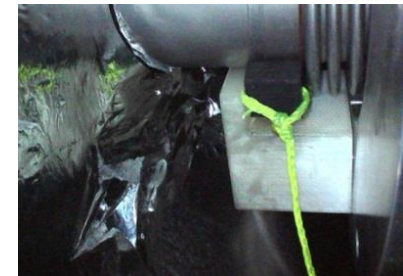
M-mounts installed to support the cold end coupler bellows during CM transport (removed at SLAC)
