LARP

RC Status Report

17 May 2011

SLAC RC Design Details

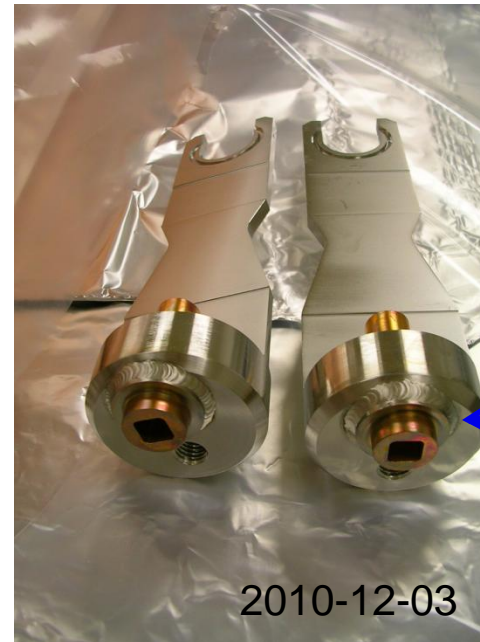
Bellows Fixtured, Protected and Welded to Vacuum Side of Baseplate

Cooling Tube Feedthrough Welded to A286 SS Jaw Support

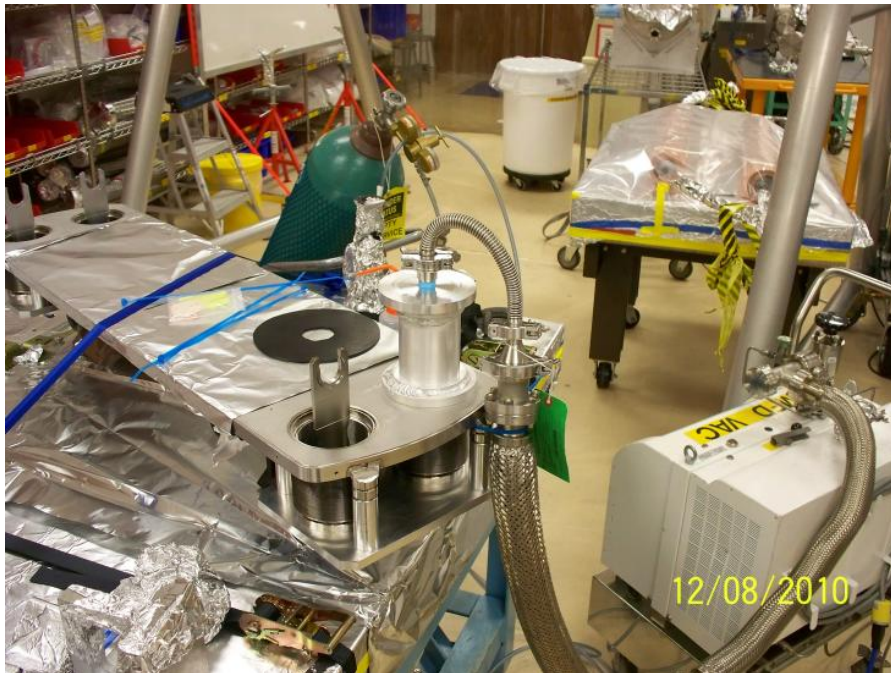
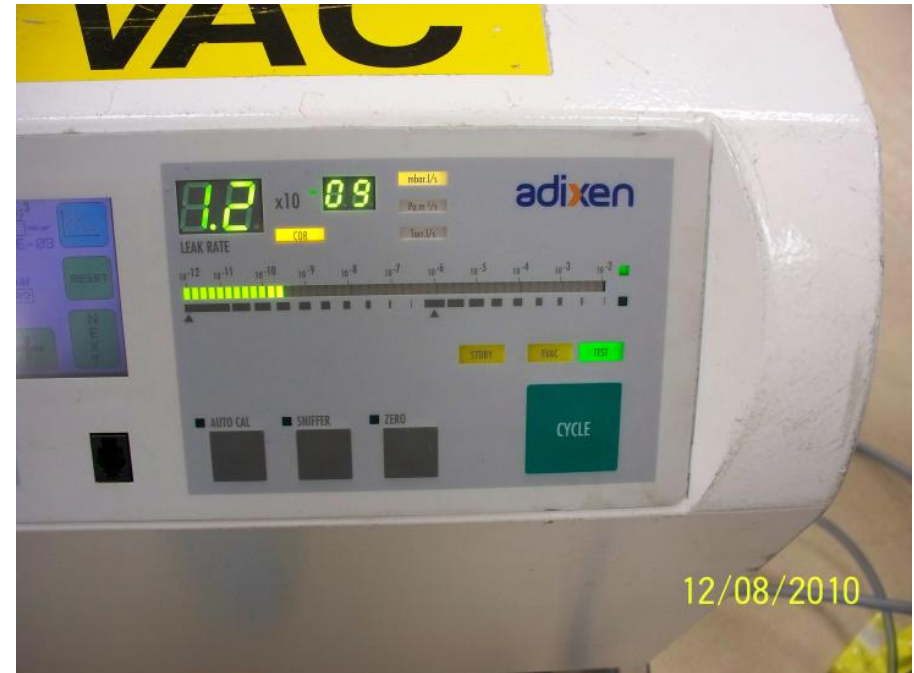
Leak Checking Bellows Welds

Leak Rate in mbar-l/sec (1.2E-9)

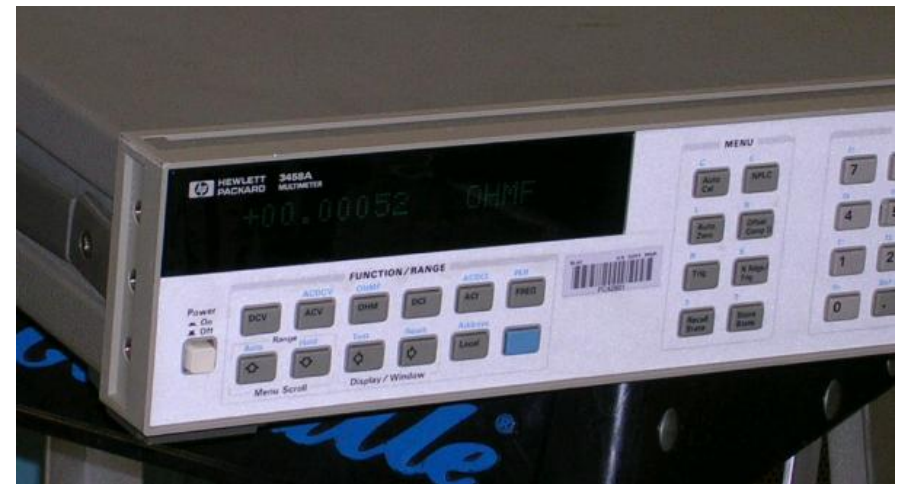
RF Continuity: $R \sim 1-2 \text{ m}\Omega$

Checked for each facet of each side of both jaws

Example: 4-wire resistance = $0.5 \text{ m}\Omega$

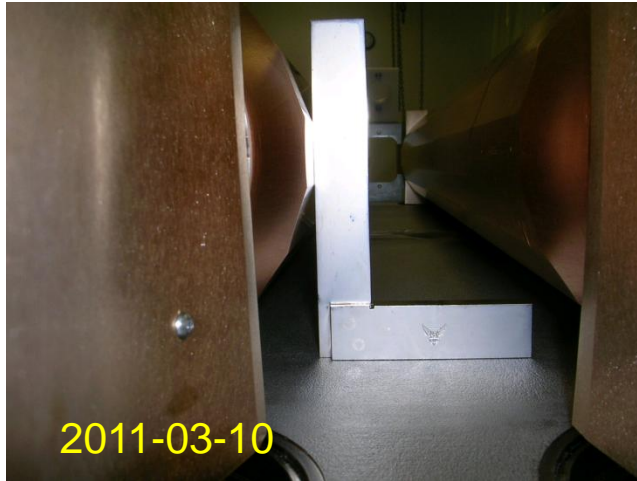
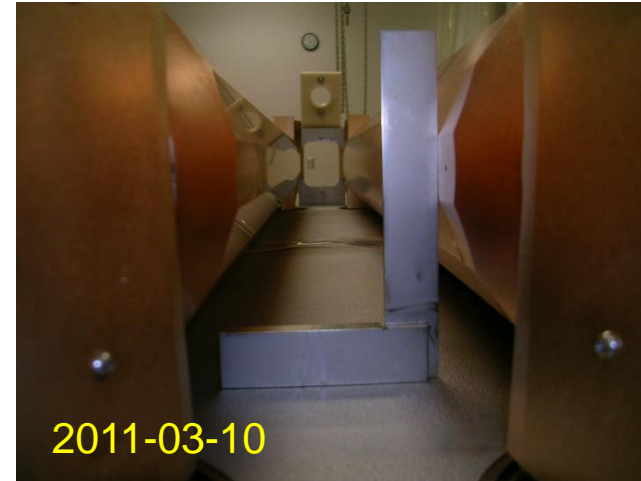
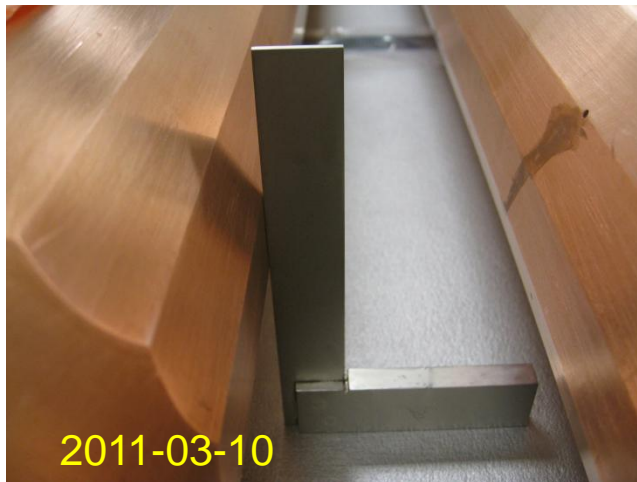
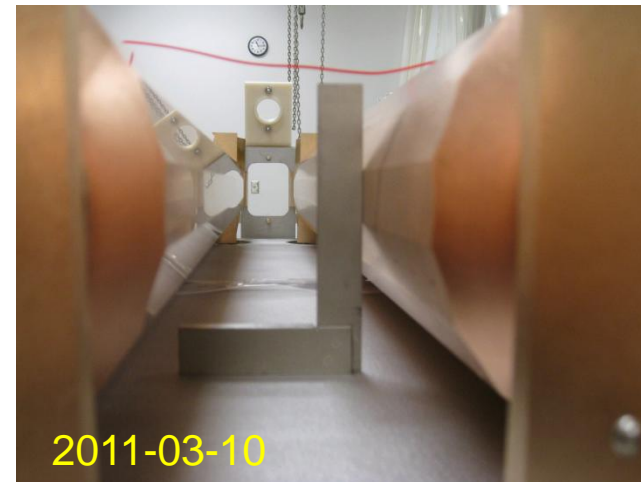
Rotation Test 1 Successful

**Tubes captured, Pre-weld of Internal Parts (13-Mar-2011)
First Permanent “Twist” of Long Straight Length of Cooling Tubes**

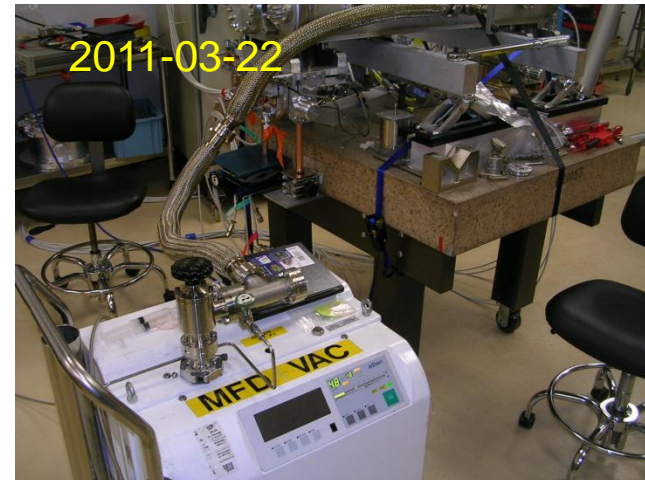
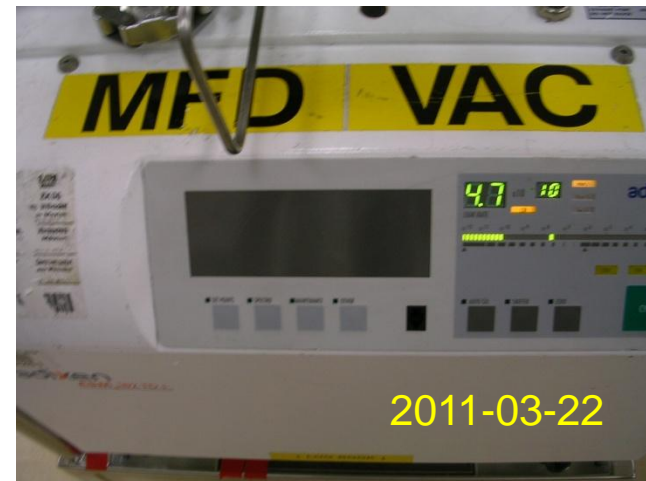
Tubes sealing
cooling tube feedthroughs
to check vacuum quality of
tank weld

Leak Rate = $4.7\text{E}-10$ mbar-l/s

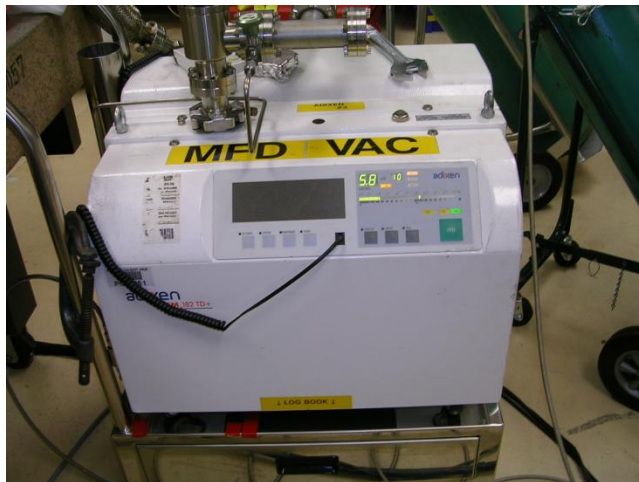
When Cooling Tubes Capped and Tank Pumped Vacuum IS Good

Pressure: 1.9E-5 Torr (via Cold Cathode Gauge)
Leak rate: 5.9E-10 mbar-l/sec (on the Adixen)

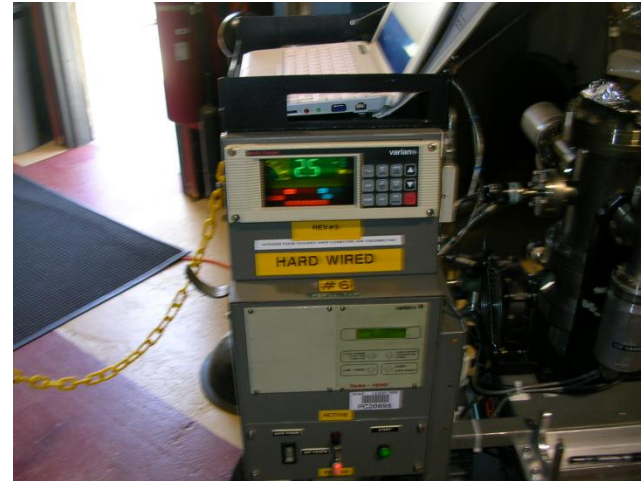
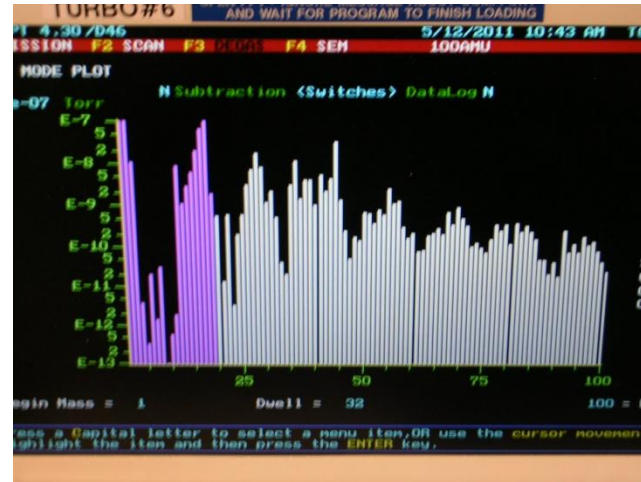
Pressure and Leak Rate Good Enough to Begin Vacuum Bakeout of Vessel with Capped Cooling Coils 2011-04-29

T~240°C and P=6.1E-7 at RGA Input on 2011-05-12

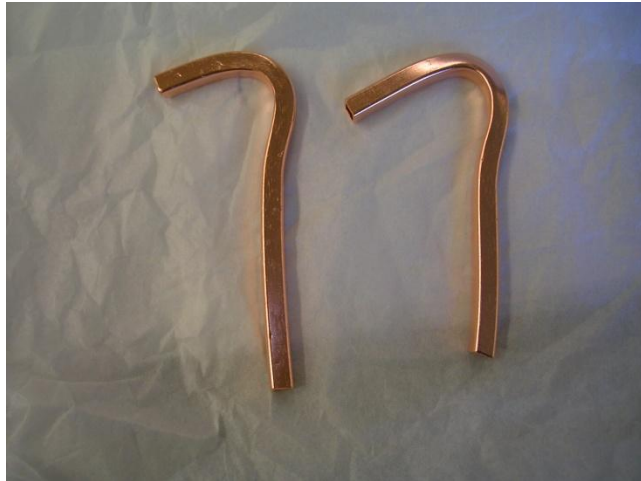
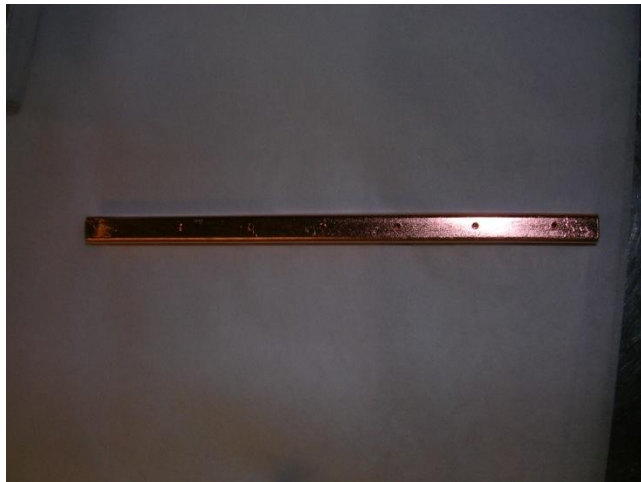
Furnace Runs to try to Duplicate Problems

LARP Bent & Straight Samples

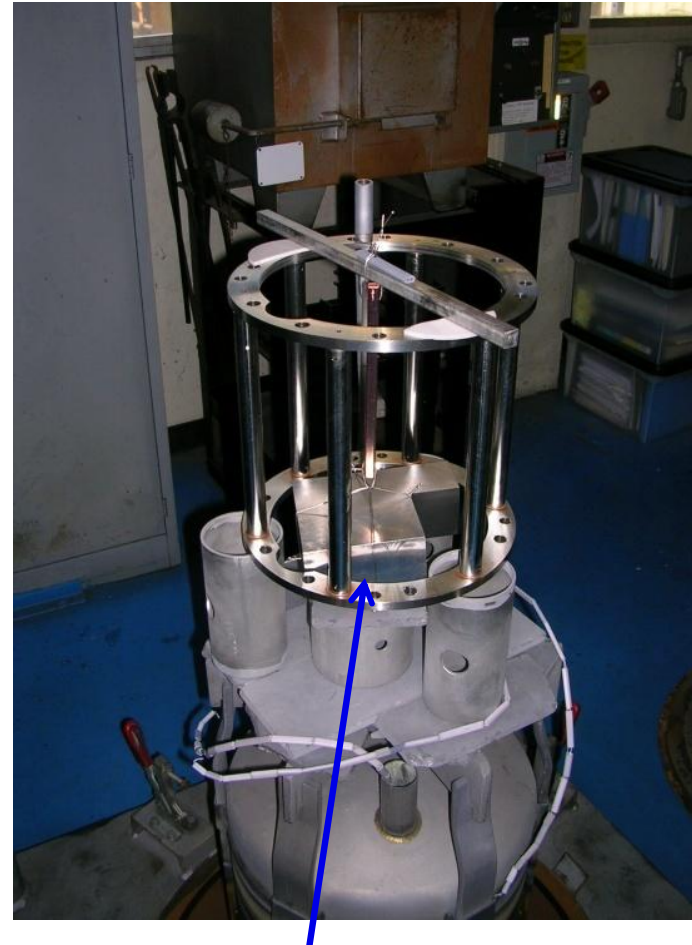
Straight Sample on Braze Oven Stand

32# Tungsten Block to Provide Stress
