CRP6 ColdBox testing update

11/28/2023

Roger, Cheng-Ju, Volodya

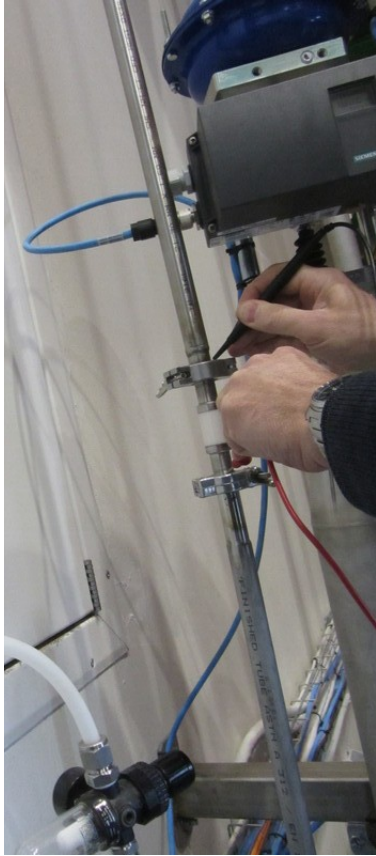
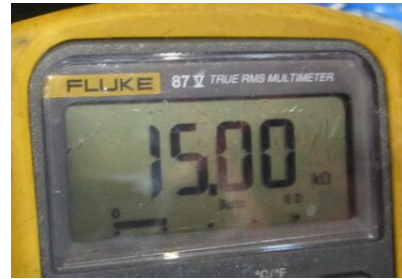
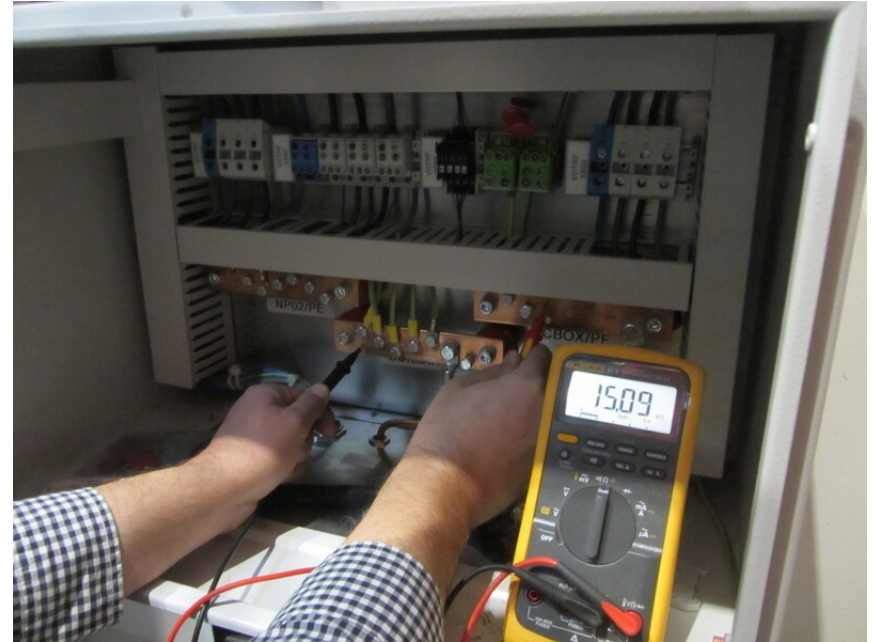
Measured 15 kOhm between ColdBox and Building Ground

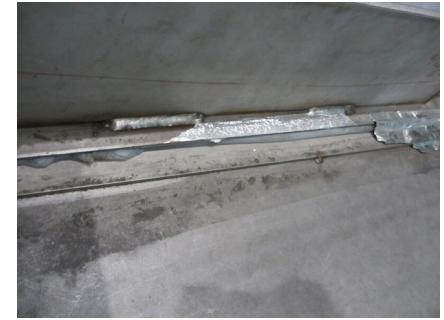
before

Changes made on the top of ColdBox to improve noise conditions (for the previous slide)

- 1) Heaters disconnected and related PTs; flange covered.
- 2) Disconnected CRP metallic frame temperature probes at the flange and terminated
- 3) Connected Cathode HV cable at the Power Supply
- 4) Sealed remaining gaps around the lid with Al foil
- 5) Tightened ground plugs on camera flange.
